# RESIDENTIAL BUILDING SURVEY

XXXXXXXXXX,  
XXXXXXXXXX,  
Bedfordshire,  
MK41 xxx

Prepared by:  
[XXXXXXXXXXXXXXXXXX](#)  
INDEPENDENT CHARTERED SURVEYORS

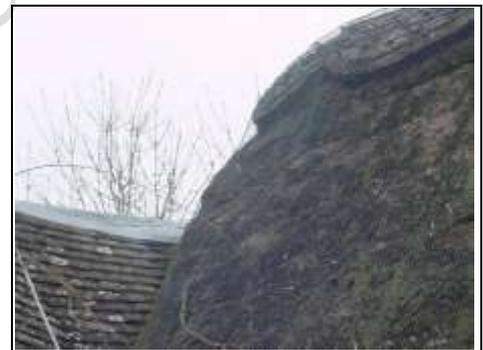
Moss in the thatched roof

Deteriorating thatched roof

**ACTION REQUIRED:** Obtain quotations for the thatch work. We would leave it to the Thatcher's discretion as to what they feel needs doing. We would obtain three quotations. You advised that you knew a Thatcher and from our discussions with the neighbours Dobsons Thatchers were employed to carry out the work on their property. We would recommend having a discussion with the neighbours about the quality of work etc.

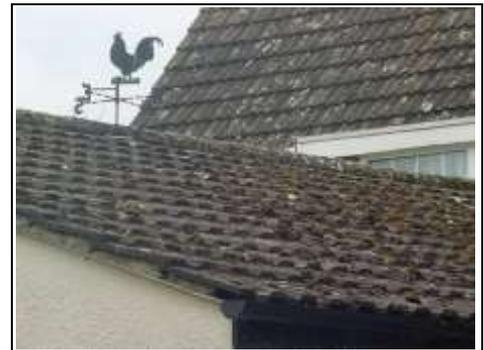
This is a shallow pitched roof and as such the tile finish will be particularly prone to damage from the moss.

Moss on the garage roof

**ACTION REQUIRED:** In the summer months use a soft brush (so that the surface of the tile is not damaged) to remove the moss from the roofs. If this causes damage to the tile surface then we would recommend that you stop and call us and we will advise further. We would also recommend that the trees are maintained as often as needed as this will help with the level of sunlight in the area as well as air movement, both of which should help to reduce the moss.

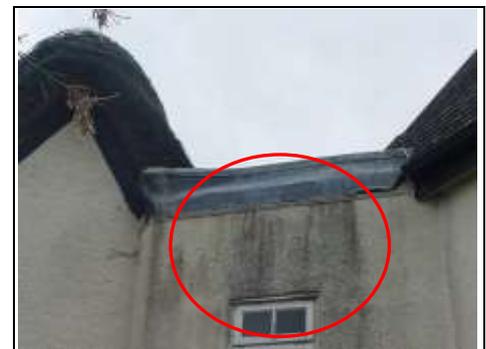
Pattern staining to the rear of the property due to the lack of detail

**ACTION REQUIRED:** We would begin by adding lead externally to make this area watertight and then carry out investigations internally, by this we mean opening up the structure. We would also add a drip detail to the rear of the property but having said that there may still be problems with pattern staining as this is quite an awkward detail.

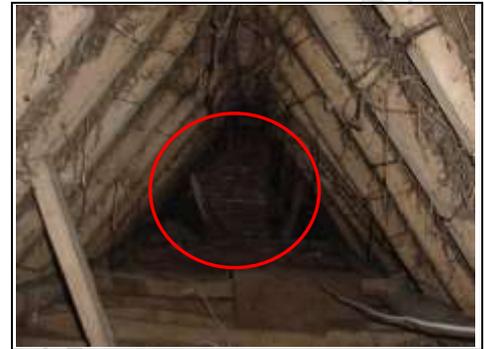
No firewall

**ACTION REQUIRED:** It is recommended that a firewall is added here and it should be as lightweight as possible. We believe there is both a boarding that can be used to create a firewall and also a blanket.

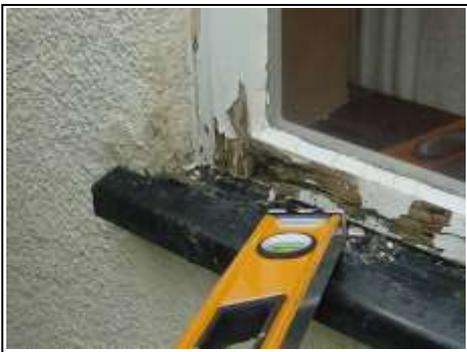
Rotting window due to there being no drip detail above and the quality of timber is not that good

**ACTION REQUIRED:** Initially we would recommend that drips are added to the render above the windows and bell mouths are added to the base of the property.

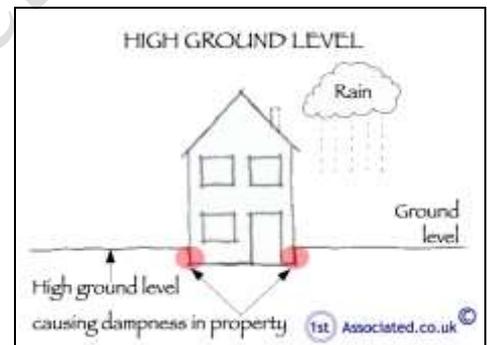
High ground level

Great care needs to be taken when the ground level is being lowered in this area to ensure that you do not do more damage than good. All things being equal the property should benefit from less dampness.

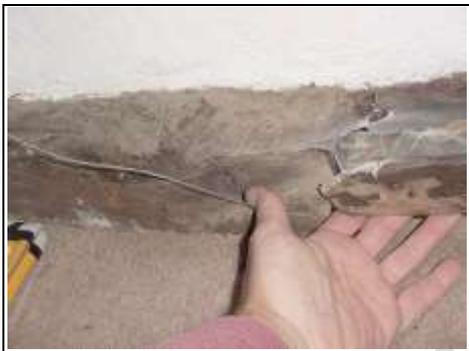
Visible sole plate, middle of the room, has areas of rot

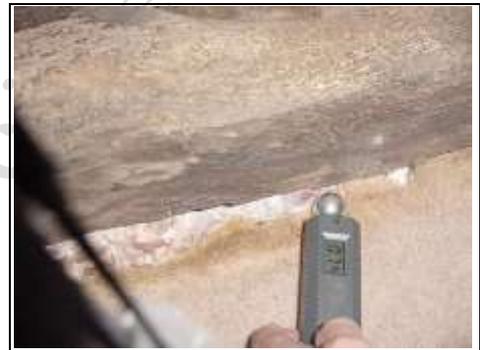
High reading of 74 to the stone/tile below the sole plate explains the rot

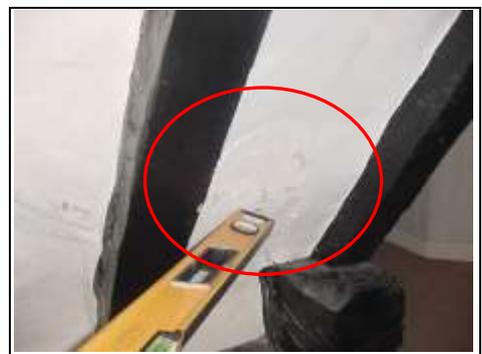
There is also dampness getting in at high level to the bedroom in the older property which we think is being caused by a defect in the thatch which is allowing water to come through. We cannot be certain of this without seeing the property when it's raining which unfortunately didn't happen during the course of the survey.

Dampness in the older property at high level in the link corridor

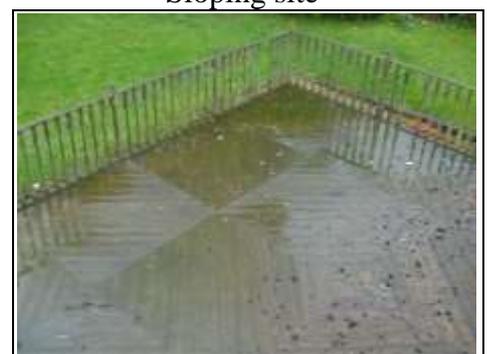
Decking area to rear of property

**ACTION REQUIRED:** We are finding that decking areas are good places for rodents to live and we are generally recommending that they are removed.

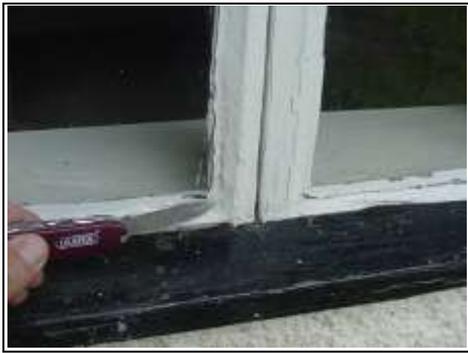
Metal window is deteriorating

**ACTION REQUIRED:** We do believe that the windows are saveable, however with some of them it may be more economical to replace. You do need to repair or replace them before the winter of 2014 as most are already showing bare timber in parts;

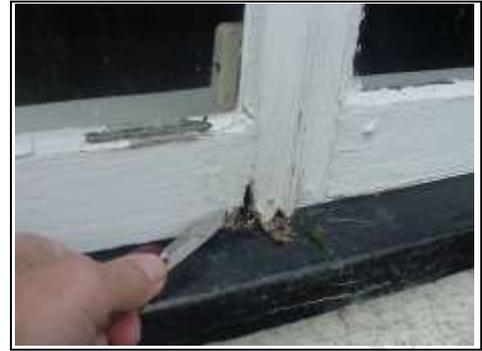
Timber window has rotted through

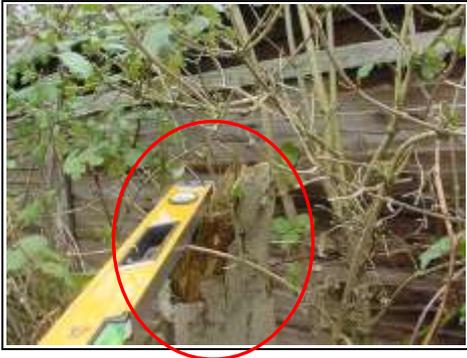
Tree hacked down to the rear right

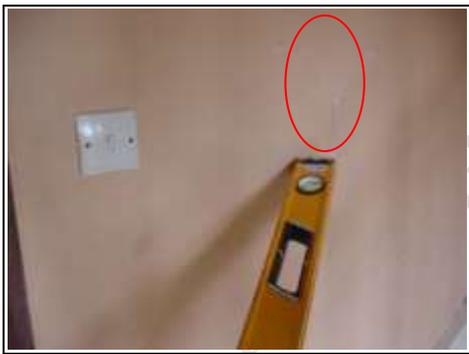
We noted cracking caused by differential movement between the original and the new property and its various amendments.

Crack near the staircase

**ACTION REQUIRED:** Monitor the cracks. By all means repair them but expect them to appear again. Your Legal Advisor to specifically ask if there has been any underpinning with regards to the property as this can cause as many problems as it can solve. If you advise us we can then investigate this further.

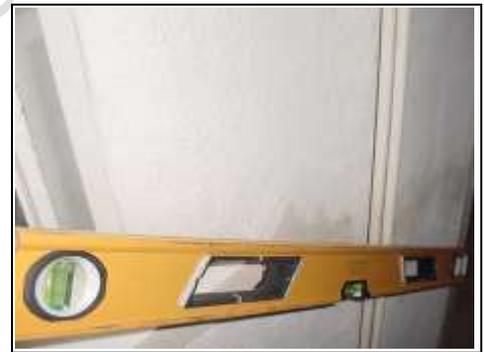
Cracking to the lounge area

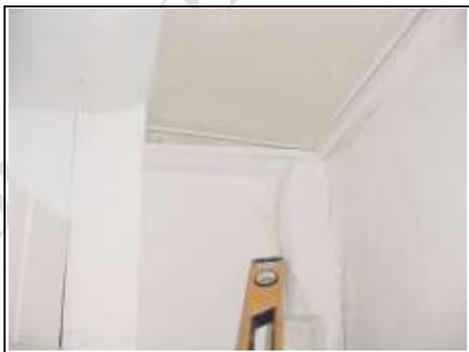
Wall to ceiling crack in the link corridor, first floor

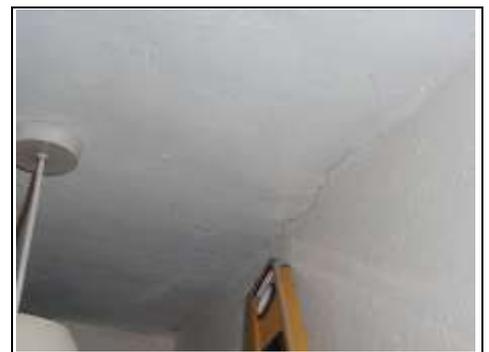
Cracking where the old building meets the new

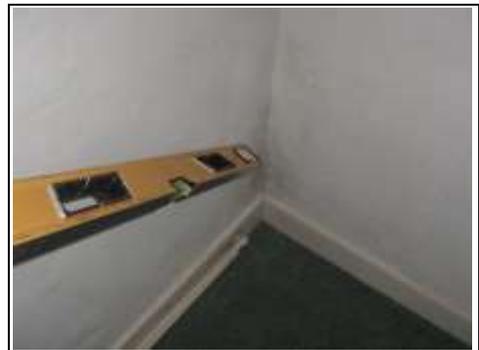
Black mould caused by cold bridging in the bedroom

**ACTION REQUIRED:** There are things you can do to help such as add large humidity controlled extract fans in the bathroom, the kitchen and any rooms that you use for drying. There is a small extract fan in the bathroom but we would prefer to see this replaced with a larger extract fan.

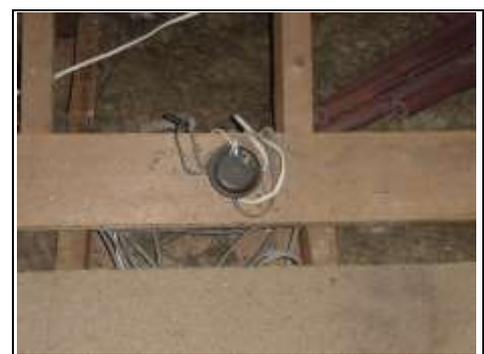
Bakelite fitting

**ACTION REQUIRED:** We would recommend that these are replaced.

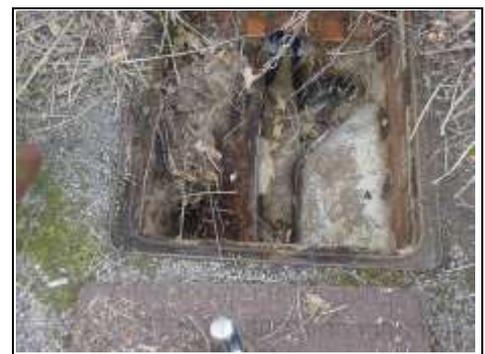
During the course of the survey the only manhole that we found was to the front of the property and this was relatively shallow and was full of roots. However, when we ran the tap from the kitchen the water did not appear to run through this drain. This means it may be bypassing it or it may run to a drain at the rear of the property, possibly with a manhole hidden underneath the decking.

Shallow drain to the front

- 1) Ask the existing owners if there is drainage to the rear of the property. We are advised they are plumbers so they should know.
- 2) Failing that the water board have listening devices and they may be prepared to listen and identify where the drains are.
- 3) Or we know a Surveyor who is good with divining rods (seriously!) and we are sure they will happy to come over to locate the drains.

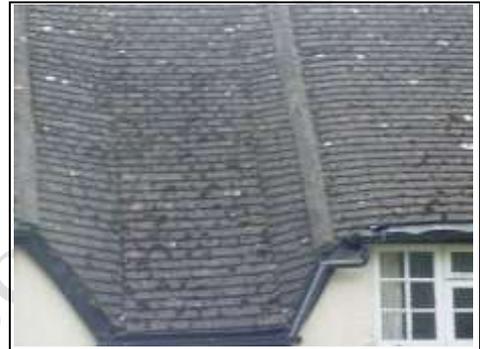
Moss on the tiled roof

**ACTION REQUIRED:** Please see our comments within the Executive Summary about removing the moss but please do not use any chemical sprays as we would say that the jury is still out on what damage these can cause.

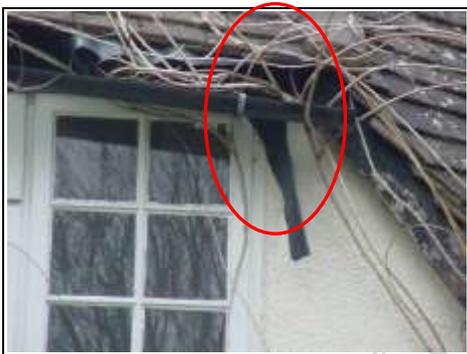
When we inspected the loft space in the modern building we found a Hessian based Bitumen membrane with insulation. This type of membrane has been used since the 1960s. We generally found it to be in average condition, with damage in some areas which is what we typically find.

Sarking felt has come away

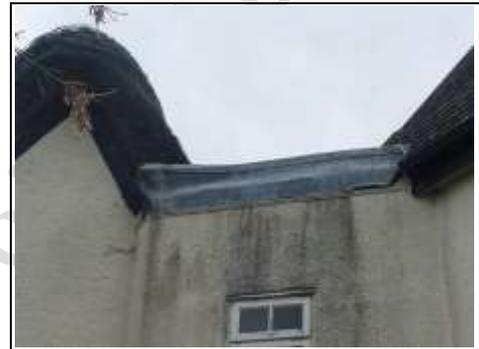
Pattern staining

**ACTION REQUIRED:** We would again clean this roof and check its condition.

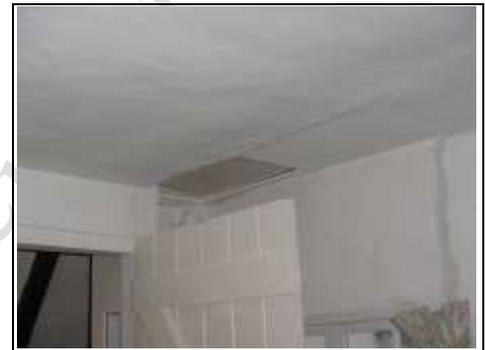
The thatched roof is accessed via the loft hatch located in the rear bedroom behind the door and is just about human sized as it has been formed between the rafters which are between 400 and 500 mm wide. There is no loft ladder, electric light or secured floorboards. We would recommend that a light is fitted but would not recommend that a ladder is added as it would mean adjusting the opening. No secured floorboards should be added as we would not recommend using this roof.

Small access hatch

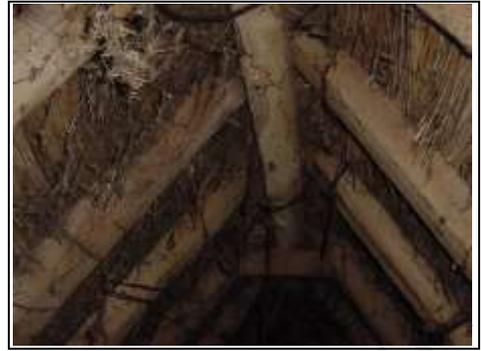
Ridge board- unusual for this age of property indicating it has been renewed post War

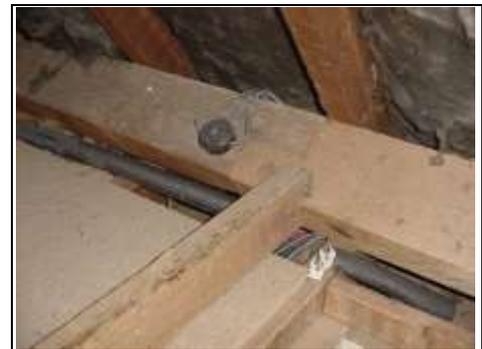
Cross brace is flimsier and thinner than we would expect

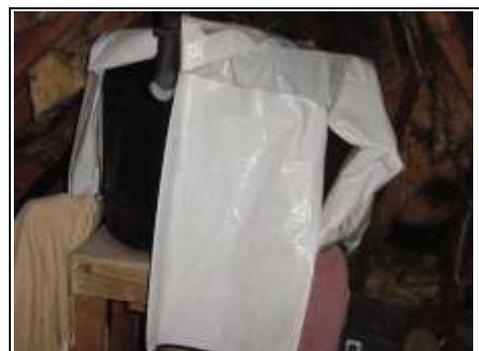
Water tank covered by plastic sheet

We would always recommend that water tanks be drained down and cleared of any debris etc. (we have seen dead birds and other unmentionable things in these tanks). As you are often cleaning your teeth with this water it is best that it is as clean as possible!

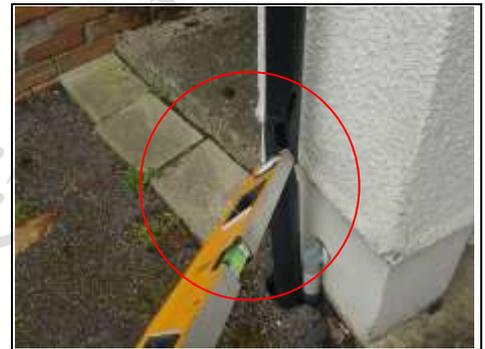
Damage visible to the downpipe left of the garage door

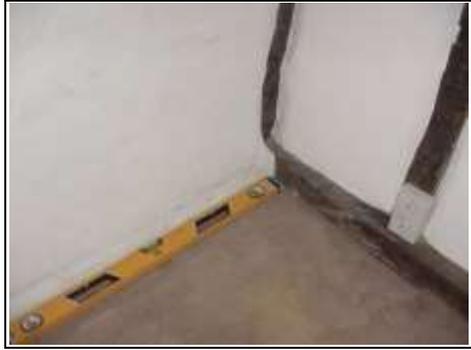
Sole plate not visible to left hand side -level indicates where it should be

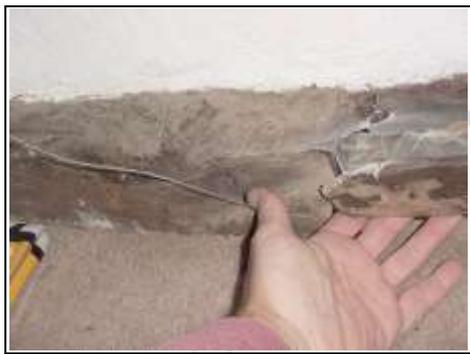
Visible sole plate , middle of the room, has areas of rot

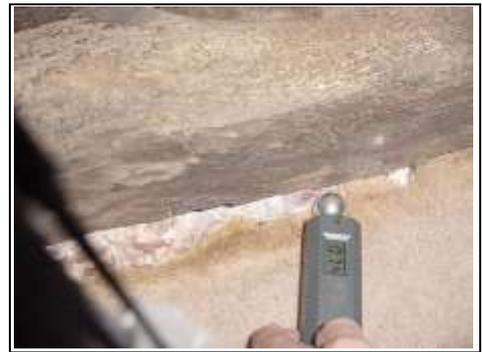
High reading of 74 to the stone/tile below the sole plate explains the rot

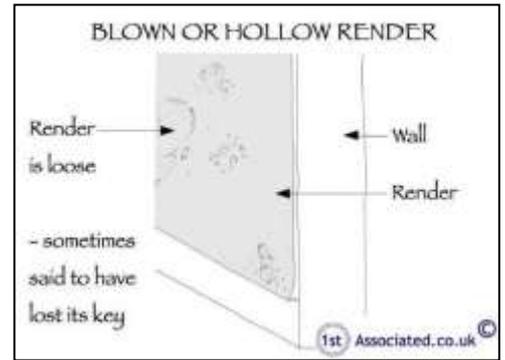
We have carried out a tap test (literally briefly hitting the render with the back of a hammer). We found it to be in average condition for its age, type and style.

Blown or hollow render

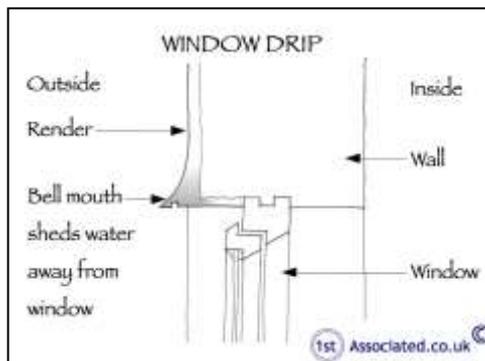
In this case we found no drip detail to the windows.

Window drip

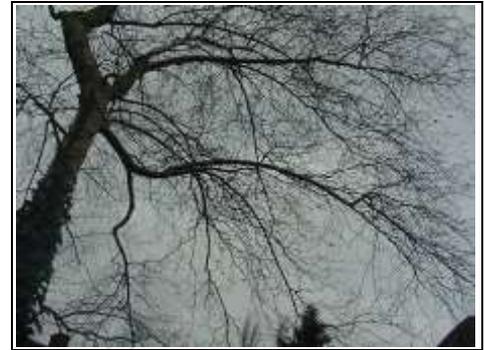
Nearby tree

**ACTION REQUIRED:** Please see our comments within the Executive Summary. We would recommend that you obtain advice from an arboriculturist (not a tree surgeon).

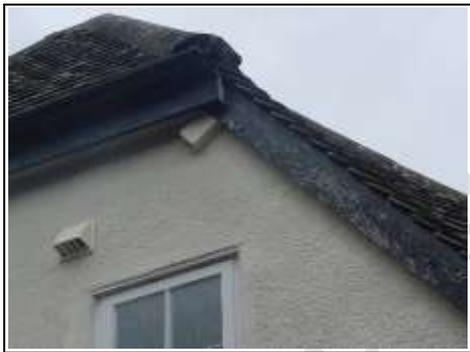
The fascias and soffits to the modern building are timber. We would comment they are in below average condition for their age, type and style. We can see that they are deteriorating with bare timbers visible.

Fascias and soffits need painting to left hand gable

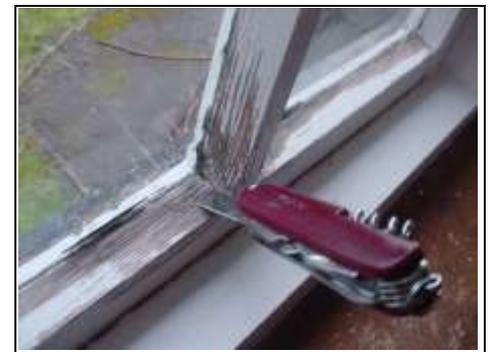
Rotting timber window

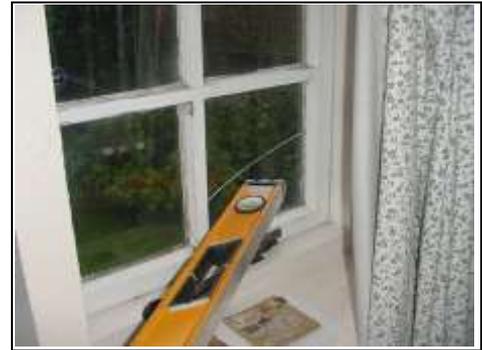
We noted a crack in the glass of a timber window. This can be a sign of movement in a property, although, in this case it may be due to the swelling of the wood and the rotting away of the windows.

Crack in the glass

**ACTION REQUIRED:** Please see our comments within the Executive Summary. We do believe the windows are saveable but whether it is the most economical way forward is a different question.

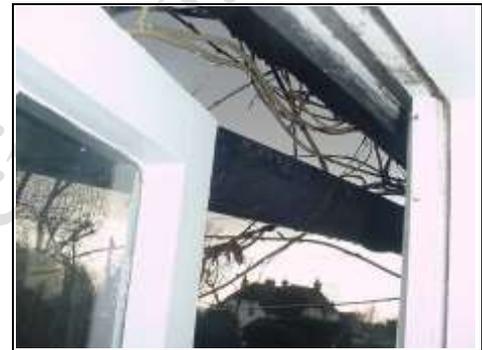
Window hits the guttering when opened in the modern property

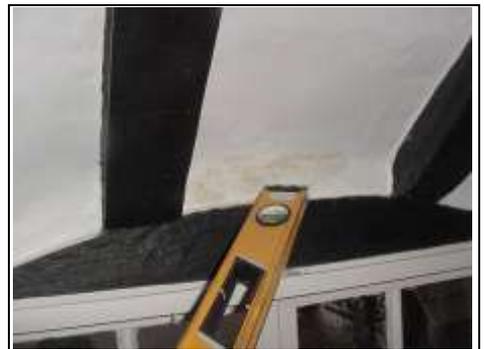
Pattern staining to wall above window in master bedroom

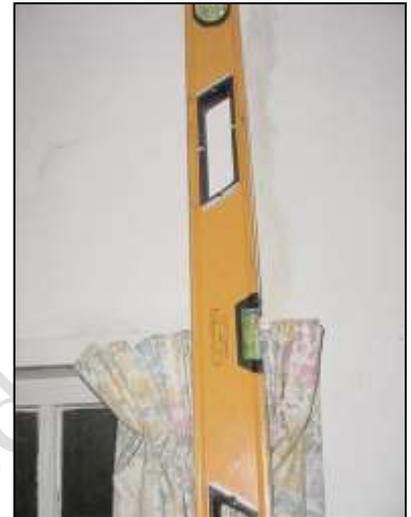
Cracking to small bedroom  
in older building travels  
between the wall and the  
ceiling

Vertical cracking in small  
bedroom

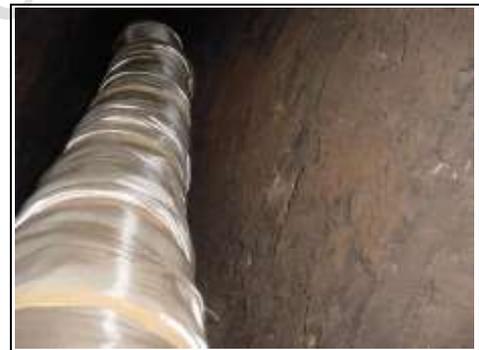
Possible asbestos in the chimney

Lining in the chimney

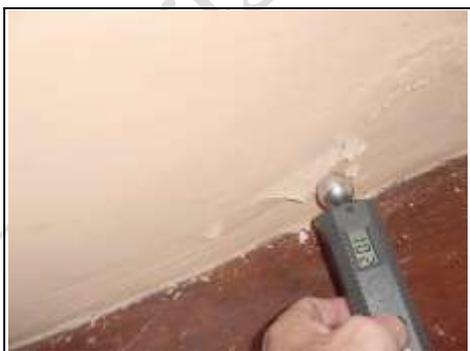
High dampness level noted under the window in the hallway

**ACTION REQUIRED:** Please see the Executive Summary.

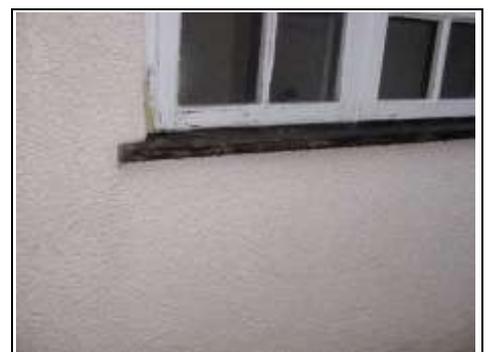
There was no obvious crack noted on the outside of the wall in relation to the damp under the window

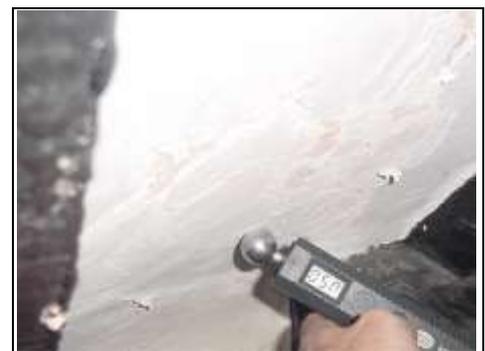
This area has been damp but was not at the time of the survey

Dampness noted to the linked roof area

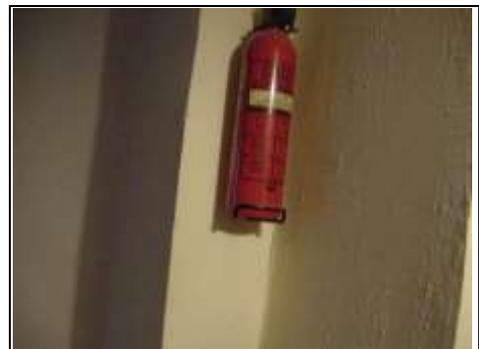
We do not think this will be satisfactory if the thatch should start to burn

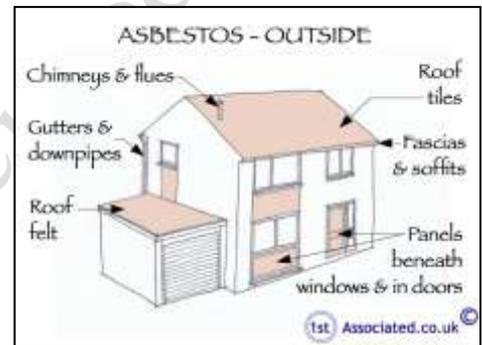
Asbestos externally

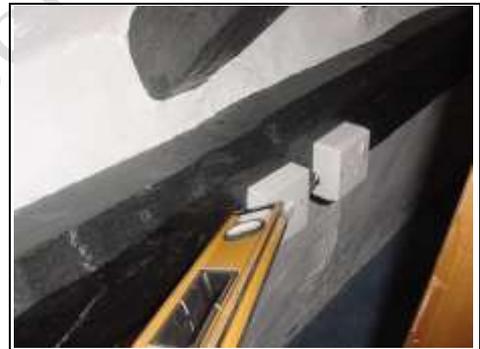
Single socket points

**ACTION REQUIRED:** You may wish to add double socket points.

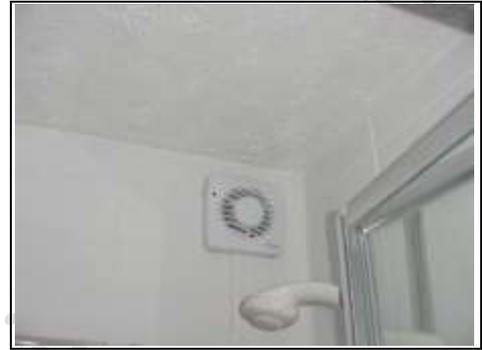
Small extract fan in bathroom
