RESIDENTIAL BUILDING SURVEY

Edgware, Middlesex

Post War
End of Terrace
Property

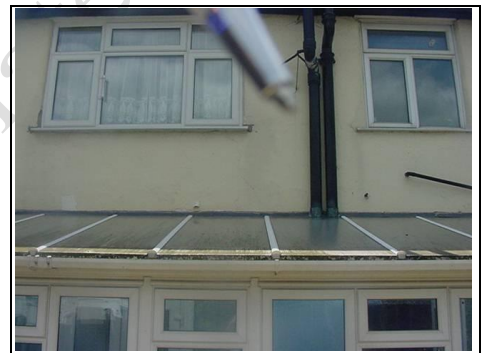
There has been movement to the property with cracking indicating problems to the rear left hand corner (all directions given as you face the front of the property). The movement may have something to do with drainage problems.

Cracking to the rear

ACTION REQUIRED: Existing owner to put in an insurance claim with regard to subsidence, by doing this you will have a limit on your liability of the excess, typically a few thousand pounds. The insurance company will monitor for a year as recommended by the Building Research Establishment which is far better than our one off inspection.

ANTICIPATED COST: A few thousand pounds, whatever the excess is. You need to have this reduced from the price of the property, if not more to allow for the inconvenience of sorting out the problem and the risk you are taking. We therefore recommend you double the figure.

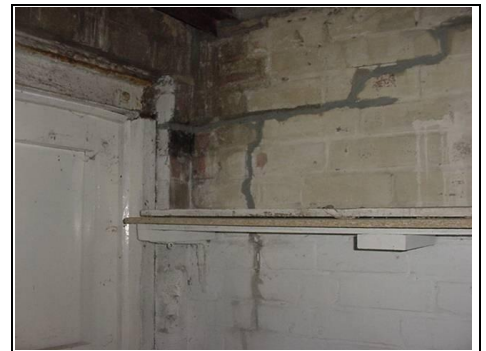
Movement to front of garage

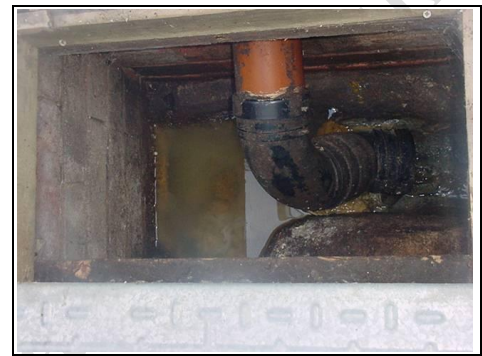
The rear man hole has had additional waste put into it, possibly from the shower and W.C. We don't believe this is up to Building Regulations standards. We would also comment that the smells from this could filter into the conservatory.

Internal manhole not to building regulations

ACTION REQUIRED: As we feel the drains may be a problem that is causing cracking in the property we would recommend a close circuit TV camera report of the whole drainage system. Your solicitor needs to check to ensure that Building Regulations and Planning Permissions have been obtained for this rear extension.

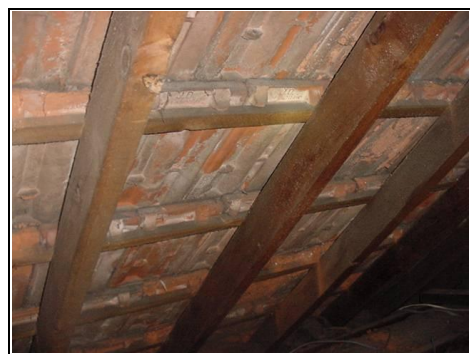
No felt in roof

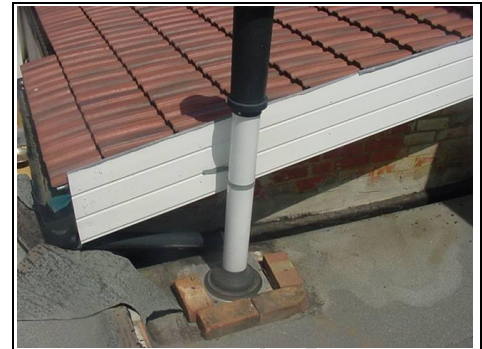
There is a very poorly detailed side roof, dampness is coming in and can be clearly seen within the conservatory/shower room area.

Looking down from garage roof at leak

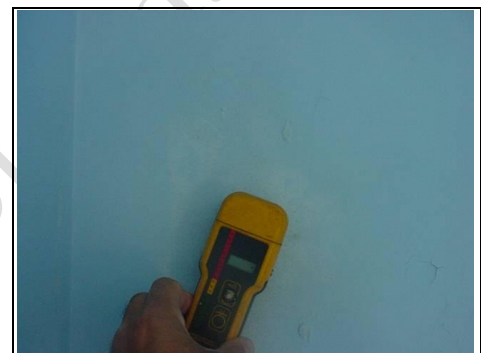
Dampness

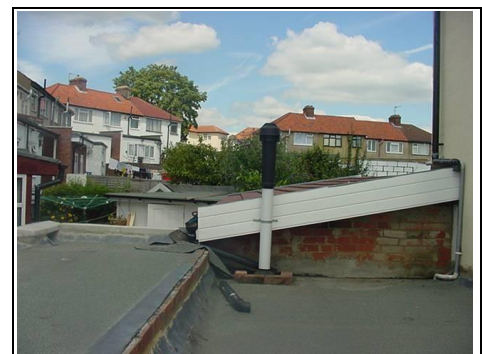
We would term the garage roof as being lightweight supported on metal bars with a sterling board (composite board) as the decking. We could feel it moving underfoot. We would also comment that the parapet wall detailing is poor and we would say prone to allow some dampness in.

Garage roof

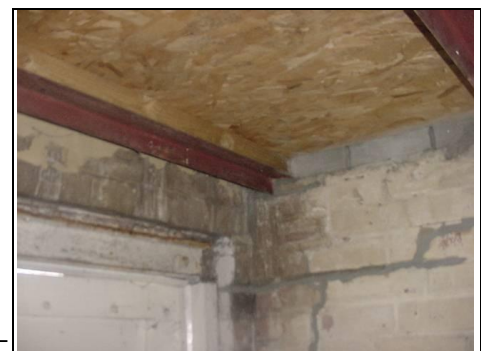
Metal joists in garage roof

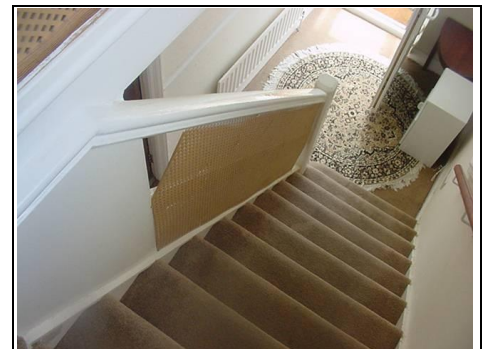
Balustrade to staircase

ACTION REQUIRED: You need a new balustrade if you are not happy with the existing one.

ANTICIPATED COST: In the region of £500 - £1,000 or more depending upon what you want or whether you are happy to repair this one; quotations required.

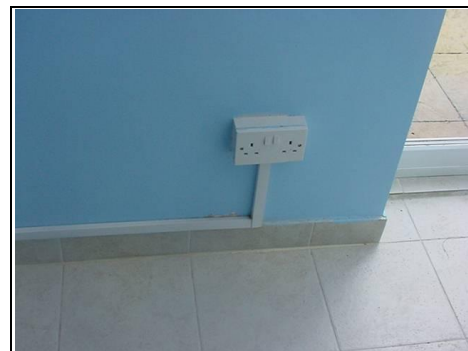
We noted an unusually large amount of surface mounted electrics to the conservatory area. As you are aware we are concerned about how this has been constructed. Has this been checked to Institute of Electrical Engineers standards?

Surface mounted electric wiring

ACTION REQUIRED: Check that there has been an electrical certificate on the whole of the property. The Institute of Electrical Engineers (IEE) recommend an NICEIC registered and approved electrical contractor carry out an inspection, test and report.

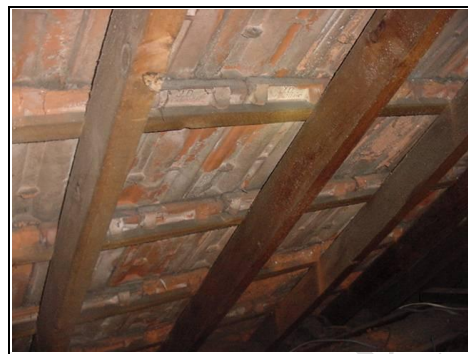
When we inspected the loft space we found there was no underfelt and it is therefore possible that during periods of heavy and prolonged driving rain some water penetration could take place through the roof coverings.

At the time of our inspection it was not raining and we could see light shining through indicating that rain could get through too.

No underfelt in roof

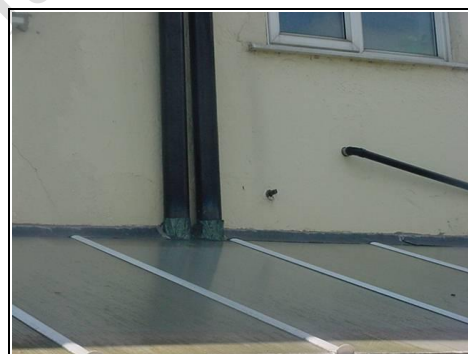
The polycarbonate roof generally looks in average condition and we did not notice any staining which often indicates there are problems. We generally find that polycarbonate roofs that have a reasonable fall on them tend to be the most watertight in this case the roof fall is shallowish. We would also be concerned about the quality of the flashing.

Conservatory roof

ACTION REQUIRED: We would expect leaks in this roof sooner or later.

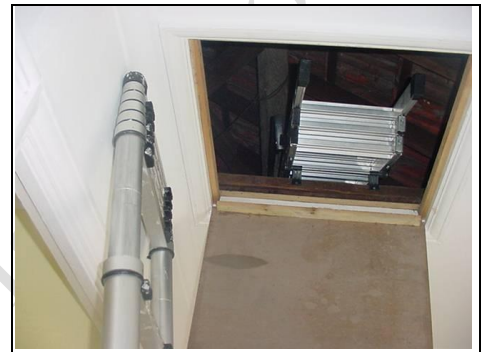
The main roof is the only accessible roof. The main roof is accessed via the loft hatch located on the landing. We had difficulty accessing the loft as we couldn't get the loft ladder down therefore we had to access beside the existing loft ladder. However assuming that it does work there is an electric light and some partial boarding throughout. The loft perimeter has been viewed by torch light which has limited our viewing slightly.

We couldn't get loft ladder down

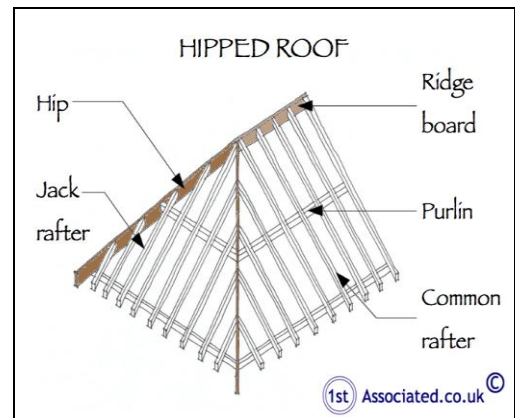
This type of roof structure has what is known as a cut hipped timber roof. This is a roof that is purpose made and hand built on site. Without the original design details we cannot categorically confirm that there are no defects however we would comment given the condition of the roof that some wind driven rain may get in and cause deterioration and there is also a twist in the roof.

Hipped roofs are renowned for slippage/movement

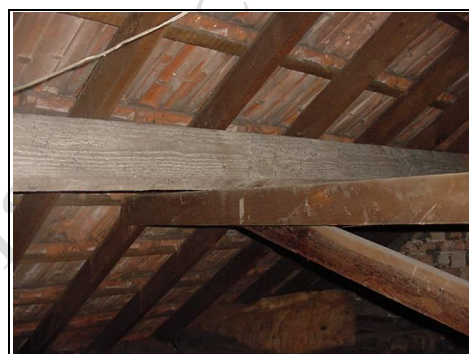
Purlins look newer than main timbers

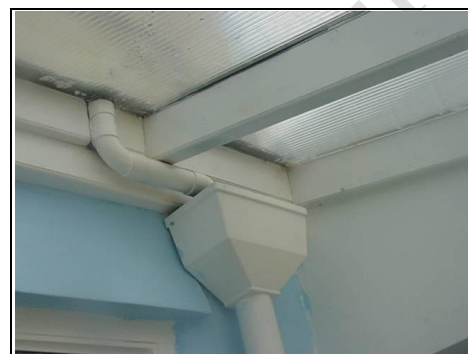
There is a hopper head within the conservatory which is not ideal. We noticed rainwater and foul water using the same pipe system over ground which isn't normally the case.

Hopper head within conservatory

ACTION REQUIRED: We would always recommend that the gutters and downpipes are cleaned out, the joints are checked and the alignment checked to ensure that the gutters fall towards the downpipes.

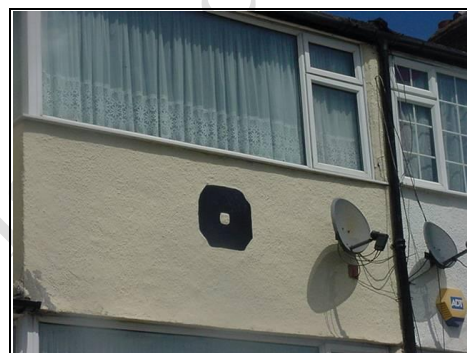
We have carried out a tap test to the render at low level (literally hitting the render with the back of a hammer) to try to establish if there are any hollow areas. We have found some areas but not too many.

Painted render

We discussed work to ensure the situation did not get worse and we feel roof, box gutter repairs and redecoration will help considerably.

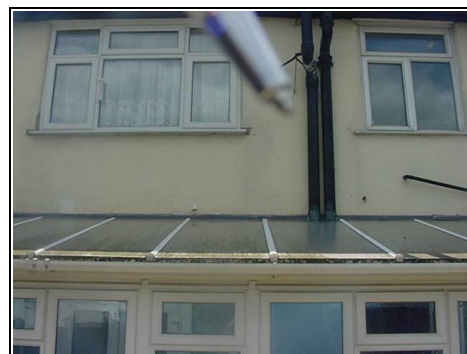
Cracks to render

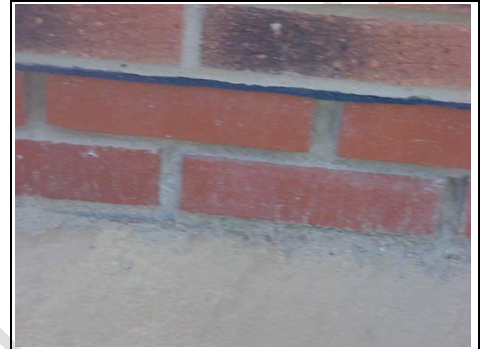
All modern properties should incorporate a damp proof course (DPC) and good building practice dictates that a differential of 150mm (6 inches) should be maintained between the damp proof course and ground levels. In this case, we can see a damp proof course to the rear of the property. Unfortunately to the older part which is far more important, we couldn't see a DPC due to the render.

Unusual detail as no mortar in some of the joints

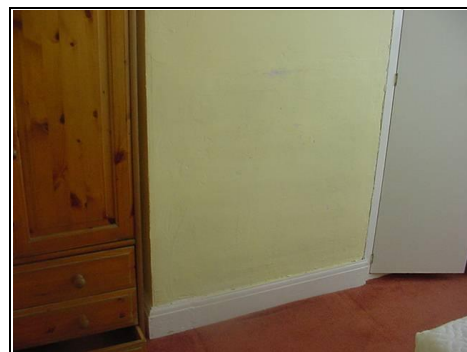
Tidying up required and vents to be added to stop the sulphate causing damage as it needs airing

ACTION REQUIRED: Airbricks to be added as soon as possible.

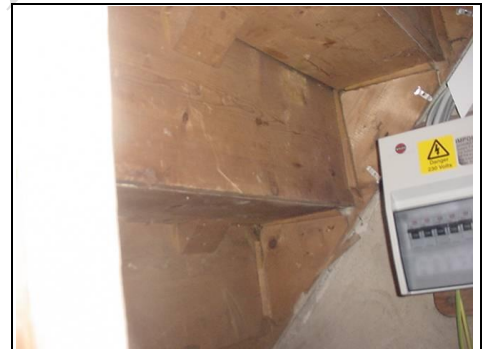
Staircase not lined

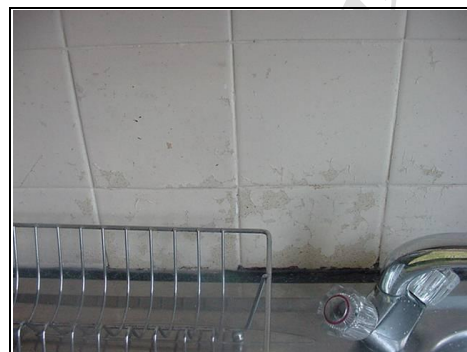
Kitchen tiles have been painted

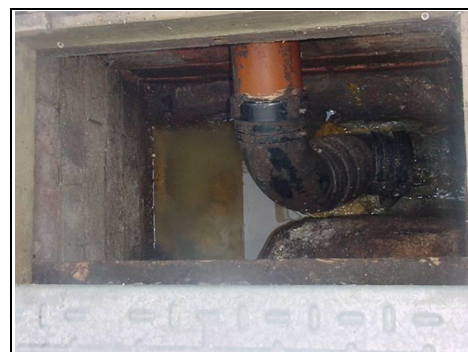
Internal manhole – not to building regulations

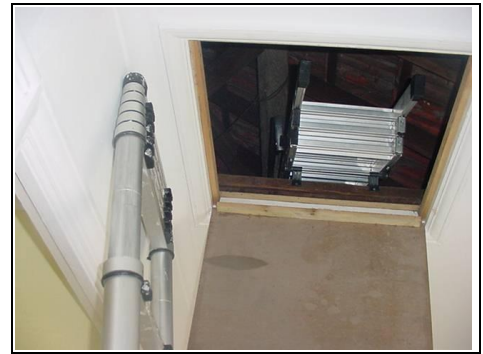
Difficulty in getting into roof as couldn't get ladder out
