# RESIDENTIAL BUILDING SURVEY

**Bedford  
Bedfordshire  
MK41 xxx**

INDEPENDENT CHARTERED SURVEYORS

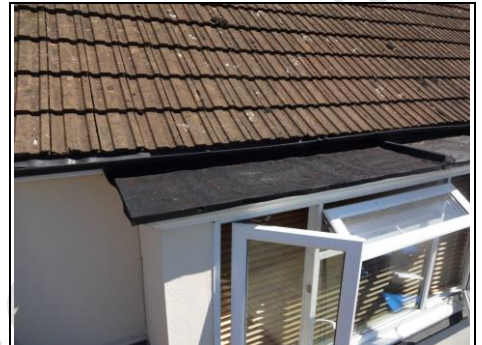
There is a flat roof to the front over the box bay window which will need replacing in the next few years or it could be patched repaired indefinitely. It may be worth adding some insulation when it is replaced.

Flat roof to the front  
Ariel view – 360 photo

**ACTION REQUIRED:** We would recommend replacing the roof as soon as you get in the property otherwise we tend to forget things like this and ensure that you use the best quality felt such as a high performance elastomeric felt.

**ANTICIPATED COST:** £250 - £1,000 depending on whether it is repairable or it needs to be replaced.

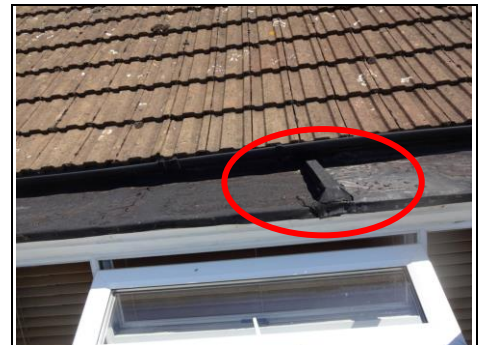
Split in the felt to the front  
flat roof  
Ariel view – 360 photo

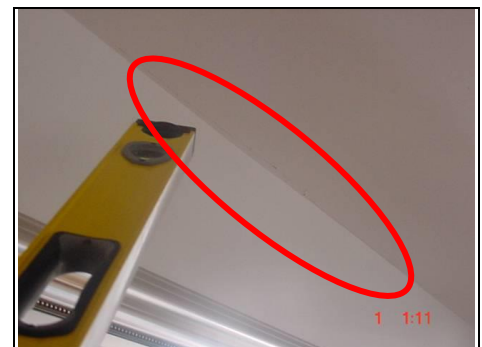
Where a building has been considerably altered such as this you can get movement starting to occur. When an old building has been altered so much we do find you tend to get hairline cracking in the plaster particularly where supporting walls have been removed or altered.

In this case there are a few hairline cracks which we feel we should mention as they may be noted when you look to sell the property and you can identify them as already being there when you originally brought the property.

Hair line cracking to the rear reception room

**ACTION REQUIRED:** Monitor.

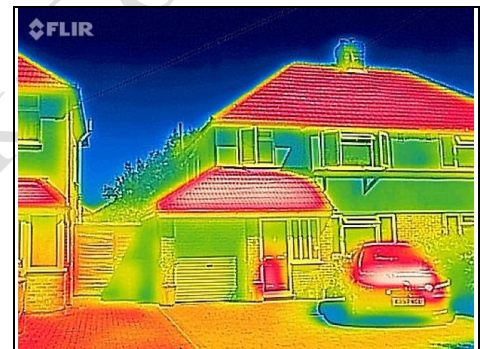
We are finding that modern extensions, particularly ones like this where there have been considerable extensions to an older property, ~~which~~ are getting over heating from solar gain (when it is sunny) during the summer months. This does of course depend on upon how warm you like to live in this property.

Thermal image  
Ariel view – 360 photo

**ACTION REQUIRED:** There is little you can do about this, you need to consider it the character of this era and type of building and building extension.

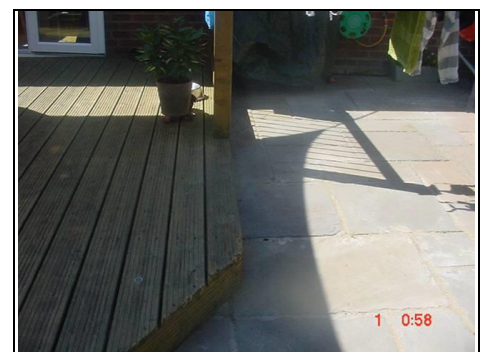
Decking to the rear garden

In this particular case the decking is against the property which can cause dampness problems.

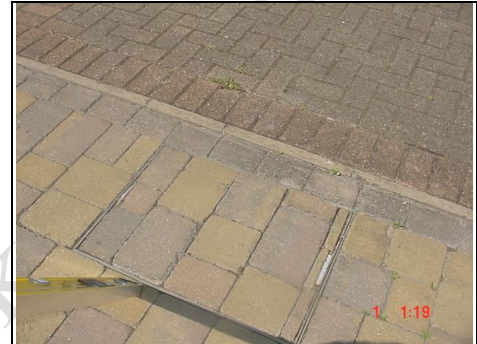
We only found one manhole to the front of the property. There may well be manholes hidden underneath the extended property.

The owner has advised us in the question and answers sheet that there are rodding eyes / access points underneath the cooler and sink area.

Manhole to the front of the property

**ACTION REQUIRED:** We would recommend you ask the existing owner to show you where the rodding eyes / access points are and ideally have the manhole lifted to check the condition of the drains.

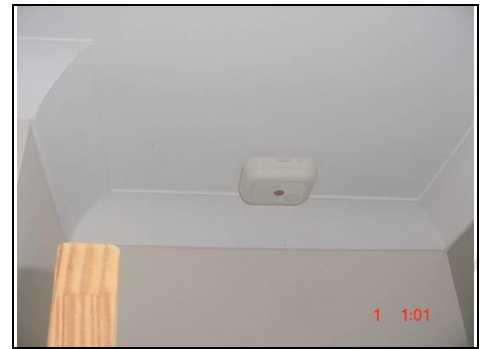
Some smoke detectors were noted; we were disappointed to see these were battery operated. The current Building Regulations require that they be hard wired into the main power supply.

Battery fire alarm

**ACTION REQUIRED:** We would recommend, for your own safety, that additional smoke detectors are installed. We would always recommend a hard wired fire alarm system and are that you are also aware that some now work from a wireless signal which may be worth investigating.

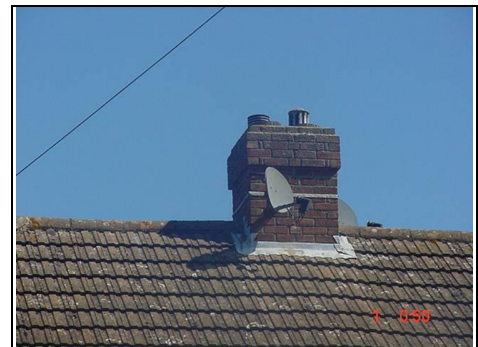
This chimney is brick finished with a lead flashing and two chimney pots. From what we could see from ground level it looked in average condition considering its age, type and style.

We noted a satellite dish is attached to the chimney which we are not keen on as it cuts into the brickwork rather like a cheese wire cutting into cheese.

Brick chimney to the right side

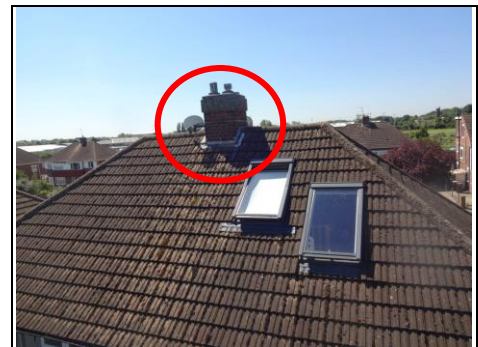
There does look to have been something happening to the flashing but we could not be certain from ground level.

The flashing to the chimney needs to be checked  
Ariel view – 360 photo

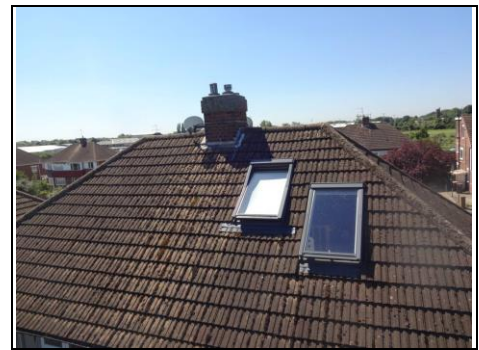
The main roof is pitched and clad with a concrete tile and, from ground level, this looks in average condition considering the roofs age type and style.

This is a hipped roof and integrally unstable as they literally lean upon themselves. This is probably the most prone to roof spread of all the roof designs that we come across.

Main roof

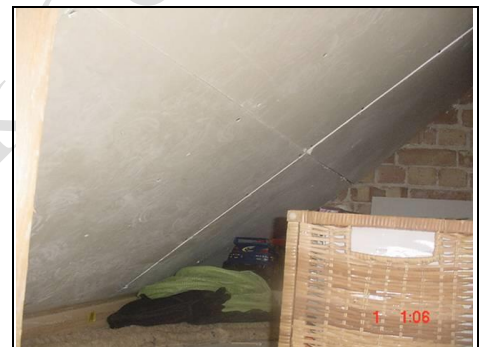
General view of inside of roof which is boarded over

**ACTION REQUIRED:** The only way to be 100 per cent certain would be to have the boarding removed so we can actually inspect the roof structure.

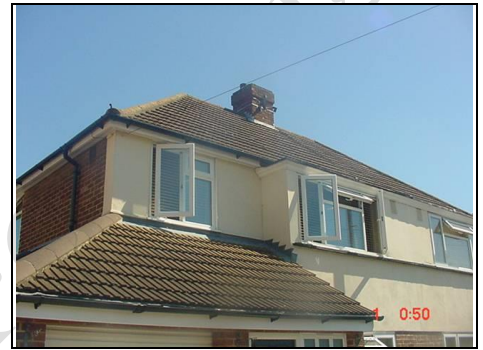
The gutters and downpipes are plastic. They are in average condition for their age, type and style.

There may be some minor leaks but most people would be happy to live with these providing repairs are carried out within the next six to twelve months.

Gutters and downpipes

We also recommend that the gutters and downpipes are cleaned out, the joints are checked and the alignment checked to ensure that the gutters fall towards the downpipes.

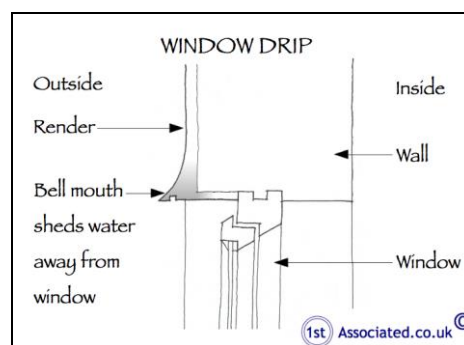
In this case we found no drip detail to the windows.

Window drip

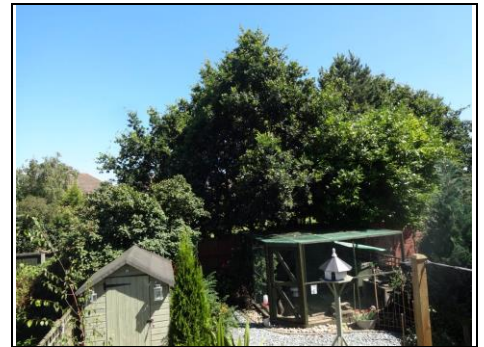
Trees overhang in the back garden from nearby park

**ACTION REQUIRED:** We would ask existing owners how recently the trees get cut down. Interestingly when we were carrying out the survey one of the neighbours asked us were we here to cut down the trees or were we here doing a survey about cutting down the trees.

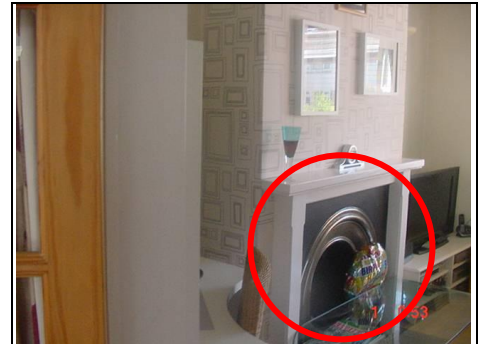
Feature fireplace to the front reception room

**ACTION REQUIRED:** We recommend you ask the existing owners when or if they have used the fire in the front reception room.

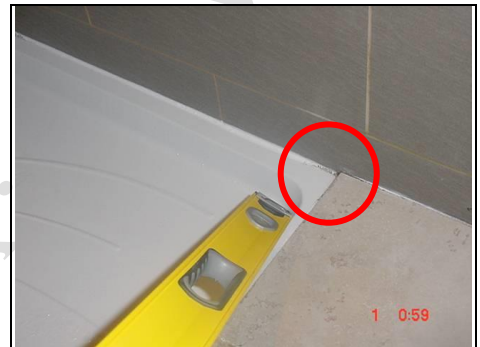
At the time of the inspection there were no significant signs of condensation. However, we did see what seem to be slight signs of possible black mould to the internal shower room. It is not that unusual to have internal shower rooms or shower rooms and bathrooms without windows to get some black mould.

Black mould in the internal shower room

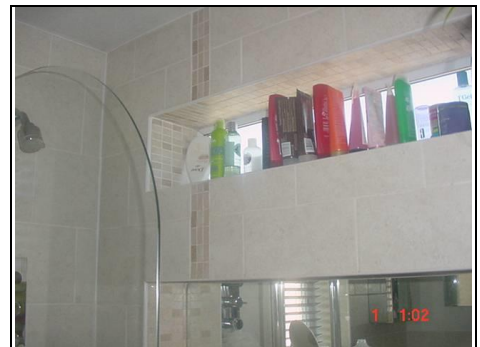
Lack of windows that could be used in the bathroom

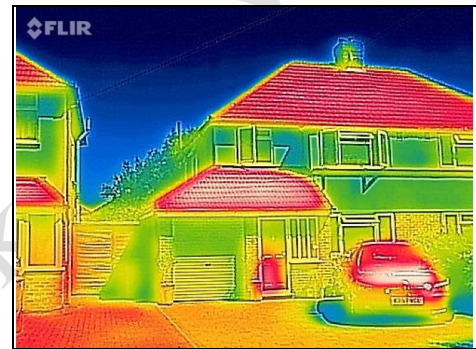
The red patches show heat loss from the property, namely from the roofs.

Thermal image photo

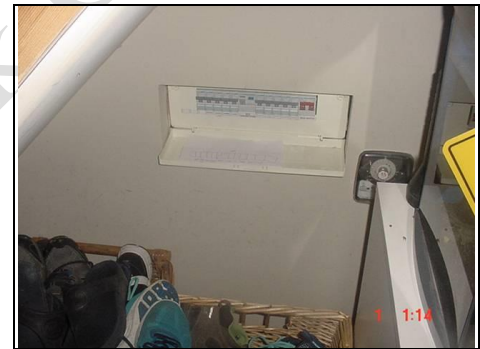
During our question and answer session we were advised that all of the new electrics were tested to building regulations Part P standard.

Fuse Board

**ACTION REQUIRED:** As the property is changing occupancy an Institution of Engineering and Technology (IET) test and report and any recommendations should be carried out by a NICEIC registered, or equivalent, approved electrical contractor or similarly approved.

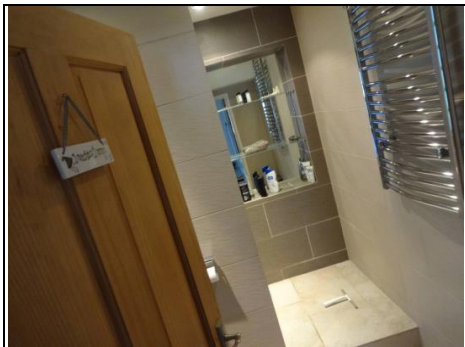
The property has an internal three-piece shower room to the ground floor, which looks in average to above average condition. We did notice some minor mould to the shower tray which we would comment it may be necessary to improve the extract fans.

Internal ground floor shower room

**ACTION REQUIRED:** We would recommend a large humidity controlled extract fan is added. By large extract fans we mean 150mm.

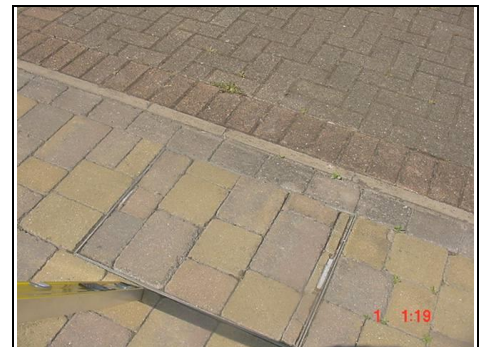
We were surprised to find only one manhole but there may be some underneath the building. The owner has advised us in the question and answers sheet that there are rodding eyes / access points underneath the cooler and sink area.

Manhole to the front of the property

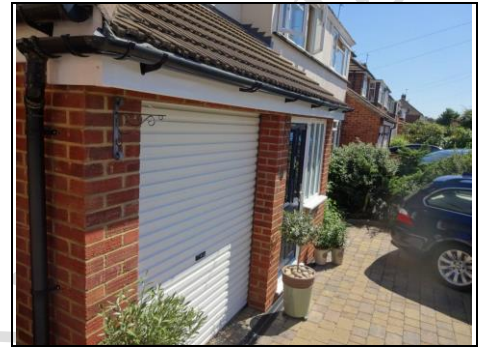
There is a garage to the front with a running gully in front of it, this needs to be kept clean if you want to keep anything of value in there.

Garage to the front left of the property
