RESIDENTIAL BUILDING SURVEY

XXXX,
XXXXXXXX,
Surbiton, Surrey,
KT6 xxxx

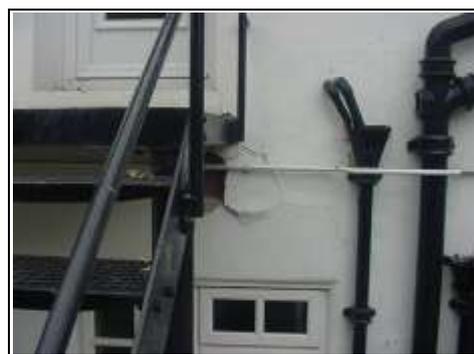
We can see that over the years there has been cracking and movement to the structure. As discussed we believe partly the reason for the cracking is the harder cement that has been used on the external of this old property which is never a good idea as older properties need to move and breathe and a lime based render is more appropriate.

Cracking near rear fire escape.

ACTION REQUIRED: You need to ensure that the existing owners have placed an insurance claim with regard to the movement. As we have only had a one off inspection it is not possible to identify conclusively from this. Normally monitoring would take place for typically a year.

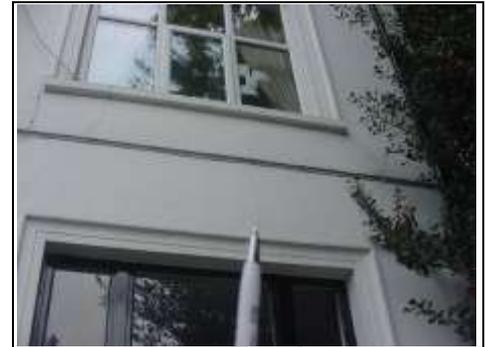
Crack around window
Pen identifies the line of cracking.

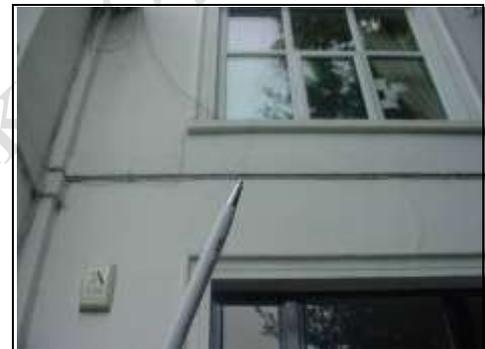
Crack above window

ANTICIPATED COST: You need to ensure that an insurance claim has been made in writing and that the insurance company are happy to commit to monitoring the property. There is likely to be an excess cost to the insurance which should be reduced from the price of the property.

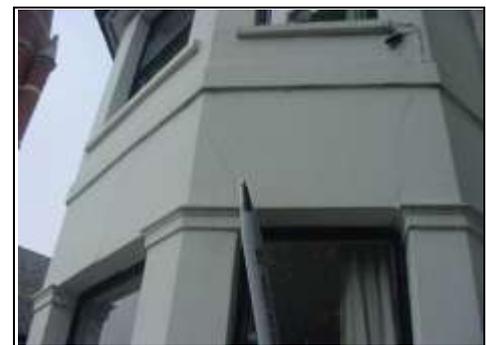
Crack above bay window

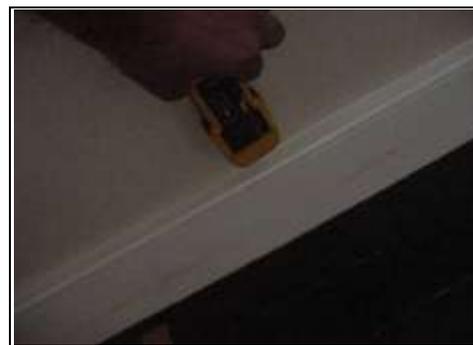
We were surprised to find we were getting dampness readings internally. We suspect this relates to walls absorbing dampness from such things as the clothes drying and the humidity from the bathroom and the kitchen that is unable to dissipate via the walls which have cement render externally.

Rising damp

ACTION REQUIRED: You need to get rid of the humid air as quickly as possible. We recommend humidity controlled extract fans to the bathroom and the kitchen and any other rooms you intend to dry clothes in!

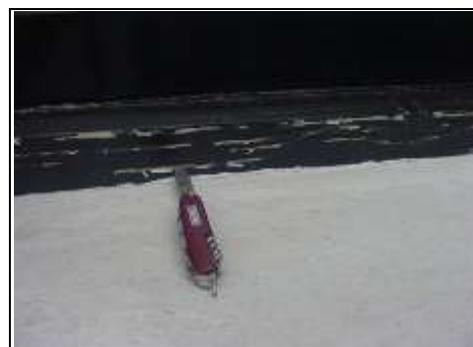
The external joinery is not in the best of conditions. Black painted timber always seems to deteriorate quite quickly. In some areas we were able to push the knife into the timber indicating it is soft. To the rear door we were able to push it right through the timber.

Knife Test

ACTION REQUIRED: general redecoration of the external timbers and making good of the timber.

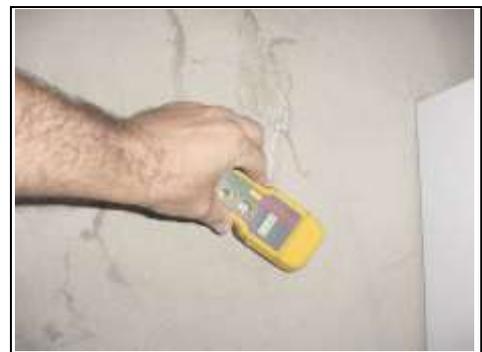
We found dampness to various areas in the basement. We are aware that the present owner has had it tanked or to be more accurate partially tanked. The basement will need dry lining to make it useable. Note, we have said useable and not habitable as local authority approval such as building regulations permission and planning permission will need to be obtained to make the room habitable.

Dampness coming through tanking

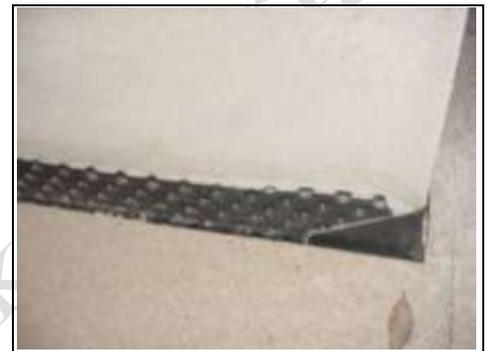
Partially tanked
