RESIDENTIAL BUILDING SURVEY

xxxxxxxxxx,
Beckenham,
London
BR3 xxxx

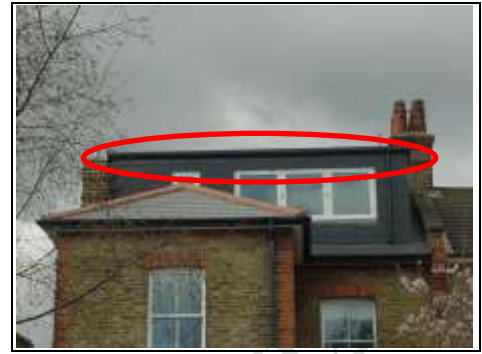
We do not like flat roofs that we have not been able to see. We would recommend that you form an access hatch so that the roof can be viewed from within the room in the roof bedroom. We have in the past formed roof windows in these roofs but sometimes this means too much sun gets into the roof space. A hatch of some sort would be of benefit to you.

Flat roof over dormer

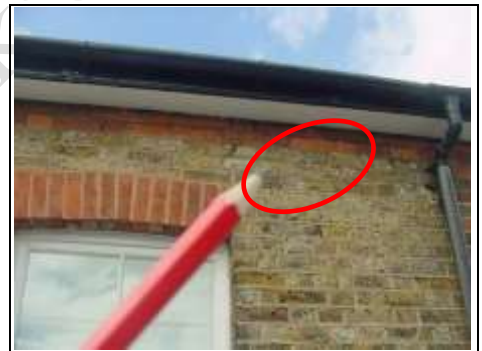
There are hairline cracks visible in the walls that have probably been caused by the structural alterations that have taken place and the removal of the rear main walls. However it cannot be discounted that there may still be movement as there are larger cracks than we would expect to see.

Cracking to the rear of the property

ACTION REQUIRED: To be on the safe side we would recommend that the existing owners take out an insurance claim with regard to the cracking (this is usually at no cost to them). You would then take over the insurance claim when you purchase the property using the same insurance company. Your Legal Advisor needs to check that this is legally correct. This will then limit your liability to the excess on the insurance policy. Again your Legal Advisor needs to check and confirm (we have used this system several times before). Monitoring of the cracking should then take place. Typically a year's monitoring is recommended by the Building

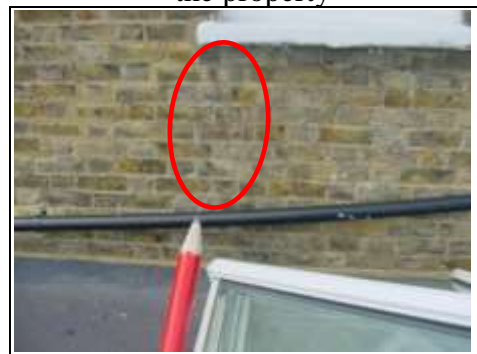
Hairline cracking

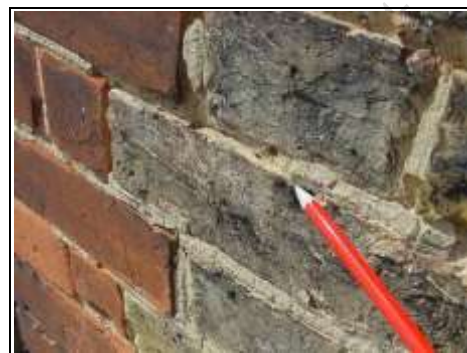
The property has been re-pointed in cement rather than in a lime mortar. In addition to this the cement that has been used is relatively hard and is starting to crack already. If you recall we showed you where it was cracking on the flashings.

Re-pointed in cement mortar instead of lime

ACTION REQUIRED: You need to remove all the cement mortar (it will eventually fall out on its own but a stiff brush will help it). We recommend you find the oldest, time served brick layer that you can who is able to carry out the re-pointing in lime mortar and to gradually replace sections of the cement mortar with lime mortar over the years.

ANTICIPATED COST: A few hundred pounds every year until re-pointing is complete; please obtain quotations.

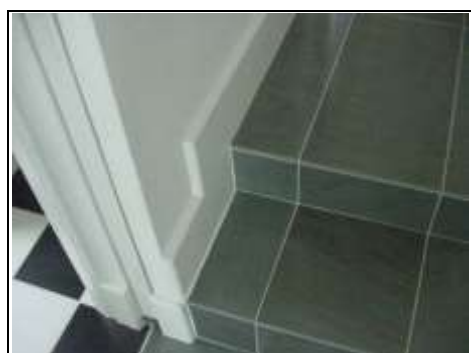
We also noted one air brick to the rear which may be a vent through the concrete floor that is blocking the timber floor.

Steps down into the kitchen.
Possible vent running through
the concrete floor

ACTION REQUIRED: In summary we would say that there are not enough air vents and more need to be added. We would add them to the side of the property and to the step and underneath the stairs. When the opening underneath the stairs is made you need to check the condition of the floor beneath.

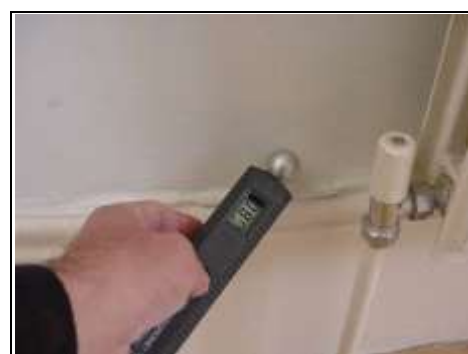
There was rising damp found to the right hand side of the property with meter readings in the 80's and the 90's. We suspect it will also be to the rear but the construction is dry lined (false walls) meaning that we cannot carry out tests with an electronic damp meter without opening up the structure.

High damp meter reading

ACTION REQUIRED: A French drain (please see our article in the appendices) to be run along the right hand side of the property as well as air vents being added. We suspect the suspended timber floor may be in poor condition which is why we are recommending that you open up the floor underneath the staircase to check its condition. Ideally this should be carried out before you purchase the property.

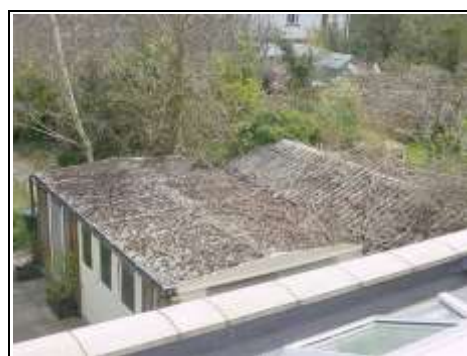
We discussed the garage in general and the Asbestos on the roof. You advised that you will be taking the garage down to create a studio which we would recommend you do. Please remember that Asbestos is a dangerous material and does have to be taken down in a safe manner. The Local Authority will usually have a

Asbestos roof on garage

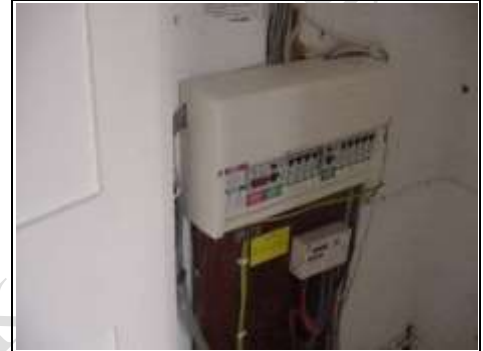
Dated fuse board

ACTION REQUIRED: We would recommend an upgrade is carried out.

ANTICIPATED COST: £250 to £500 for a new fuse board plus the cost of an Institute of Electrical Engineers (IEE) test and report and any work recommended; please obtain quotations.

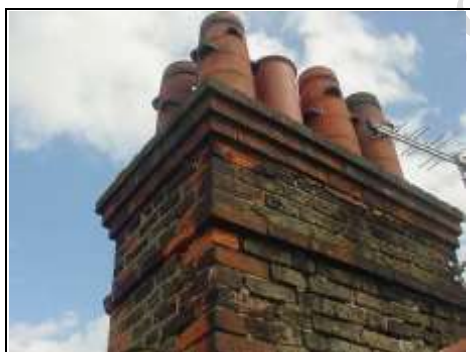
This chimney is brick finished with a lead flashing and several chimney pots (half of which are yours). From what we could see from ground level it looked in below average condition considering its age, type and style and needs re-pointing.

Chimney one – main roof

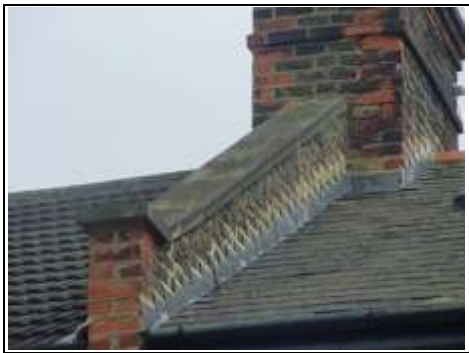
In this case there is a parapet wall to the left hand side of the main roof that transfers down onto the roof below. It is built from brick with a coping stone. Our concern is that the lead flashing looks to have been pointed with a cement mortar which will crack relatively quickly. We much prefer a plumbers mastic to be used where a lead flashing is present.

Left parapet wall (front)

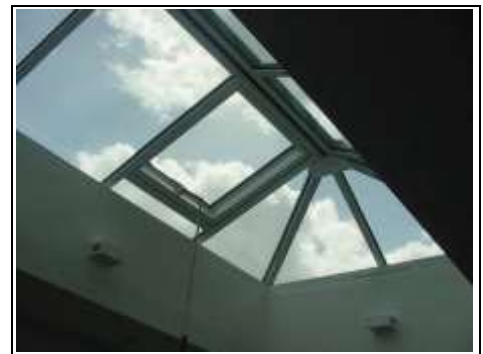
Roof window above kitchen

In our experience, sooner or later, the roof windows will leak around the base. You would have to see the roof in wet weather to understand if there is ponding etc. that may cause this to happen in the near future.

ACTION REQUIRED: We would recommend that you have a look at the roof window, to the flat roof over the kitchen, when it next rains from the bedroom window to see if you can see any ponding.

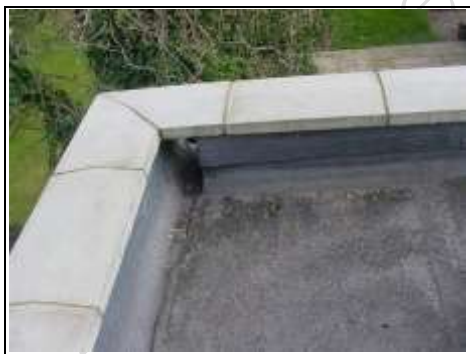
We mentioned earlier within this report that movement has been identified within this property and that this could be initial settlement following the alterations that have been carried out. Such initial settlement could include the roof window which would then in turn affect the flat roof.

Some pattern staining on the roof indicating water is ponding on the roof.

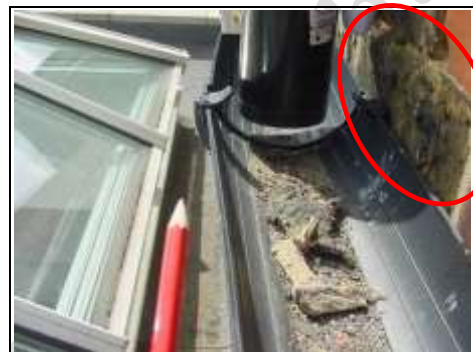
Downpipe has been cut too close to the gutter. It will block, overflow and cause dampness in the property (circled)

ACTION REQUIRED: We would recommend setting aside the sum of £1,000 to re-organise the gutters and downpipes.

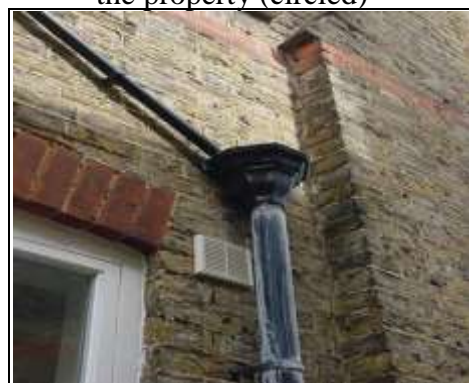
Cast iron and plastic downpipe is overflowing and needs to be checked and cleared of any vegetation

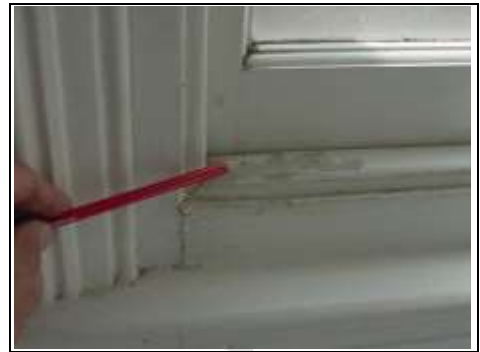
Dampness to upstairs bathroom window possibly caused by overflowing gutters.

We are not one hundred percent certain why there is dampness coming into this window, it may be condensation but it may be from overflowing gutters.

Dampness to bathroom window

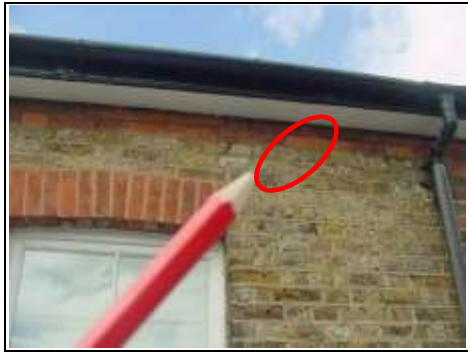
There are hairline cracks to the rear of the property.

Cracking to the rear of the property

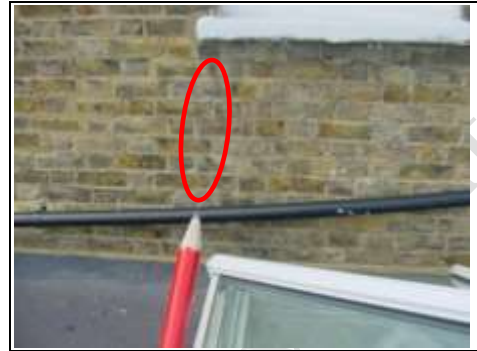
Cracking

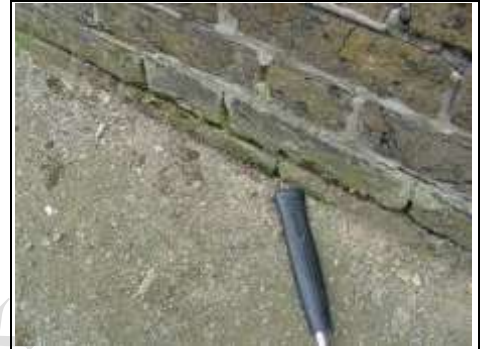
All modern properties should incorporate a damp proof course (DPC) and good building practice dictates that a differential of 150mm (6 inches) should be maintained between the damp proof course and ground levels. In this case, we cannot see a DPC. We believe the ground levels are a bit high and it may be hiding the damp proof course, if there is one.

Where is the DPC?

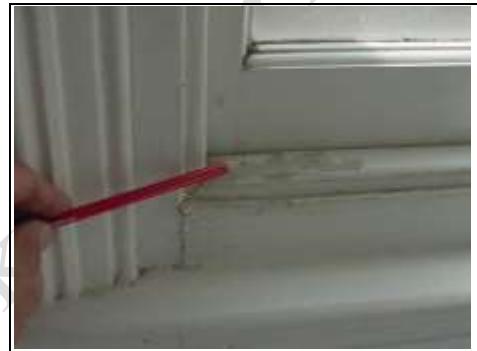
Dampness coming in through bathroom window. This may be due to condensation but may be due to leaking gutters

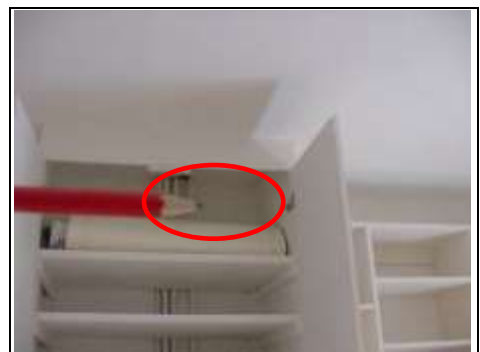
Our concern here is that the property may have been decorated to sell and as such this has hidden some of the cracks. This is why we could only see them within cupboards.

Cracking to the rear bedroom in the cupboard

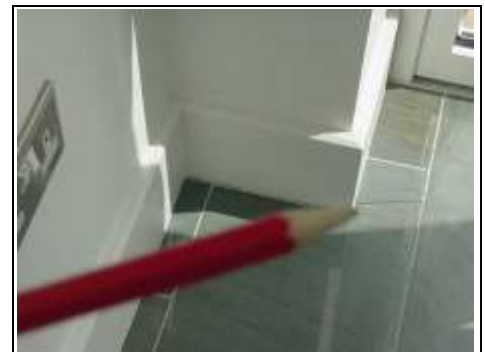
We note there are no expansion joints to the tiles in the kitchen/dining area which may mean they will crack. We can see one crack in the rear left hand corner.

Tiles cracked in kitchen because no expansion joint around the tiles

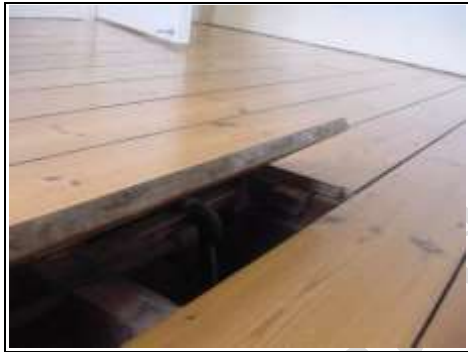
Several floor boards were loose but did not quite lift up completely

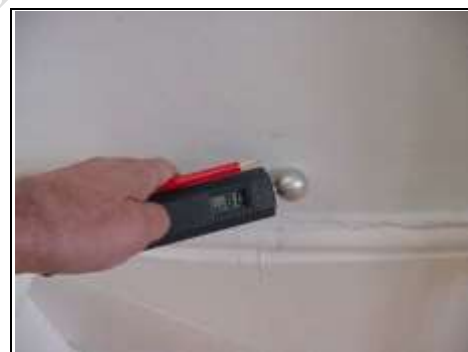
A random visual inspection and tests with a moisture meter have been taken to the perimeter walls. In this particular case we have found rising damp. We took high readings on the right hand side of the property due to, we believe, high ground levels.

Testing for rising damp

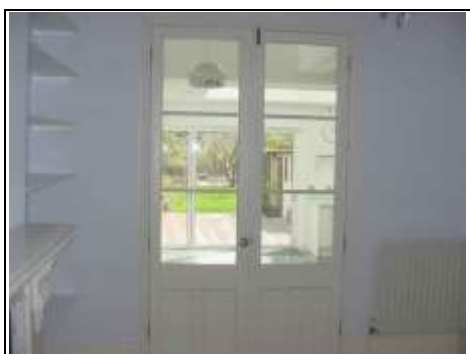
The doors are generally panelled with the exception of the glazed doors that lead into the kitchen/dining room area. There is no British Standard Kite mark on the glass in the doors which is not unusual in this age of property but it does mean it is not safety glass. If you have young children you may wish to replace this with safety glass.

Glazed doors

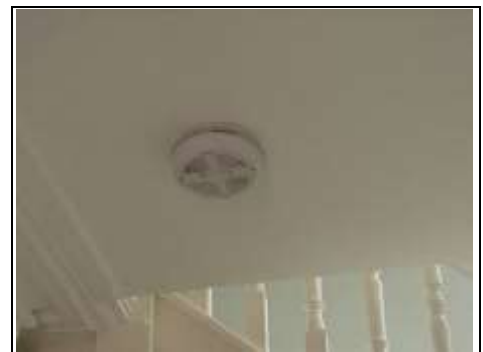
Some battery smoke detectors were noted. The current Building Regulations require that they be wired into the main power supply. Obviously in a property of this age this is difficult, as it would mean having surface mounted wires or cutting wiring into the plaster.

Smoke alarm
