RESIDENTIAL BUILDING SURVEY

**Pinner Village
London
HA5**

**Prepared by:
INDEPENDENT CHARTERED SURVEYORS**

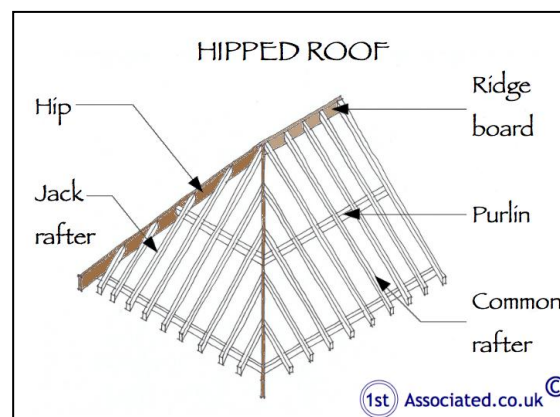
1.1 Hipped Roof

We can see there has been some movement both inside the hipped roof and externally we could see some tiles have moved.

We would comment that hipped roofs of this age often have close boarding internally to help strengthen the roof. This roof is not close boarded.

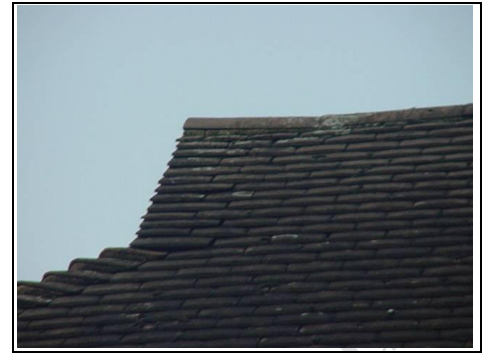
Minor movement to the roof tiles

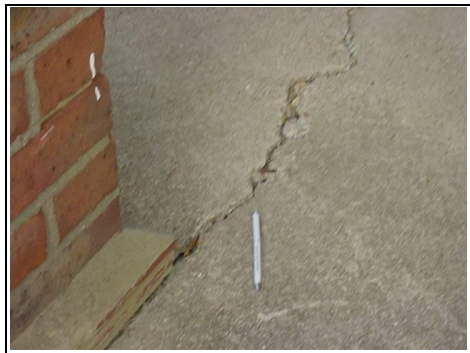
We can see cracks externally on the left hand side of the property around the drains which may be the cause of the cracks and the movement we can see.

Cracking to left hand side

ACTION REQUIRED: Have a closed circuit TV camera report of the drains to see if there is any movement signs within them. We would recommend this is carried out before you legally commit to purchase the property.

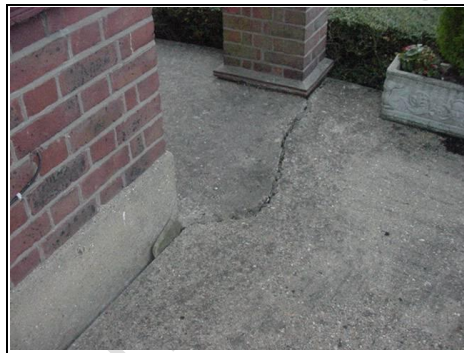
Cracking to rear left hand side

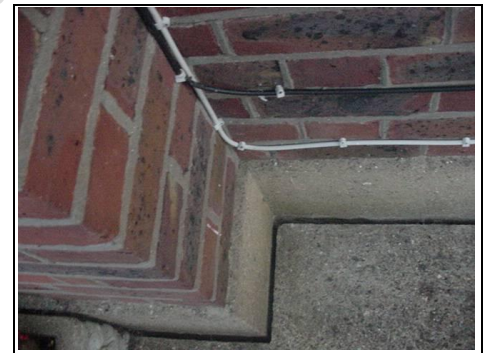
Movement gap between concrete and wall

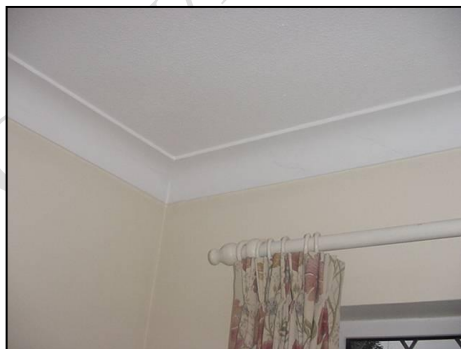
We can see a few tear marks within the property to the front lounge and one of the bedrooms that could also be attributed to movement.

Cracks to reception room rear left hand corner (unfortunately you cannot see them on photo)

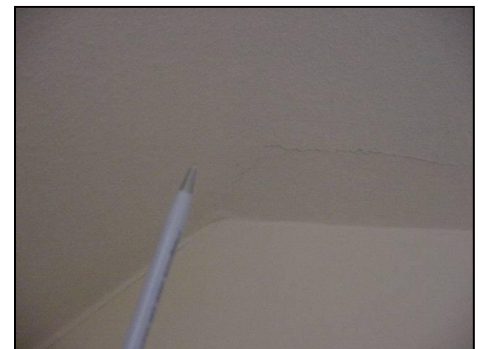
Cracks in front right hand bedroom

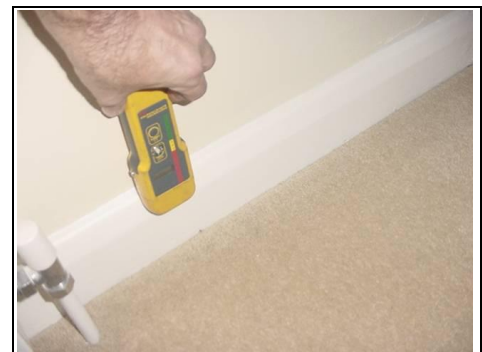
Surprisingly we found minor dampness to some areas of the property on the ground floor, particularly in the hallway area and the lounge. We believe this may relate to condensation, or it may be because the property has been empty for some time (during our question and answer session with the owners they advised that they had just got back from holiday).

Checking and finding minor rising damp

ACTION REQUIRED: We would not recommend any action.

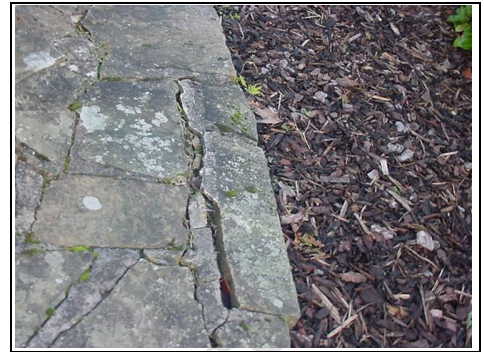
3.1 To the Paines Close side the garden is starting to fall away and would benefit from re-grading and repair to the path and associated areas.

Path falling away

ACTION REQUIRED: General maintenance of the garden. It should be noted that the trees may have Tree Preservation Orders on them. Your legal adviser to check and confirm this before you proceed to purchase as this will limit what you can do with the trees.

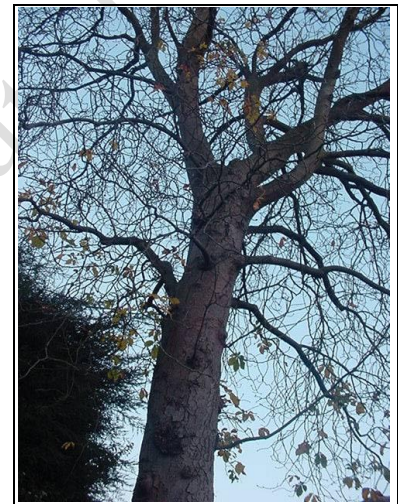
3.2 The trees do not look to have been maintained for some time. Whilst they are further away that an insurance company like nevertheless we still would recommend they are regularly maintained.

Trees need maintaining

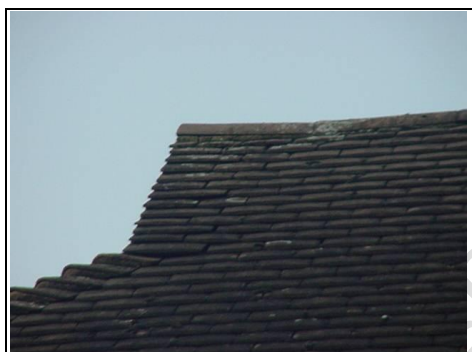
The main roof is pitched and clad with a small concrete tile and, from ground level, this looks in slightly below average condition considering the roofs age type and style. This is because we can see the tiles have opened up slightly (and we do mean slightly). This is often the sort of movement we see in a hipped roof, however it can also indicate movement in the structure as a whole.

Minor movement to roof tiles

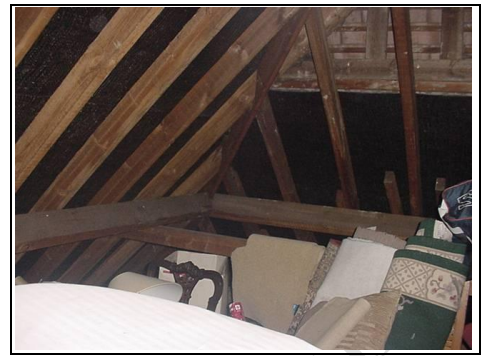
There has been some slight movement in the hip which we can see. We can also see some slight staining to the timbers at the gablet end which indicates some dampness is getting in to these areas, which relates to the roof tiles that we have seen movement on, as mentioned earlier.

Slight movement in the hip

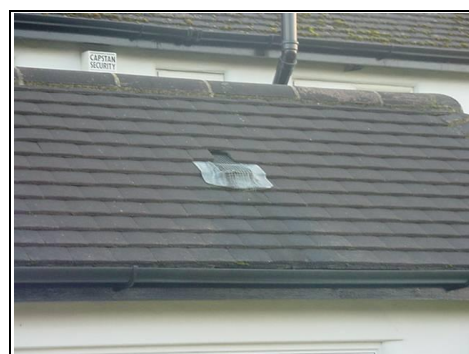
We believe the flat roof outlet overflows the gutter below and causes dampness to the rear of the kitchen/dining room area.

This is the outlet that the water comes from the flat roof

We would always recommend that the gutters and downpipes are cleaned out, the joints are checked and the alignment checked to ensure that the gutters fall towards the downpipes.

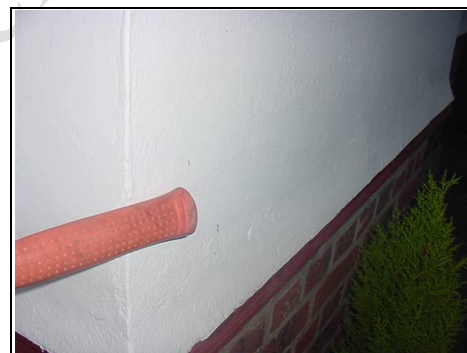
Repairs to render

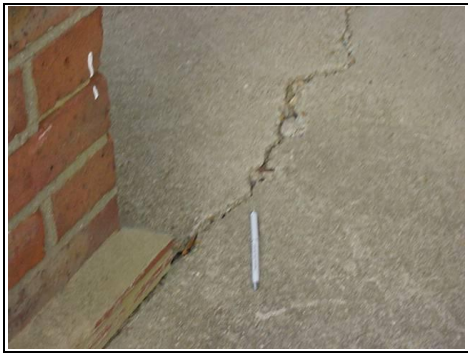
Cracking to left hand side

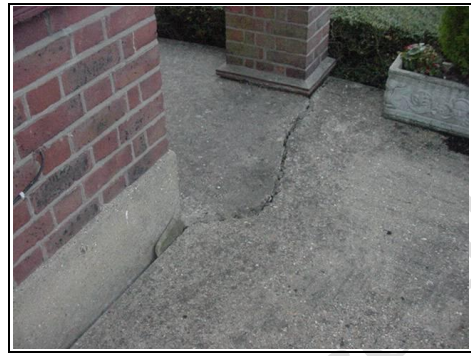
Cracking to rear left hand side

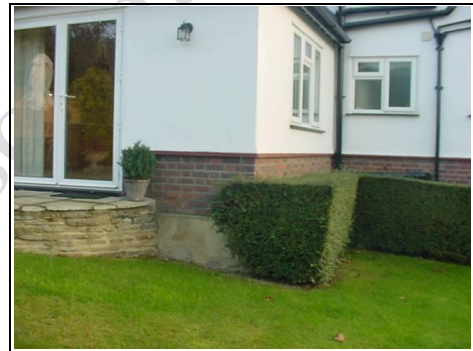
There was a hidden retaining wall on the left hand side that we would like to have seen close up. Unfortunately we could not because of the hedge. This is the area where we suspect the minor movement has been.

Hidden retaining wall to rear

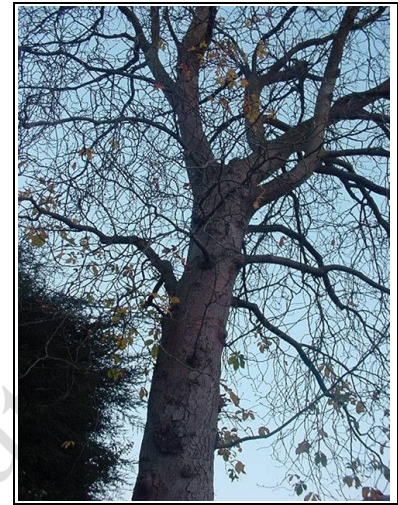
Large tree in rear garden

ACTION REQUIRED: Please obtain advice from an arboriculturist (not a tree surgeon).

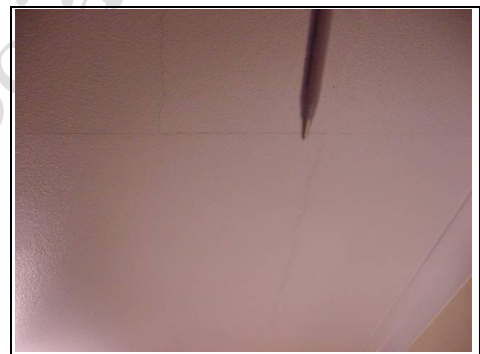
This is quite a common occurrence in older properties, brought about by differential movement in the structure to what the plasterboard can cope with. They tend to be very straight cracks.

Plasterboard cracks

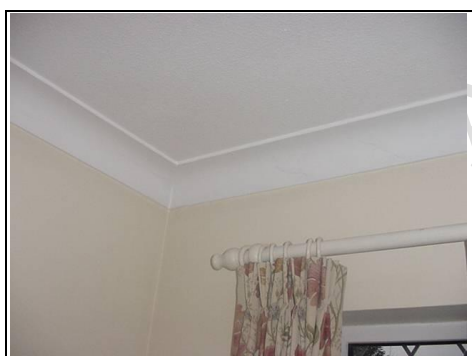
We noticed some tear cracking in the lounge, which generally indicates that there has been some movement in the property, however we would stress again that the movement is limited.

Tear cracks to reception room rear left hand corner (unfortunately you cannot see them on photo)

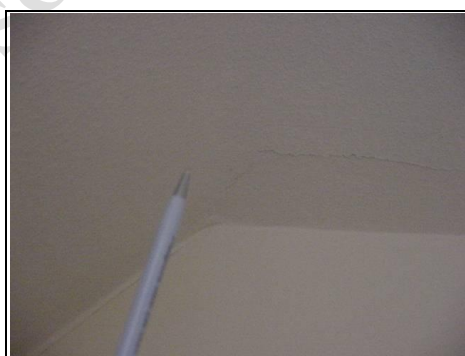
Tear cracks in front right hand bedroom

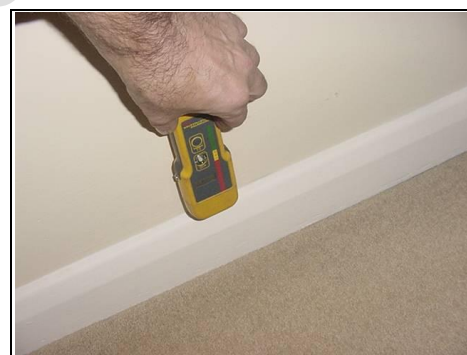
Testing for and finding minor rising damp

ACTION REQUIRED: Please see the Executive Summary

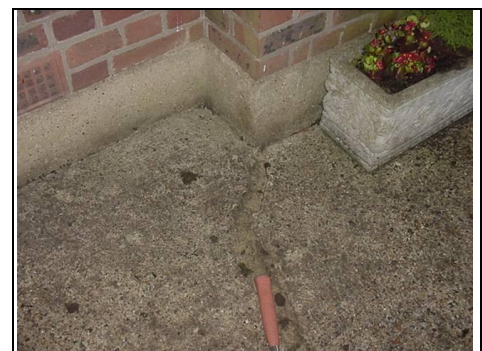
Cracking near to drains

ACTION REQUIRED: You need to have a closed circuit TV camera report in this area due to the cracking that we can see above.

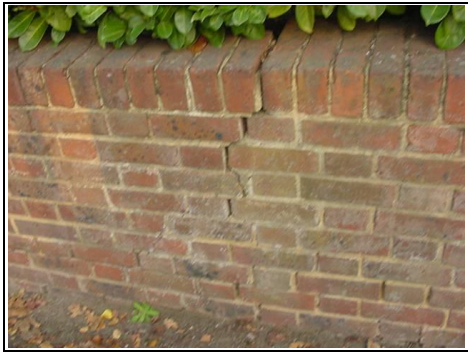
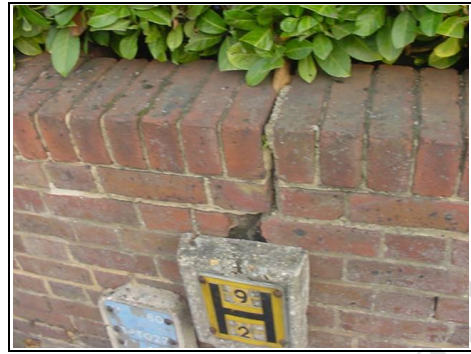
Cracking to boundary wall on left hand side
