RESIDENTIAL BUILDING SURVEY

Sheffield

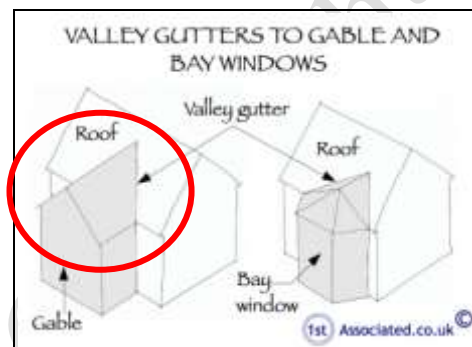
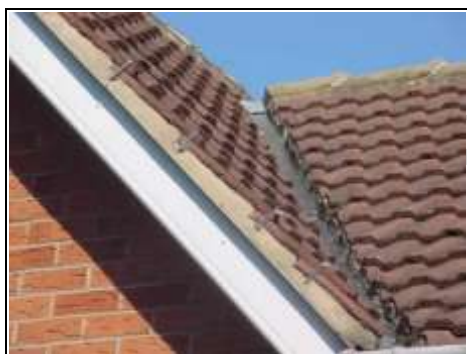
Valley gutter

This property has valley gutters. Valley gutters are formed where two roofs meet and these are generally problematic. The cement does look like it is starting to deteriorate.

ACTION REQUIRED: We believe that repair will be needed within the next five years, possibly quite soon, therefore you do need to carry out periodic inspections to check that no cement has fallen out/damp getting in.

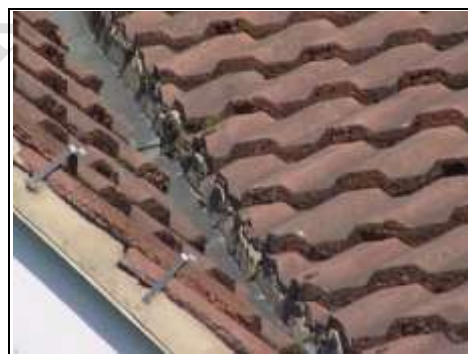
Close up of valley showing the cement is starting to deteriorate

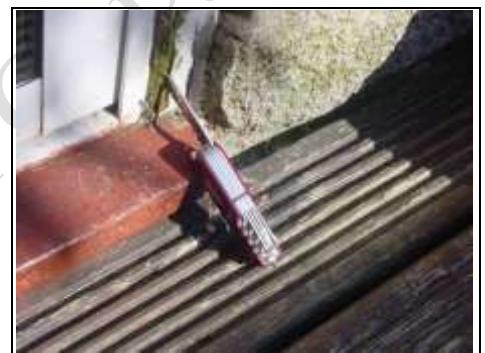
Rot to base of doors indicates that rainwater is going into the building rather than around it

ACTION REQUIRED: We would recommend a French Drain or running gully around the property to allow rainwater to pass around the building rather than through it. This, providing there haven't already been any problems caused, will reduce any dampness in the property.

ANTICIPATED COST: In the region of £2,500 - £5,000 as this is difficult and awkward work. As the drains are positioned on the left hand side of the property you should be able to get into these. Please obtain quotations.

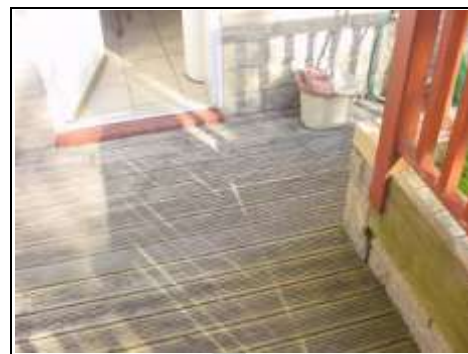
We noted that the wood decking to the rear of the property sits directly against the house. This can lead to dampness via capillary action. We always recommend that decking is at least 100mm away from the house walls.

Decking runs directly to the building at rear of property

We would also recommend putting poison under the decking as they are a great home for vermin. You mentioned that you had seen a rat trap; we didn't see one during the course of our survey but we did notice poisonous food located in the roof space. The reason vermin are attracted to particular houses/areas is because it is a warm, dryish area and food being regularly available.

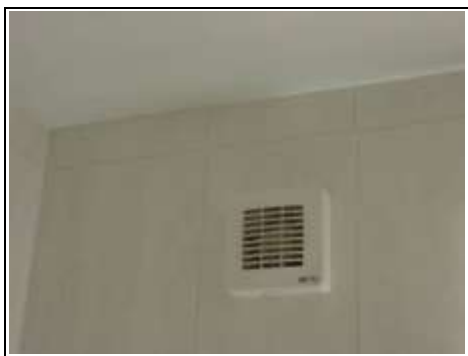
We can see that the humidity creating areas such as the kitchen, the bathroom and the en-suite have a higher than average chance of getting condensation. This is because the extract fans are small and are full of dust and dirt and need a good clean.

Small extract fan in second floor bathroom

ACTION REQUIRED: Large extract fans with humidity controlled thermostats to be installed within the kitchens and bathrooms which are moisture generating areas.

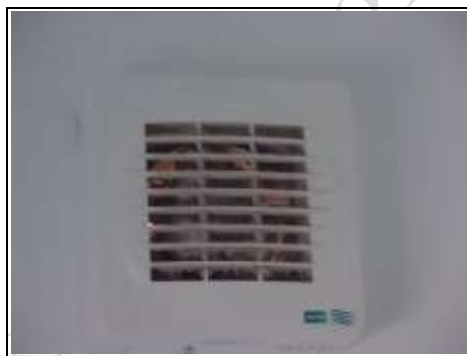
Extract fan in en-suite needs work

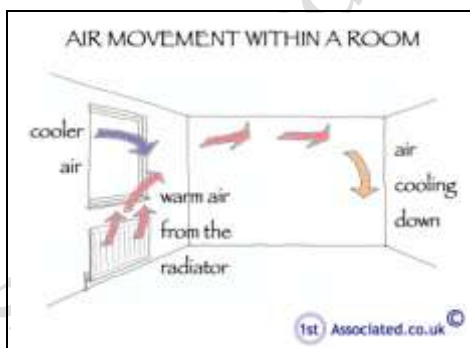
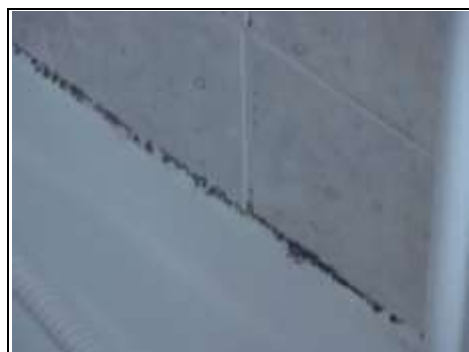
The shower to the master bedroom en-suite has signs of mould which we believe is due to lack of air movement and excessive humidity.

Mould to shower

We would strongly recommend that you replace existing fans with large extract fans which are humidity controlled. As mentioned when we had our telephone conversation we feel that we are still very much in the experimental age with the increases of insulation that we are using in our properties which are sometimes not appropriately matched with ventilation.

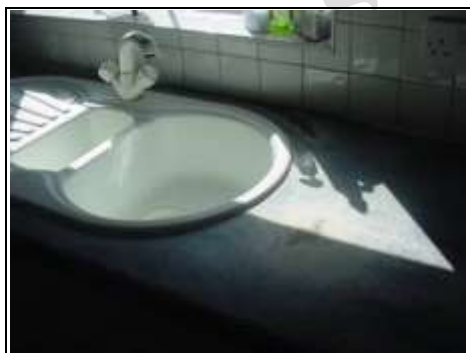
The worktops in the kitchen were worn and a door was missing at the time of our inspection. Whilst you may be able to replace the worktop it would then make the rest of the units dated so you would be looking towards a new kitchen.

Worktop is worn

ACTION REQUIRED: Replace kitchen.

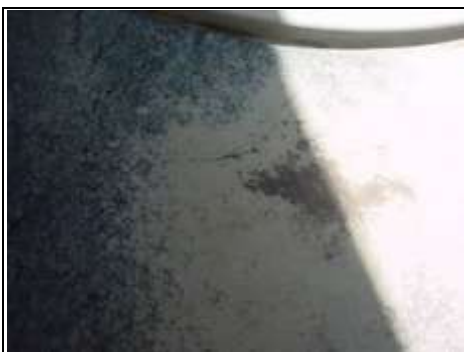
Close up of worn worktop

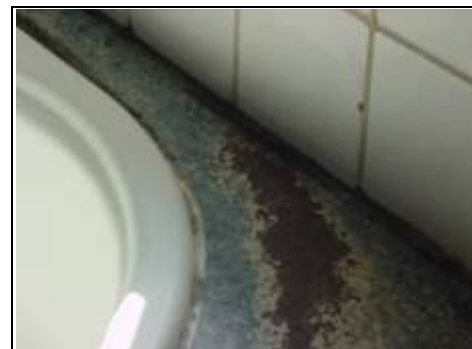
Worn worktop

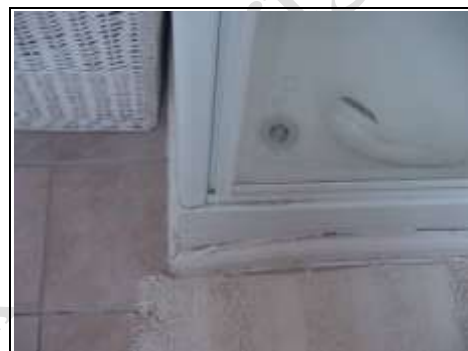
We believe that the en-suite shower unit is leaking. This may be as simple as a joint that leaks when compressed and the trap on the wastepipe.

Leak to shower unit

ACTION REQUIRED: You can open up the shower tray (which doesn't look in particularly good condition), but we have always found it difficult to put shower trays back together again! Unfortunately whilst this is probably a relatively small problem, it could mean that you have to have a new shower tray or at least the sides to it.

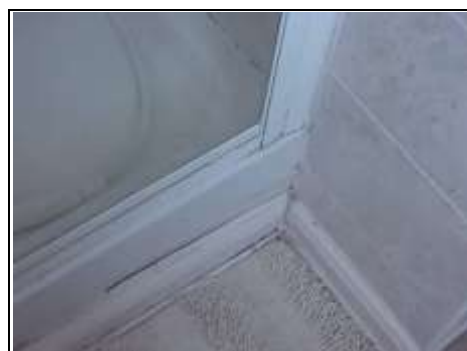
Leaking shower

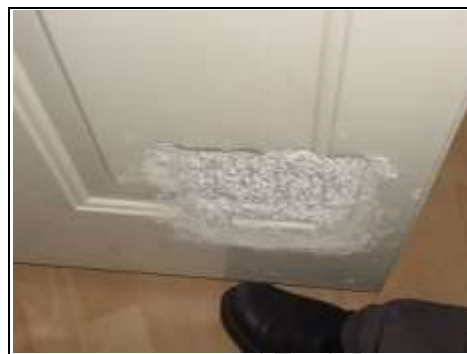
Door to garage damaged. This should be a fire door.

ACTION REQUIRED: We would suggest that you have a good look at the property again as there are lots of stored items hiding areas. We feel that you would probably agree the majority of it would benefit from redecoration and replacement and repairs in some places where the dog has caused damage.

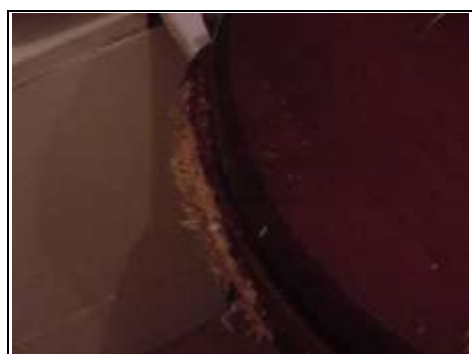
We noted in some areas the decoration and fixtures and fittings are in below average condition, for example the toilet seat, the skirting and door architrave have all suffered from damage by the dog.

Damage by dog

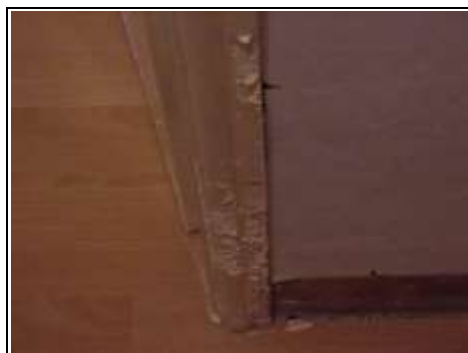
Damage to skirtings

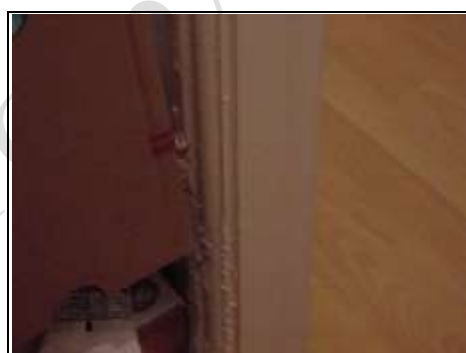
Damage to architrave

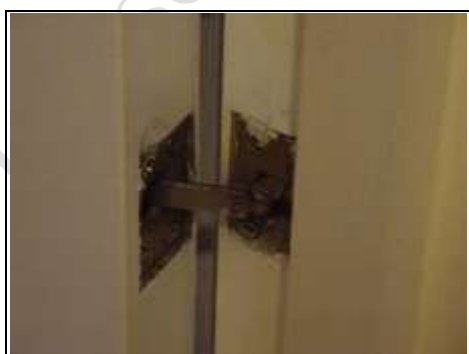
Perco door closer

We also noted doors to the staircase had their door closers removed (known generically as Perco door closers which is their trade name) or have broken and not been replaced. We talk a bit more about the fire risk in the next section.

ANTICIPATED COST: Replace the door closers which are likely to be a few hundred pounds or a few thousand pounds if you wish to put a fire alarm system in; please obtain quotations.

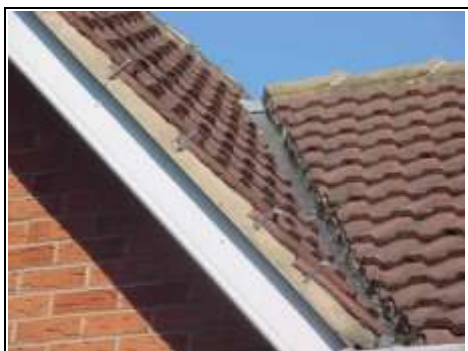
Valley gutter

Just to reiterate valley gutters can be a problem area and look to be in this case with the cement deteriorating in the valley gutter.

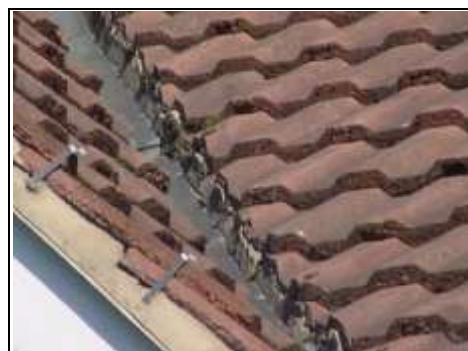
Close up of valley showing the cement is starting to deteriorate

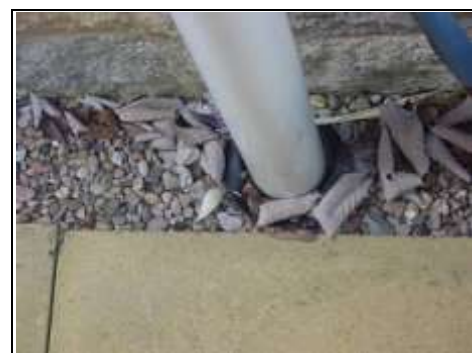
We noted that the rainwater goods discharge directly into the ground, a practice that we are not keen on as they are often prone to blockages. Ideally, they should be changed to a gully system.

Downpipes going directly into ground

We would also recommend that the gutters and downpipes are cleaned out, the joints are checked and the alignment checked to ensure that the gutters fall towards the downpipes.

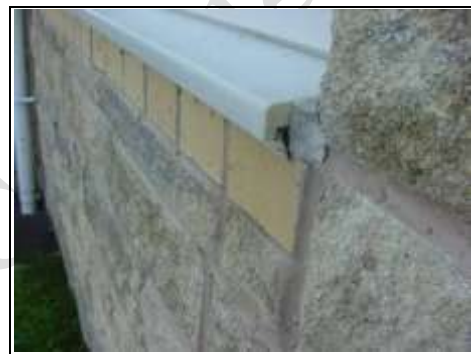
The property has plastic double glazed windows with trickle vents and small window sills, which generally look to be of a average quality. The window sills surprised us as they effectively mean that any water from the window that runs down the window to the sills then drips against the brickwork so we believe in the long term there will be pattern staining and possibly moss beneath the windows.

Very unusual the window sills are not projecting out

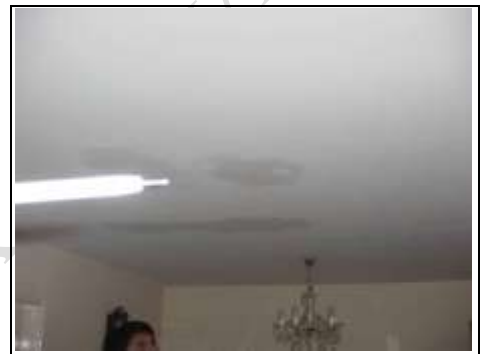
From our visual inspection of the ceilings and our general knowledge of this age and type of construction we believe that the ceilings are likely to be plasterboard or there may be some proprietary boarding such as wall board. We asked the owners about the marks on the ceiling, which he advised us had come about due to moving partitions. These look more like damp stains to us which may have come about from leaks from the kitchen above or in a worst case scenario the retaining wall to the rear of the property.

Marks to ceiling in ground floor lounge

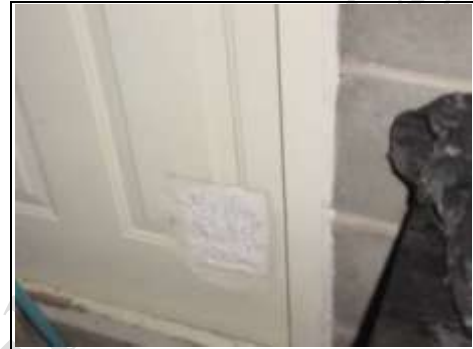
Damaged door

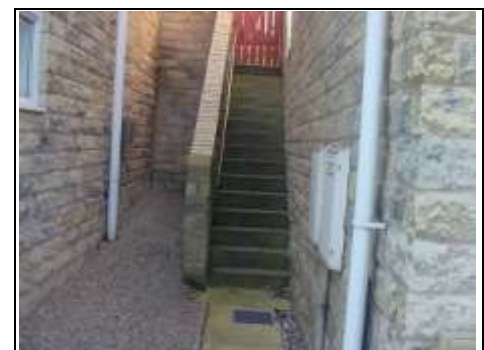
We noted an external concrete staircase to the left hand side of the property. Our thoughts are that this may be a bit of a waterfall when it rains hard. You need to stand outside the next time it rains heavily.

Concrete staircase to left hand side
