RESIDENTIAL BUILDING SURVEY

CAMBRIDGESHIRE

**Non-traditional
Modern
Semi-detached**

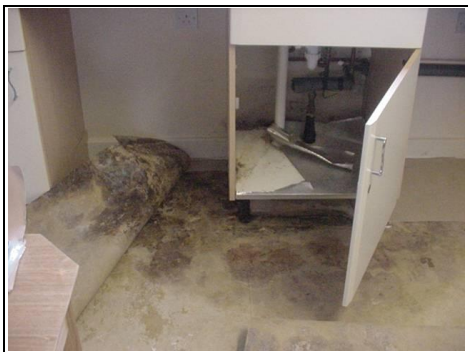
There is dampness evidence to the perimeter of the property. This could in theory come from a water leak in the kitchen (we suggest a chlorine test). However from our inspection on the day of the kitchen and our test in the bathroom we feel it is much more likely to be condensation. We refer you to our comments in the section Humidity generating areas not appropriately ventilated.

Dampness under kitchen unit

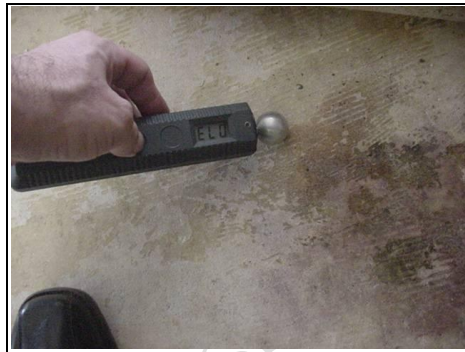
Electronic damp meter readings on kitchen floor

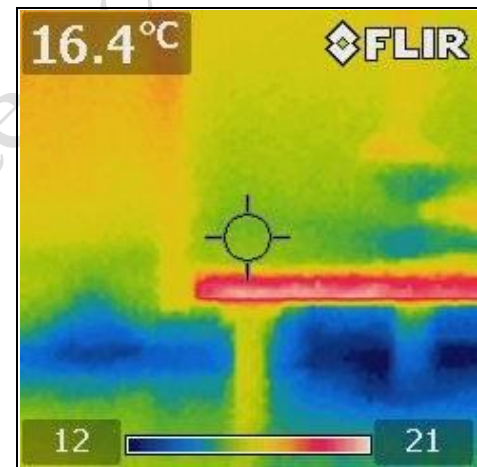
Thermal imaging photo showing cold areas underneath the kitchen units with cold water pipes directly above

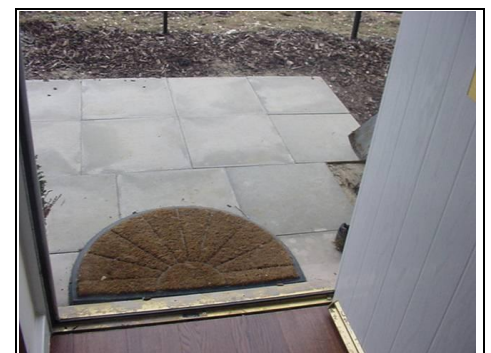
We were surprised at the coldness around the perimeter of the building. We feel this may be due to the level of the building as you are aware the internal floor level and the external ground level are very similar, whilst it could also be due to lack of insulation in the area. We have had experience of opening up in properties to find that the problem has been poor workmanship with a lack of insulation. Presuming all things are equal and it has been constructed correctly the base between the floor and the wall is colder than we would expect and may be causing condensation on the pipes at low level.

Ground levels have very little difference from outside to inside, a small ramp would have been sufficient to deal with the difference and still allow access to the property under the Building Regulations

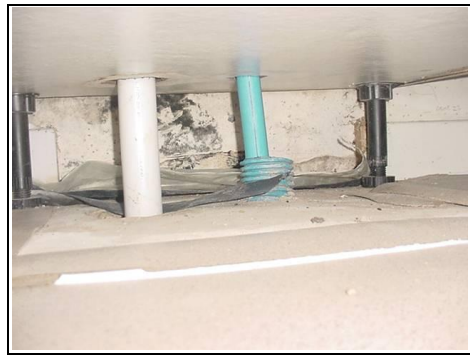
This shows dampness where the floor meets the wall

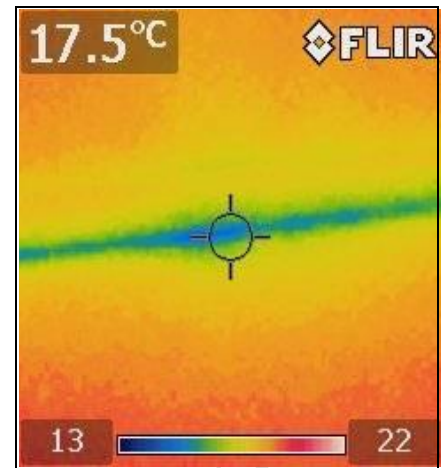
This shows the coldness where the floor meets the wall

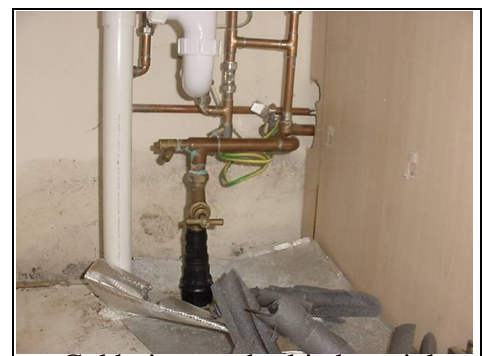
We believe the owners have been advised that there may be a leak to their plumbing system in the kitchen. A way to check this would be to have a chlorine test. Whilst it is feasible that it is a pipe leak we would refer you to the adjacent photos where you will see the coldness of the pipes under the sink which when they meet the warmness of the air and the relative humidity, condensation will occur.

Cold pipes under kitchen sink

ACTION REQUIRED: Take a sample of the moisture to the floor and chlorine test to check whether it is a leak from the pipes.

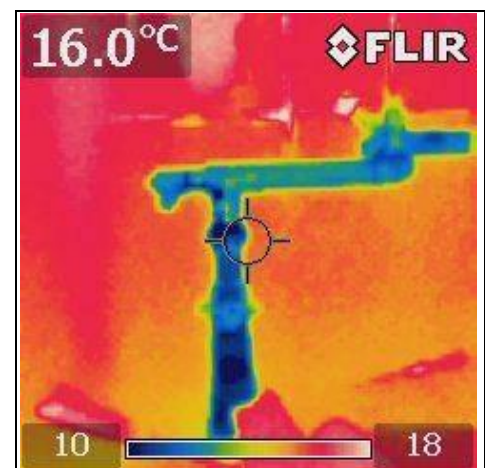
Cold pipes under sink

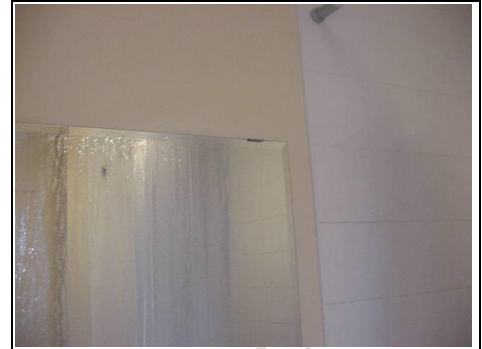
We have run the shower for fifteen minutes and found that condensation occurs within the bathroom (as recommended the bathroom door and the windows were left shut). Condensation was visible to:

- a) Tiled surface
- b) Window
- c) Door
- d) Mirror
- e) Plasterboard was damp to touch

Condensation to mirror

ACTION REQUIRED: General investigation of a lack of suitable ventilation within the humidity generating areas, i.e. when in use the bathroom does produce condensation and we would assume this is the same in the kitchen and possibly the utility room.

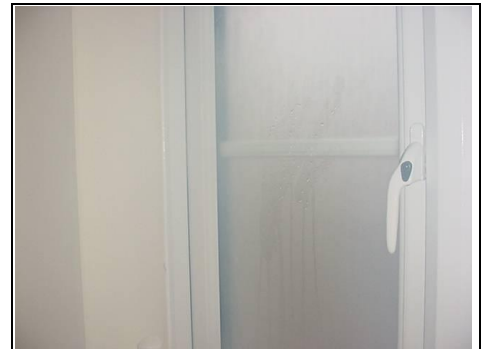
Condensation to window

We would specifically highlight our concern to parties involved that there is not sufficient insulation and this within this type of building construction will lead to long term defects occurring such as mould growth and possibly deterioration damage to the timber framed structure.

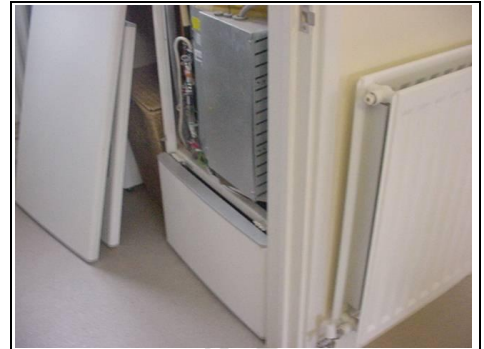
You advised us that the NIBE had been back to look at the recovery system and advised that it is running correctly. We are equally aware that you are unhappy obviously due to the dampness and also due to the bills that you consider high and that you will be forwarding data to us of your monthly bills in the near future.

NIBE heating system

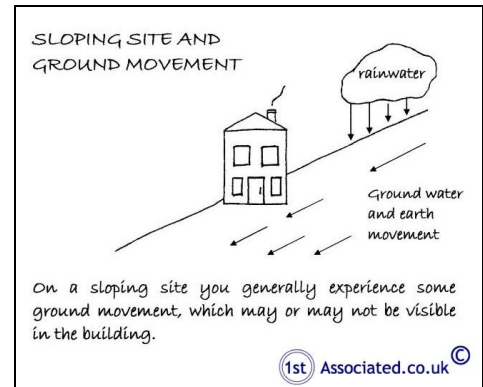
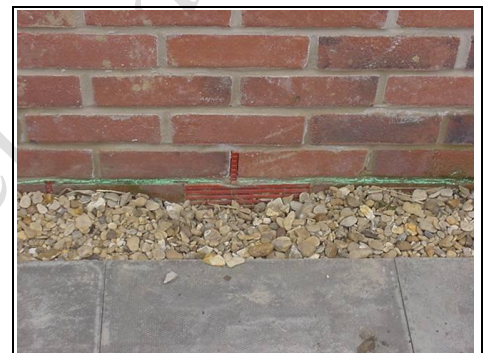
We believe the property sits on a clay soil which is relatively common in the area and will retain water. Please see the appendices for information on clay soils. There is the additional problem of the sloping site that falls towards the property with the land drains that don't appear to be channelling the water around the property and the further problem of the inside and outside ground levels being very similar and finally you have the unusual issue of the damp proof course not being to the building regulations requirements of 150mm. We are aware also that there is a double damp proof course which is unusual.

The green line represents damp proof course and the air brick is acting as gutter at ground level/below ground level

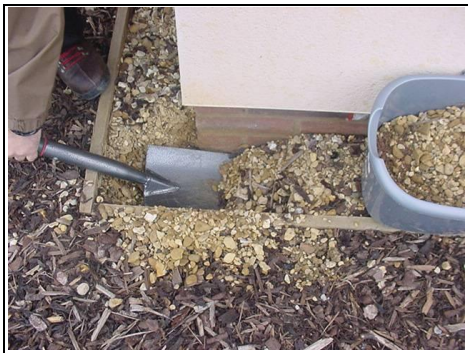
There are French drains around part of the property, that from our investigations have not been constructed correctly.

Digging up French drain to front left hand side

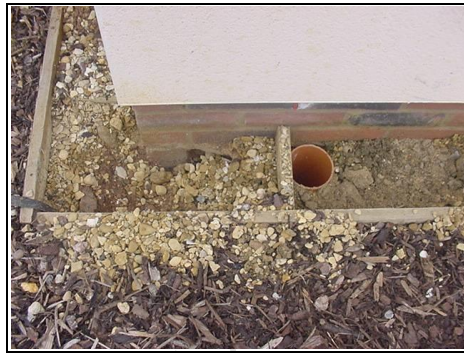
The exposed French Drain which hasn't been traditionally constructed

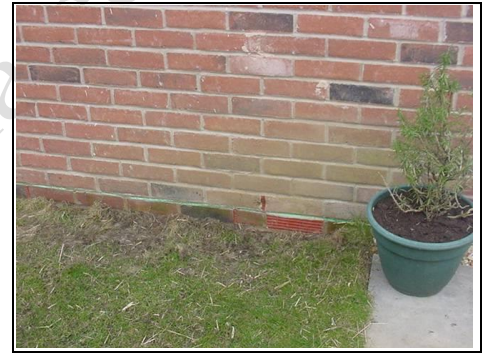
French Drain needed to the rear of the property?

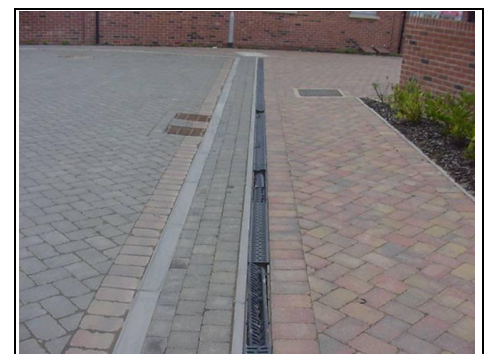
On a broader development view we would also ask what land drains have been put in to ensure the rainwater and surface water has a path around the property as this is a sloping site. The land drains that we could see were damaged and do not appear to be functioning correctly.

Broken running drain to the rear of the property

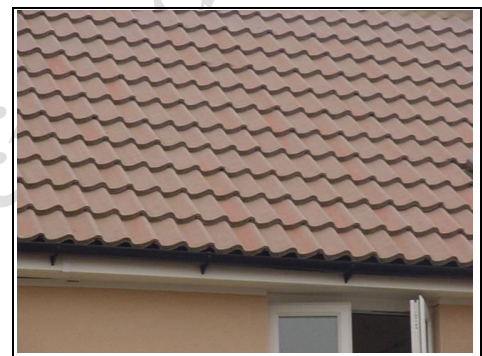
The roof is pitched and clad in a large interlocking concrete tile in a pantile style. From what we could see the concrete tiles are lying level and true and look in average condition although as they are relatively new this is what we would expect.

View of the concrete tile roof

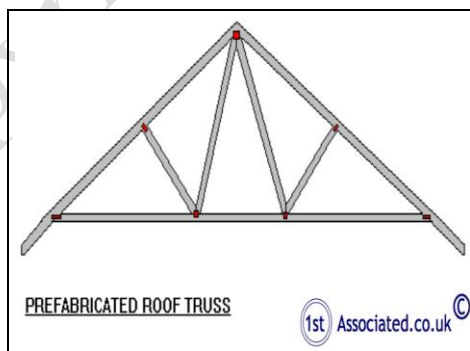
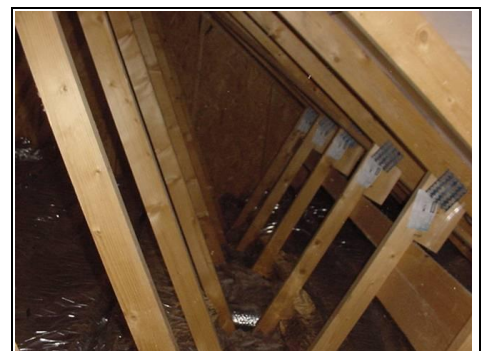
The roof structure is a pre-fabricated fan trussed roof rafter which looks like a "W". These are made in a factory and transported to site and then lifted into place. Without the manufacturer's calculations and installation details we cannot comment categorically on the roof structure although it is in line with what we typically see.

View of roof

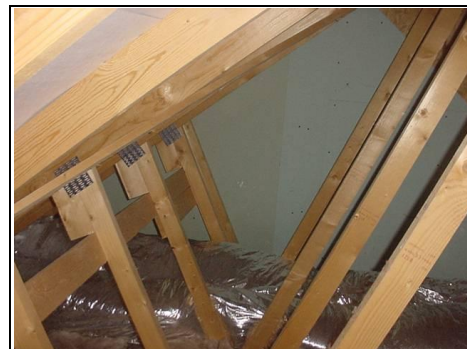
We found the roof timbers generally in average condition; they were slightly soft when pressurised indicating there may be condensation in the roof. We have inspected the roof structure for:

Our examination was limited by the general configuration of the roof, the mass of insulation and the vent pipes. The air vent pipes were an unusual feature of this property which we rarely come across. As mentioned the roof from what we could see was generally found to be in average condition, with what we believe to be minor condensation. It is feasible that there are problems in the roof that are hidden by the mass of insulation.

ACTION REQUIRED: The only way to be 100 per cent certain is to have the roof cleared and checked. We would normally recommend to add further ventilation to the roof at the gable end but given this unusual type of non traditional construction this may not be appropriate, we would have to have the design as a whole explained to us by the original designers to be certain of this recommendation.

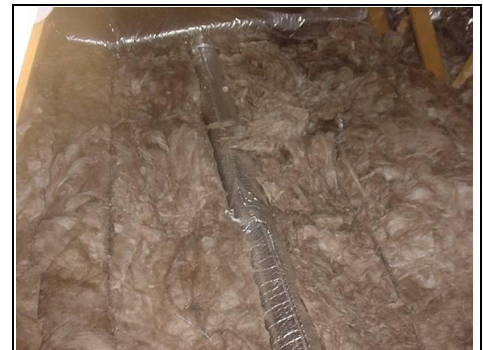
The property is vented in the form of a breathable membrane but there are also vent pipes within the roof.

Air vents to roof

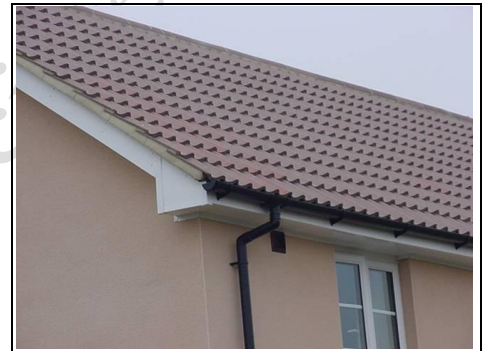
From ground level the gutters and downpipes looked to be plastic and appeared in reasonable condition. There may be a few repairs, but we feel that most people would be happy with getting these carried out.

Gutters and downpipes

ACTION REQUIRED: We would always recommend that the gutters and downpipes are cleaned out, the joints are checked and the alignment checked to ensure that the gutters fall towards the downpipes.

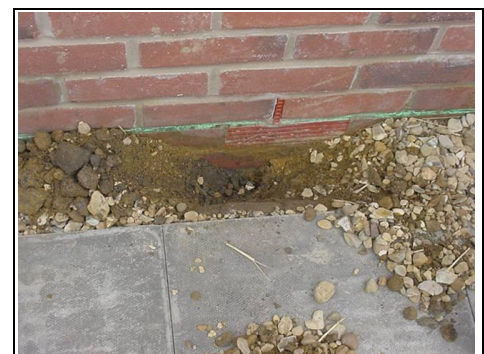
Superficial French drain

ACTION REQUIRED: Please see our comments in the Executive Summary.

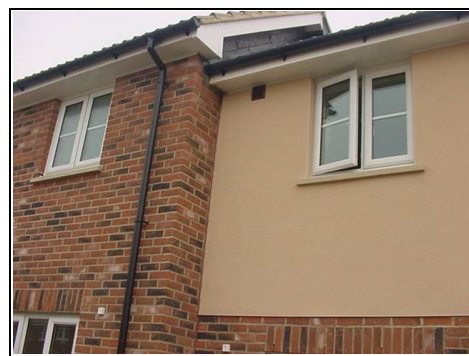
To the upper parts the property is rendered, this we believe will be onto the timber framework. We have found that in dry lining the render panels can deteriorate relatively quickly compared with older rendering.

Render

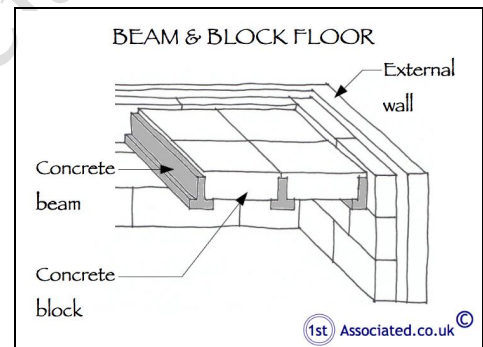
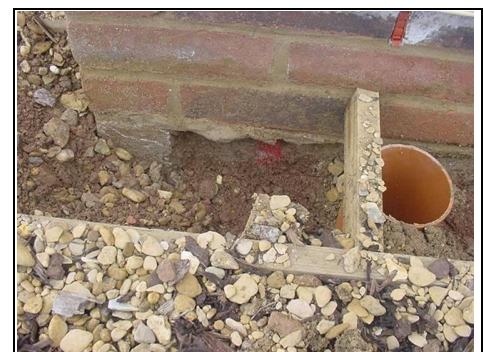
Given the properties age and type, we would expect the foundation to be a strip concrete foundation built up with blockwork. We were concerned when we dug up the French Drain the brickwork didn't seem to be sitting wholly onto the blockwork beneath.

Brickwork isn't sitting wholly onto the blockwork beneath

ACTION . REQUIRED: We would recommend further investigation around the foundations to see how the brickwork sits on the blockwork.

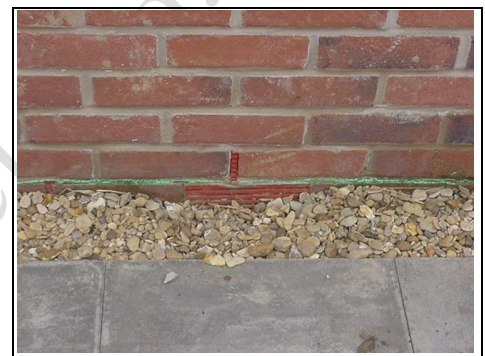
All modern properties should incorporate a damp proof course (DPC) and good building practice dictates that a differential of 150mm (6 inches) should be maintained between the damp proof course and ground levels. In this case, the property seemed to have two damp proof courses. We have spoken to you about this and you advised that it is due to the Building Regulation requirement to meet the Disability Requirements of Part M of the Building Regulations. We have not come across a double damp proof course before in all the surveys that we have carried out.

The green line represents damp proof course

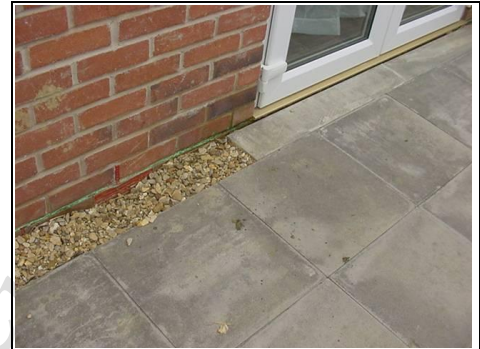
Airbrick acting as a gutter

ACTION REQUIRED: We would recommend a French Drain is added down the side of the property and the airbricks are guarded to stop water getting into them.

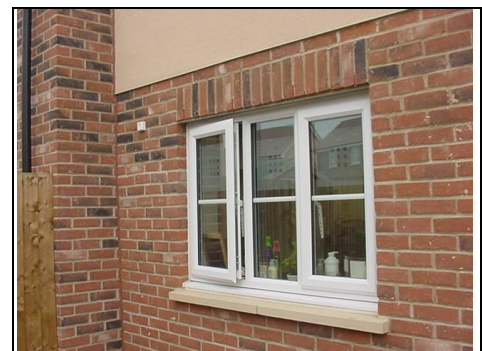
The property has plastic, double glazed windows, which generally look to be of an average quality for the year made. We were aware they had no trickle vents which is the normal requirement. Please see our comments in the Executive Summary about this property having a sealed system where the windows shouldn't be opened, which all relates to the air recovery system.
