RESIDENTIAL BUILDING SURVEY

Milton Keynes. MK17

INDEPENDENT CHARTERED SURVEYORS

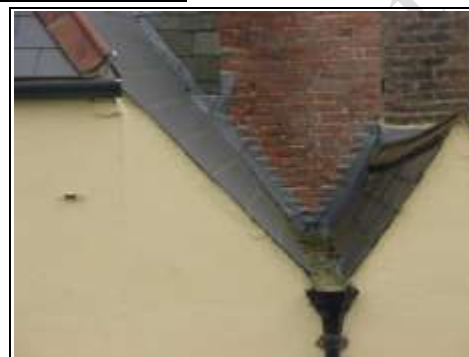
We have found dampness coming in from the left hand chimney (all directions as you face the property) the one next to the high level valley gutter. This means that there are problems to the chimney and the adjacent valley gutter which literally had a cloth in place.

Valley gutter to rear of property at high level

Access needs to be gained to the rear roof section of the property. We would recommend a roof window is formed to the roof, (subject to Local Authority Approval) as access needs to be gained to

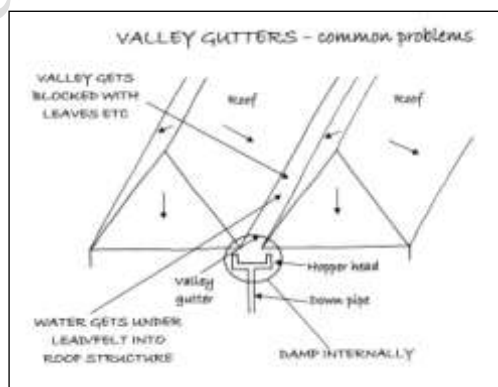
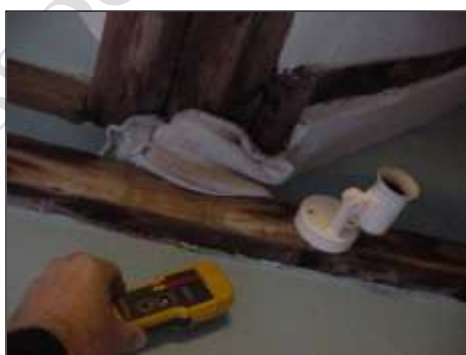
Dampness coming through from the adjacent valley gutter, with cloth in an effort to keep the area dry!

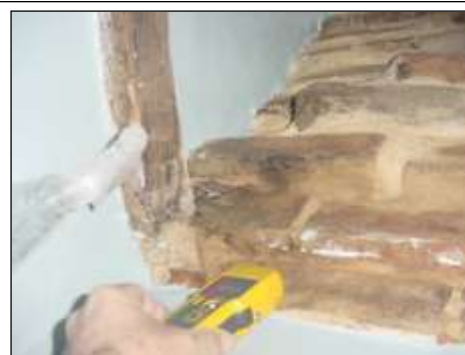
Found a combined dampness problem coming in from the rear left hand chimney (all directions given as you face the property).

In some old buildings we find that this is simply an awkward detail you will need to accept that dampness will come into this area to an extent and this will be a characteristic of the building. You do also need to check the damage that has been caused to the timbers by the dampness which is why we recommend a section of this roof is opened up. We would be more than happy to return and have a further look once you have opened up this section of the building. If you do decide to install a roof window this of course will give extra daylight into the area. We would also suggest fixing safety bolts to the chimney to enable safe working in this area as you would be responsible for the safety of workmen. The right hand side chimney also needs to be checked.

ANTICIPATED COST: We would expect costs in the region of £500 - £1000 for the fitting of a roof window, this would then allow you to view the amount of work (do remember you may have to get Local Authority Approval) and a further £1000-£5000 for the repair work depending upon the extent required, you will have a better idea when you can actually see the area; quotations required.

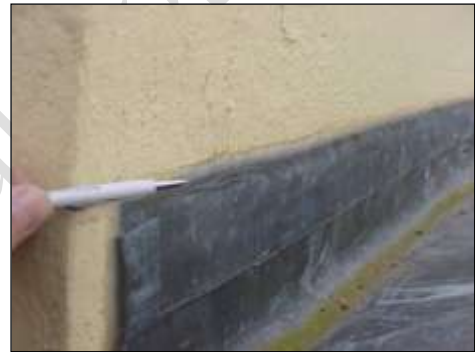
We suspect the valley gutter between two roofs is to be the area likely to leak.

Mastic seal to the lead flashing indicating problems

Ideally we would recommend that the conservatory is completely redesigned (if indeed it was designed originally!) We would suggest a higher double pitched roof would be more appropriate for this age of property and allow the forming of a box gutter that you could walk on to clean, this would be very expensive and needs further thought.

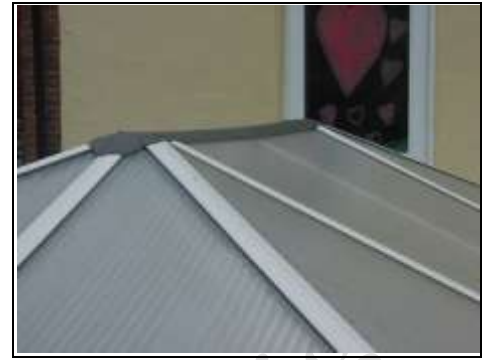
Whilst we are on the subject of the conservatory we would just add that this type of conservatory with a polycarbonate roof with a terrible Flashband detail to the ridge! Is from the cheaper end of the market and as such will suffer from heat gain and heat loss during the summer and winter months respectively. You may wish to look at improving the roof by adding a glass roof (this can be tinted, they can have argon in them etc, etc to reduce the affects of solar gain and heat loss) with a higher pitch or alternatively the addition of a vent in the roof to allow the heat to be dissipated in the summer months.

Poor quality repair to the ridge in Flashband that needs replacing

ACTION REQUIRED: Consider redesigning the conservatory, at the very least we would recommend blinds internally to stop the heat gain and heat loss and also the ridge needs repairing.

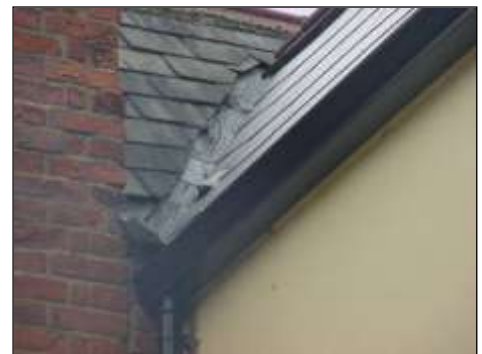
The main building has a mansard style main roof which is clad in natural slates with the exception of the repairs that have been carried out to the rear which have been carried out in a modern manmade slate. There still looks to be problems in this area where the main roof meets the new roof as the lead looks to have been tarred (indicating dampness is getting in) and also has been returned at the end at the base to help prevent the rainwater surcharging running down the building.

Natural slate to the left hand side and manmade slate to the right hand side and a lead valley gutter that has been tarred indicating that it has leaked

ACTION REQUIRED: We recommend to the main roof that you stand outside next time it is

raining heavily and see where the rainwater is surcharging over the gutters. We suspect a box gutter will be needed and a swan neck downpipe is not working, you may for example be able to use a downpipe to a water butt in this area.

ANTICIPATED COST: You also need to budget for repairing the remaining slate roof (we would never recommend that a slate roof is replaced with a manmade slate roof as in this case) and set aside the sum of £1000-£3000 for these various items; quotations required.

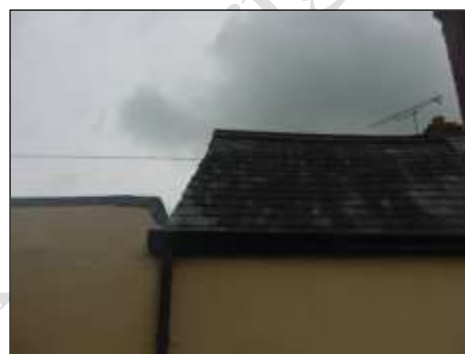
We noticed some lead tingles are still visible to the rear roof. This indicates that there may be problems with nail corrosion which does mean this roof is likely to need repair.

Lead tingles visible

ACTION REQUIRED: We never recommend that a natural slate roof is replaced by a manmade slate in

this era of building as they have different characteristics which unfortunately has taken place on this building. We understand why people have carried this out with a natural slate being approximately more than treble the price of a manmade slate.

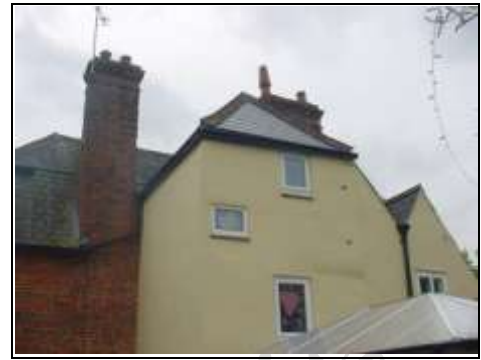
There are areas of render on the property which again looks to have been formed with a cement base rather than a lime mortar. Again this is stopping the area from breathing. Although we believe some of the render is still lime as we can see undulations to the rear of the property. This may lead in due course to cracking in the render. The cracking in the render needs to be sealed. It has been difficult to view the render close up to the rear as most of it is at high level.

Repair work required to render

ACTION REQUIRED: Any cracks in the render to be sealed as soon as they appear, this will be quite difficult due to the conservatory limiting access.

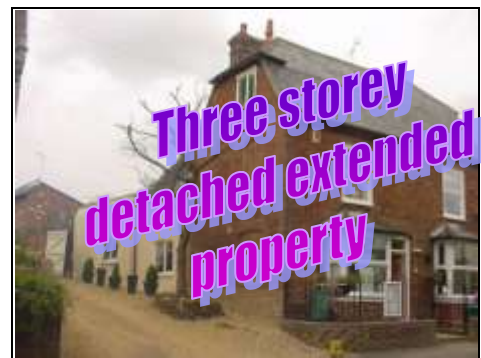
3.0.1) The property sits on a sloping site and as such the ground levels are above the floor levels. In most instances we have found dampness at the property both to the perimeter walls and internal walls.

Property on a sloping site

3.0.3) We recommend a French drain is run along the property to all sides to lower the ground levels. On the left hand side of the property you would of course need the permission of your neighbours.

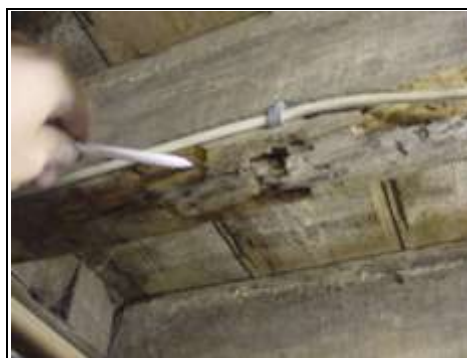
Signs of woodworm in basement

ACTION REQUIRED: We would recommend opening up sections of the property at roof level and at floor level to check for woodworm and also check for wet rot and dry rot at the same time. The ideal locations to open up are:-

- i) Rooms in the roof around the chimney areas
- ii) Front and rear walls of the ground floor, first floor and second floor.
- iii) You need to take a photographic record.

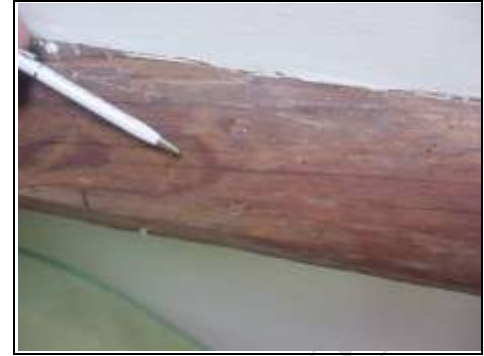
Signs of woodworm in rear building

We are in two minds as to whether to recommend woodworm treatment as there is only a limited amount of exposed timber in the property and the unexposed timber would affectively remain still being attacked by the woodworm. This is why we recommend investigation work first. We suggest setting aside a sum of £1000-£3000 for investigation work and minor repair work. We would be more than happy to return when the property is opened up to make further comments; quotations required.

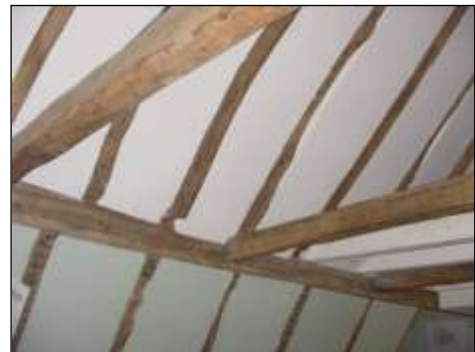
7.0.1) We believe the original structure of this property was timber frame, you can see elements of the timber from structure throughout the property and we would refer to what we can see as the carcase. It would have been built using local materials; generally known as vernacular architecture. Local materials in this case would have been sandstone and infilling the timber panels with wattle and daub or similar local materials.

Timber frame structure.

ACTION REQUIRED: As mentioned we would recommend some opening up to be carried out to investigate the hidden areas of the property to ensure that you carry out work long term for the correct repair of this building.

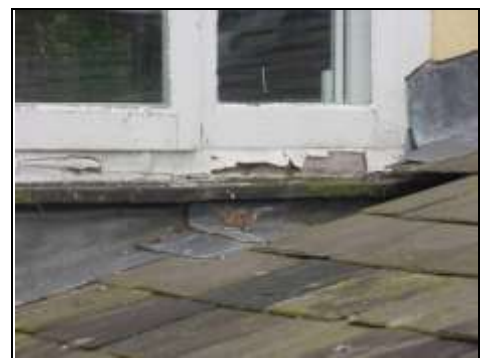
- 9.0.1) The windows are a mixture of plastic and timber. The painted/stained windows require redecoration, we could see paint flaking and timber visible in some areas, we would however term them as saveable.

Timber window degrading

ANTICIPATED COST: We advise you to set aside the sum of £3000-£5000 as you may wish to replace some of the inappropriate plastic windows to the front of the property with timber sliding sash windows; quotations required.

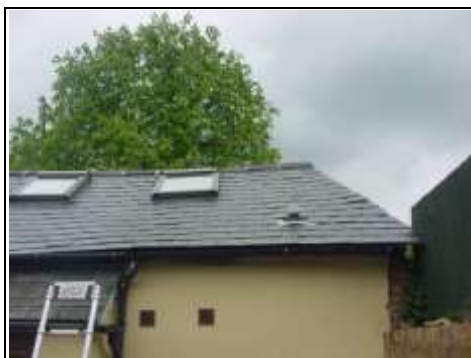
10.0.1) The main roof is pitched and finished with a manmade slate. The slates do not sit as flat as we would expect and there is also some visible leaking internally. We note that some of the slates are held in place by tingles, indicating there may be corrosion to the nail fixings. Overall we would comment that the roof looks in below average condition which seems very strange as given that it has a manmade slate on it we would expect it to be carried out fairly recently.

Undulation to rear building roof

ACTION REQUIRED: Check to see if there is an insurance backed guarantee available with the roof. If not then we would like to see a section opened up to check its condition.

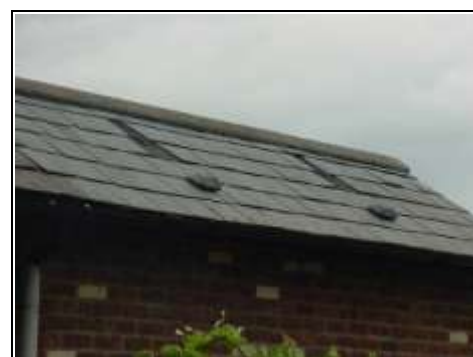
11.0.1) We would specifically draw your attention to the unusual detail to the rear of the property where slates look to be missing. We have not come across this detailing before, we would recommend slates are added back in place.

Rear of roof with missing slates

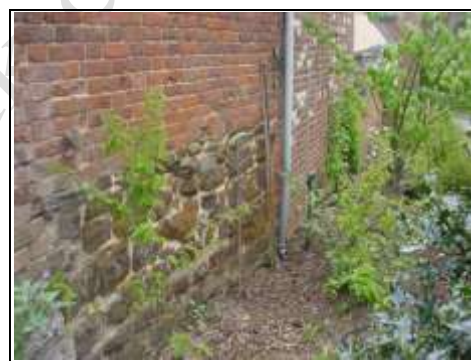
12.0.1) We suspect there is dampness to the rear walls due to the high level of the ground outside on this general sloping site. We are unable to check the walls due to the dry lining. We also noted there is sandstone to the base of the walls which could be contributing to the dampness.

Sandstone at the base of property

ACTION REQUIRED: We have recommended earlier a French drain is added and would also recommend that the gutters are checked on your neighbours side to ensure that they are collecting the water correctly when it rains and we would also recommend ad hoc re-pointing in this area.

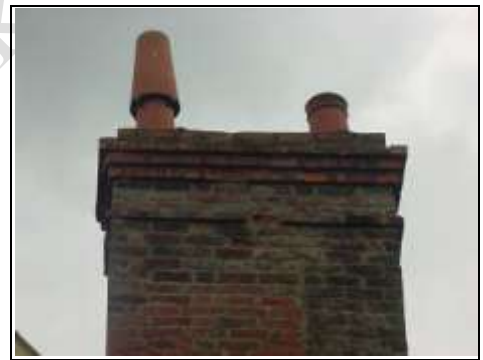
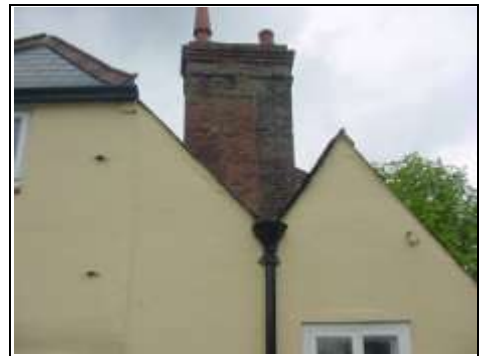
Chimney One

This chimney is built in brick with we believe a lead flashing (we literally could not see most of it) and two chimney pots/flues. From what we could see the chimney needs some ad hoc re-pointing and the flashing needs checking/replacing as there is dampness inside. We were unable to see the very top of the chimney know as the flaunching, we therefore cannot comment upon it.

ACTION REQUIRED: Please see our comments in the Executive Summary with regard to adding a roof window to allow closer examination of the chimney and also the dampness that is being caused by the condition of this chimney.

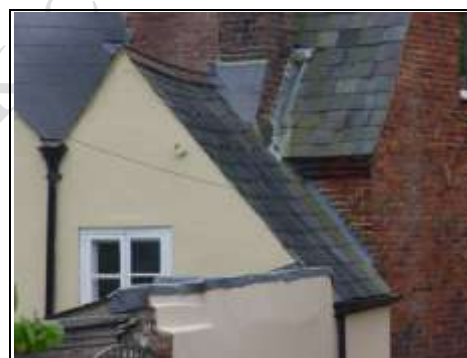
The roof is pitched and clad with natural slate and man made slates. It is a mansard type roof, with Dutch gables. Overall we believe the roof to be in average condition, considering its age type and style. It has however suffered from recent repairs, we could comment are not best practice. Also the section to the left hand side of the property where we can see lead tingles and therefore it is likely to be in need of repair in this area.

Lead tingles to rear of main roof

ANTICIPATED COST: Set aside the sum of £2000-£5000; quotations required. Please see our comments in the Executive Summary about the valley gutter to the rear of the property.

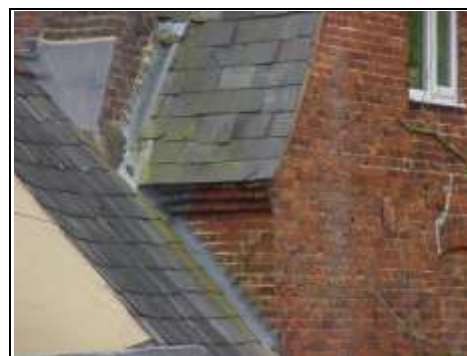
Lead tingles to left hand side of the roof and displaced slates to the right hand side

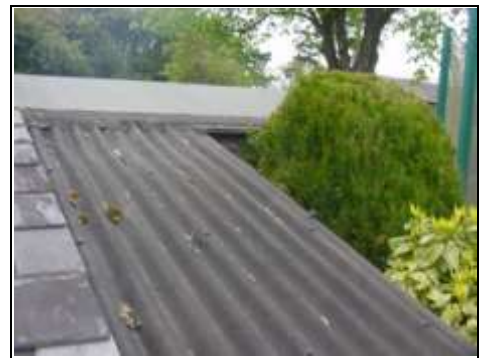
Fibre roof, also to the rear, we would replace with a slate roof in keeping with the rest of the property

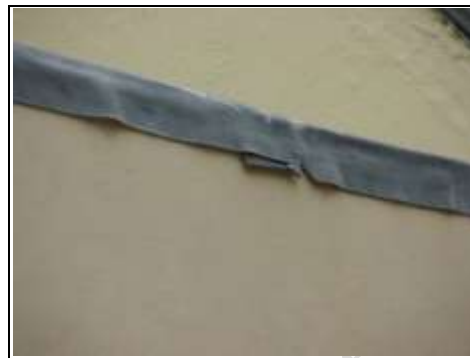
Detail to the top of the single pitched roof is awkward, the lead turns. As far as we could see this will allow water to drip down this side of the wall and may well lead to dampness getting in.

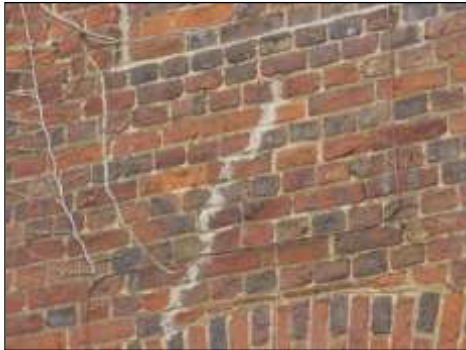
Cracking we believe this relates to gable end movement

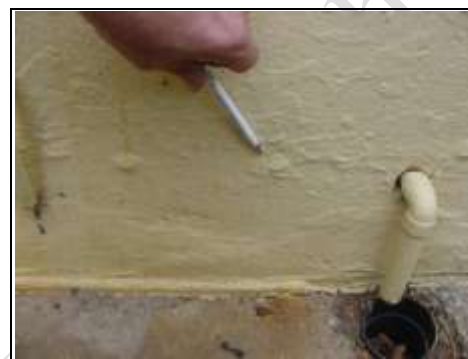
All modern properties should incorporate a damp proof course (DPC) and good building practice dictates that a differential of 150mm (6 inches) should be maintained between the damp proof course and ground levels. In this case, holes have been noted on the outside of the building, which have been drilled into the wall. This is a typical sign that a chemical injection damp proof course has been inserted. This is not appropriate for this age of property.

Old inserted damp proof course to right hand side main building

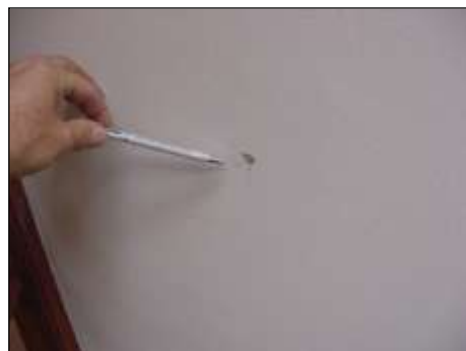
Plasterboard ceiling
top floor degrading

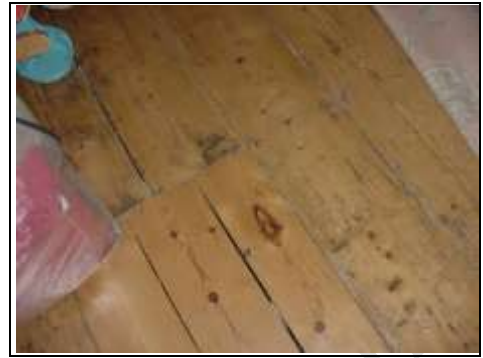
Top Floor: Older timbers have woodworm and there are new replacement timbers

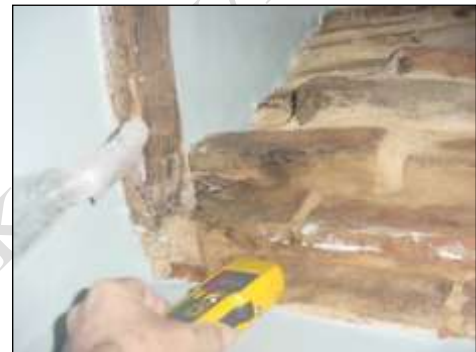
Some lateral dampness was found around the chimney areas and also there areas of hollow plaster on the walls indicating that there is dampness coming in through the brickwork. We would refer you to our comments about carrying out some ad hoc re-pointing externally and also refer you to our comments about the general high humidity in the property both of which may be contributing towards this.

Dampness coming in from chimney one

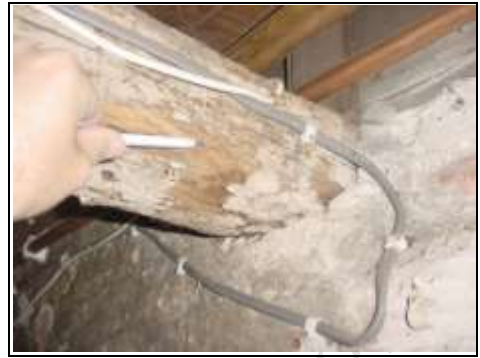
Woodworm

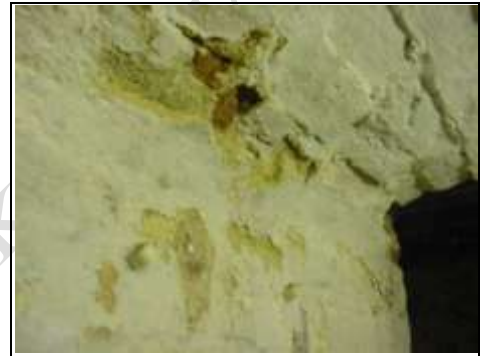
Spalling to chimney

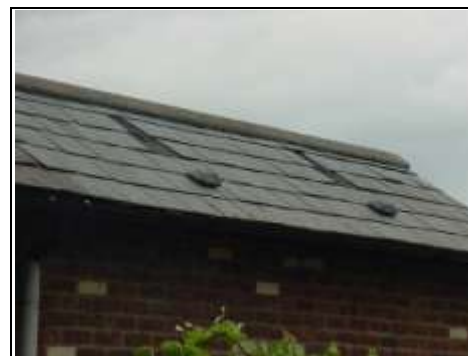
Missing slates

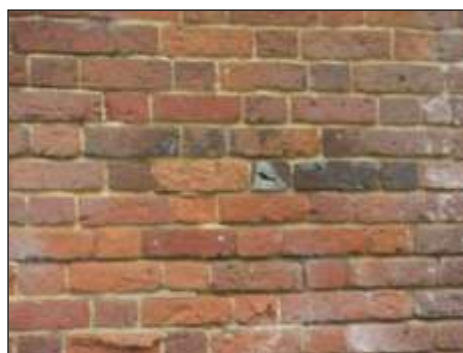
Brickwork in need of re-pointing

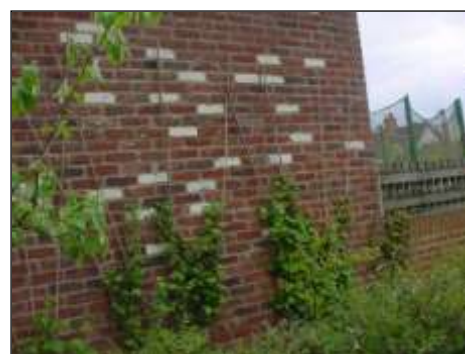
Plants on the brickwork

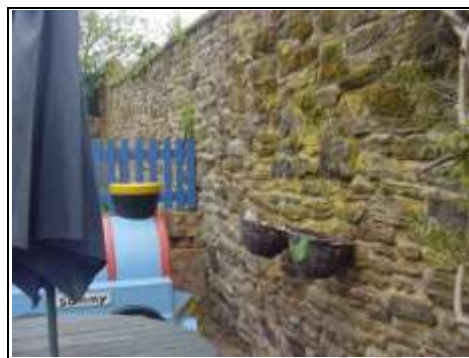
Bulging Boundary wall

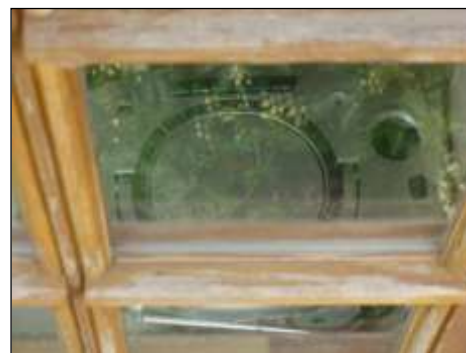
Window starting to deteriorate.

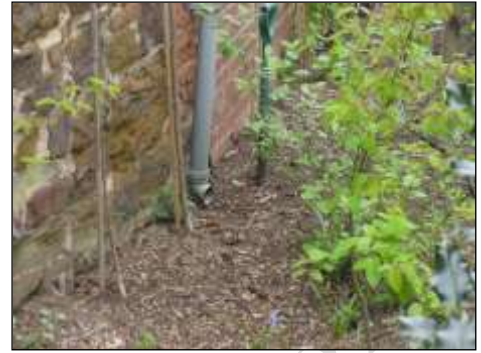
Rainwater discharges directly to the base of the property
