# RESIDENTIAL BUILDING SURVEY

XXX XXX  
Long Melford  
Sudbury  
Suffolk. CO10 XXX

This is a two storey terraced property that is being refurbished, altered and amended as we are surveying the building. The property has a traditional timber frame with a modern rear extension and an outbuilding and has had various alterations and amendments as part of this refurbishment.

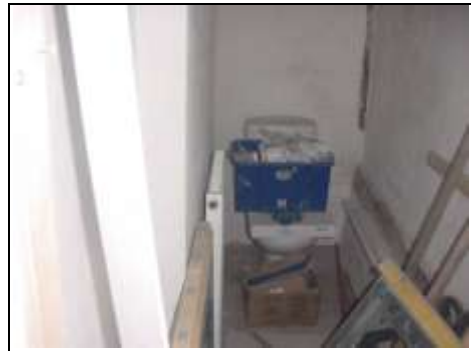
Unfinished WC

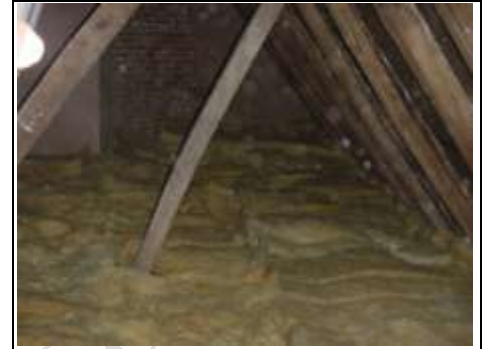
The insulation in the roof we feel will cause condensation as there is no ventilation.

Mass of insulation

**ACTION REQUIRED:** Add ventilation to the roof. Ideally remove all the insulation in the roof and reconsider how to do this properly. There are already areas where the timber is becoming softer.

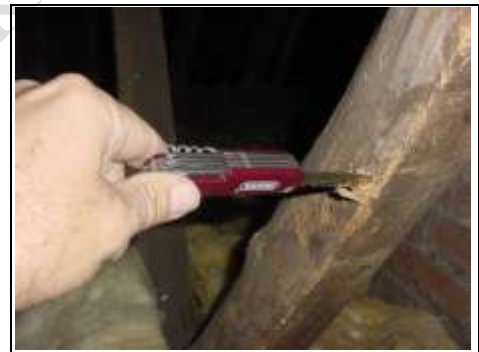
Timber becoming softer

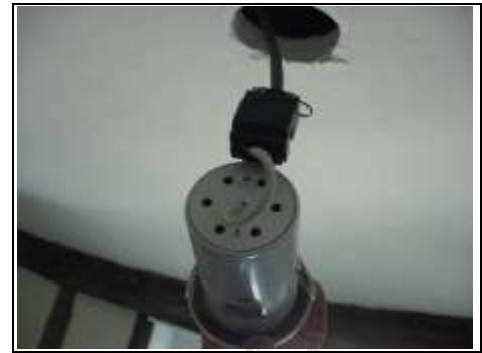
The ceiling lights in many of the rooms which are not appropriate and gives heat out into the ceiling area which is not ideal in a timber framed property.

Light fitting giving heat directly into floor and roof space

**ACTION REQUIRED:** Change to wall lights that self vent.

**ANTICIPATED COST:** A few thousand pounds or at the cost of the developer; please obtain quotations.

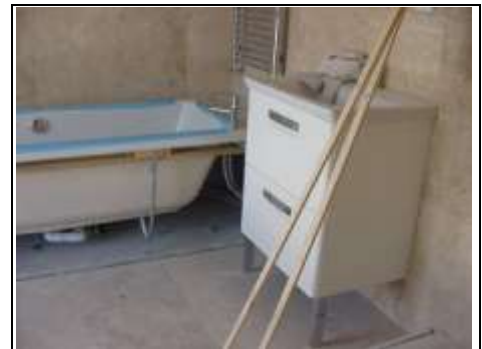
Bathroom

The bathroom size, particularly the bath is not particularly generous.

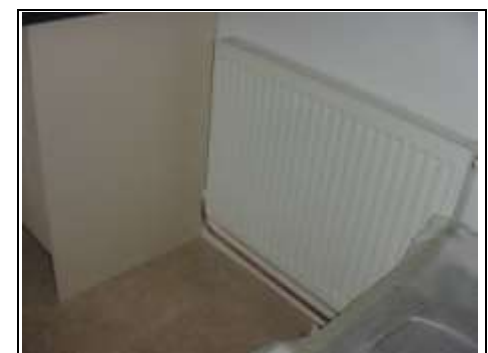
The kitchen radiator is not ideal and it is debateable whether you actually need a radiator in the kitchen particularly on an internal wall was well as it reduces the amount of storage space in the kitchen.

Kitchen radiator

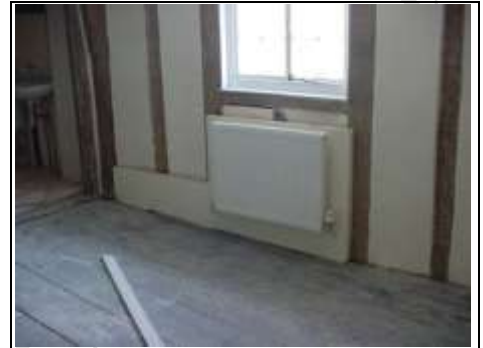
The radiator with the ugly boarding in the master bedroom we would have thought there would be a more presentable way of carrying out this work.

Radiator with ugly boarding around it

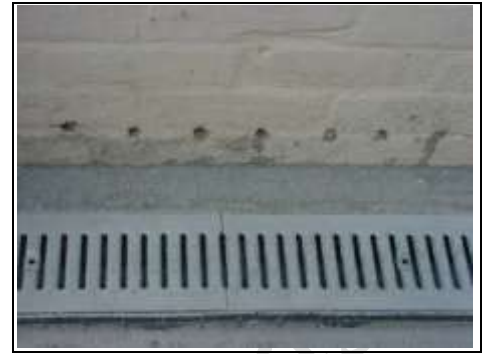
These buildings need to naturally breathe which is brought about by the use of lime materials. There seems to be a lack of understanding of old properties with the damp proof course inserted into the front of the property and the rear.

Damp proof course

**ACTION REQUIRED:** There is little you can do to undo the work.

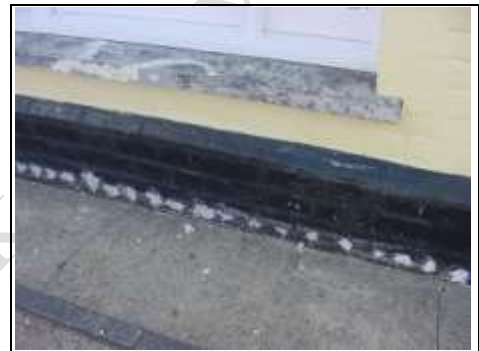
Damp proof course to front

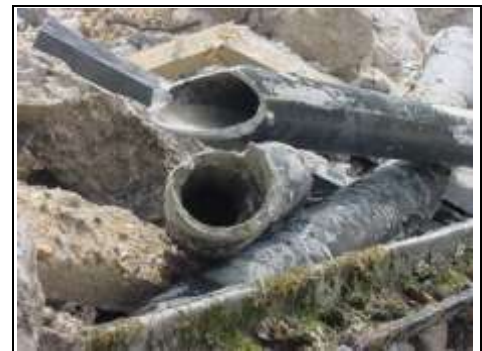
We could see that asbestos pipes have been removed and are still present on the site. They have not been bagged and merely put into the rubbish heap which, to us, represents poor project management. There is also some remaining asbestos on the rear outbuilding roof. Please note we are not asbestos surveyors.

Asbestos pipes removed and not bagged for disposal

**ACTION REQUIRED:**  
Asbestos to be removed from the site.

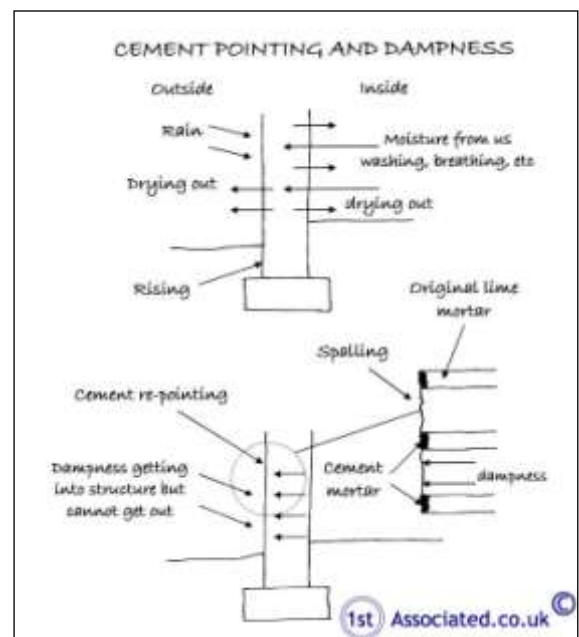
Our overall impression was disappointing that this standard of work is still being carried out on Listed Buildings which shows a general lack of knowledge about older properties and how they work.

Cement pointing and dampness

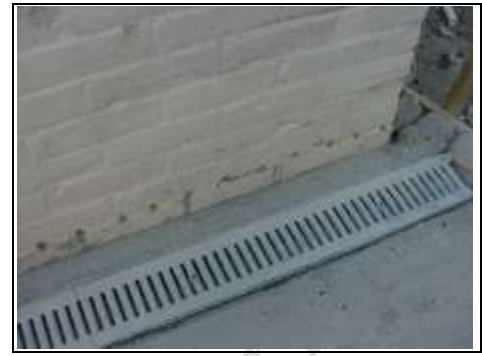
There rear of the property sits on a sloping site towards the main building. We are advised that paving slabs are going to be put onto this area and we are concerned that rainwater may be discharged towards the property which will overflow and over flood the gulley that has been put in place.

Running gulley

You need to ensure the running gulley runs to a manhole, we would much prefer to see a reducing of the ground level and a French drain in an older property.

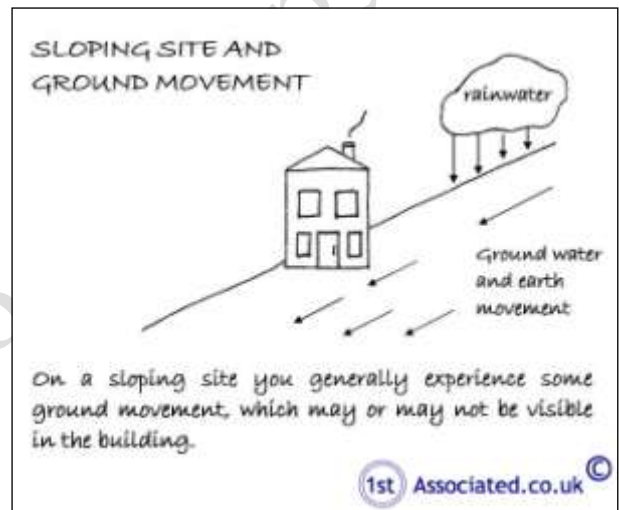
Sloping site

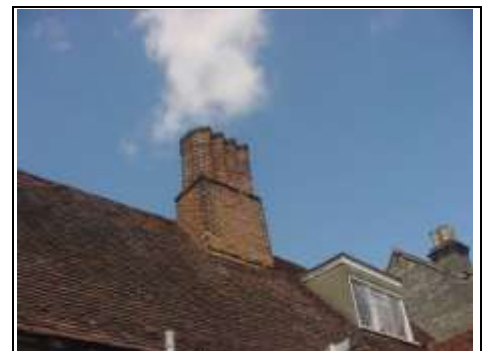
We noticed that there is light coming through in the main roof, near the chimney, indicating that work needs to be carried out to the chimney and the chimney flashings. We spoke to the builders on site who advised that no work had been carried out to this area.

Rear left hand side chimney letting in light and dampness to property

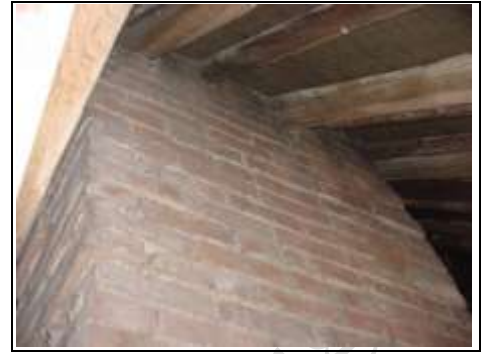
Dampness in chimney

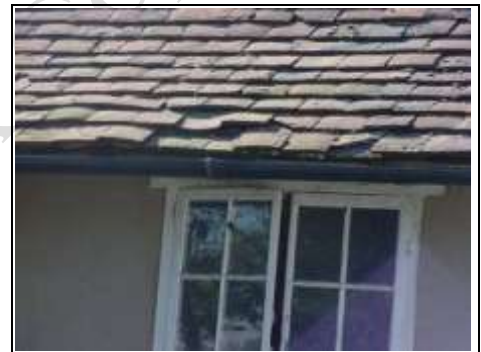
We could also see that some roof tiles are misplaced.

Missing tiles to rear

We would recommend a roofer carries out careful work to the roof over a period of approximately half a day to a day.

A few hundred pounds;  
please obtain quotations.

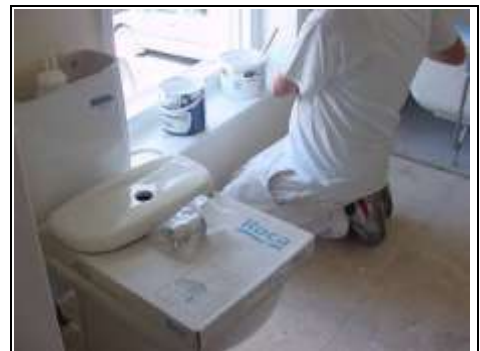
At the time of our survey painting was taking place using Dulux paint when specifically requested to use Farrow and Ball paint.

Dulux paint being used
