RESIDENTIAL BUILDING SURVEY

Ealing

**Victorian Detached
Property with loft
conversion**

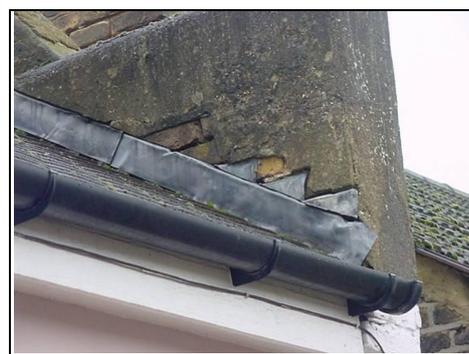
The flashing to the rear left hand parapet wall is poor and rather than stepping with the joint has been cut through the brickwork. There are also render repairs required.

Poorly fitted flashing to the rear left hand parapet wall

ACTION REQUIRED: Check lead flashing and carry out render repairs to the parapet walls. This may need scaffolding.

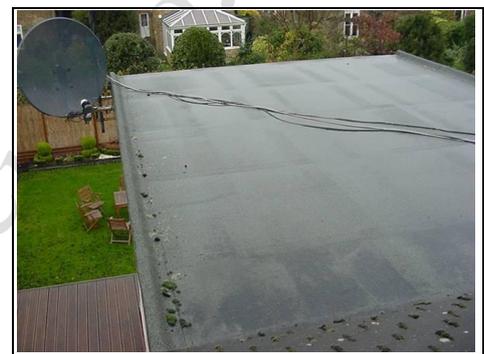
- i) There is a risk of water getting in below although we couldn't visually see any at the time of our inspection and
- ii) That the roof will deteriorate quicker than is typically expected, which in our experience has a life of fifteen to twenty five years.

Flat roof to rear of property

ACTION REQUIRED: With the felt roof you need to expect there to be an above average number of repairs sooner rather than later. With the wood decking covered roof, we recommend removing the wood decking to expose the roof to check the condition of it. We expect it could go one of two ways, either a perfect example of roofing with the exception of the flashing or a roof in poor condition.

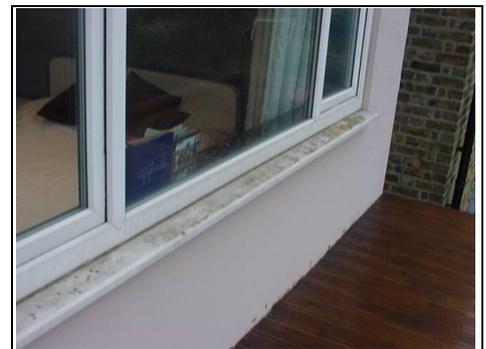
The second roof to the rear is covered with a wood decking meaning that we can't actually see the roof, however we can see that there is no flashing between the roof and the main building.

Wood decking covering the roof. Here we can see where the decking meets the main wall where there is no flashing

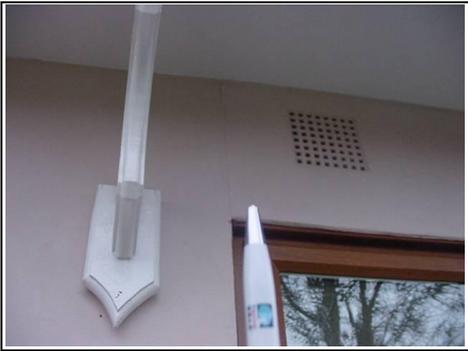
We can see throughout the rear of the property there is cracking to the render particularly on the left hand side at high level. We can also see that repairs have been carried out to cracking indicating that it is a known about problem. The cracking could be for many reasons, from movement to the cement being too hard at the rear of the property; however we feel that you need to specifically ask the current owners if any underpinning or structural work has taken place to the property.

Crack in the render to the rear

ACTION REQUIRED: To be on the safe side, we would recommend the present owners put in an insurance claim identifying this cracking was noted during the course of a building survey, but as it was a one-off inspection it couldn't be conclusive. The insurance company will then carry out monitoring over a period, usually a year (as recommended by the Building Research Establishment) and carry out work as necessary. This all needs to be in writing as this would then limit your cost to the excess within the insurance and any supplements they would then charge you if and when work was carried out.

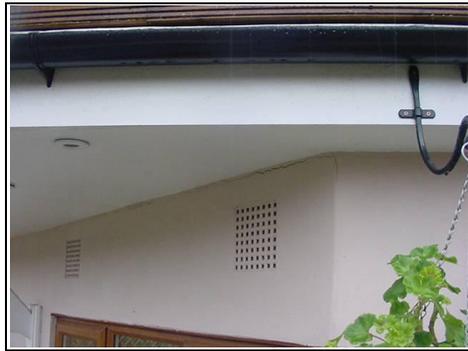
Crack at high level

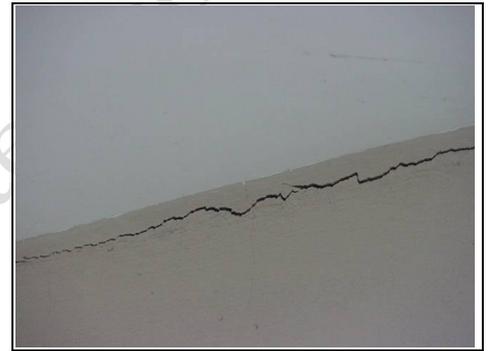
Close up of crack at high level

Cracks that have been repaired which are now hairline

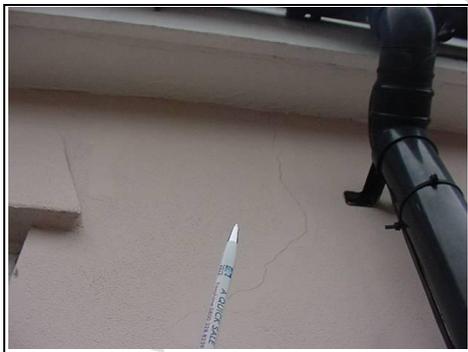
Cracking to the rear left hand side

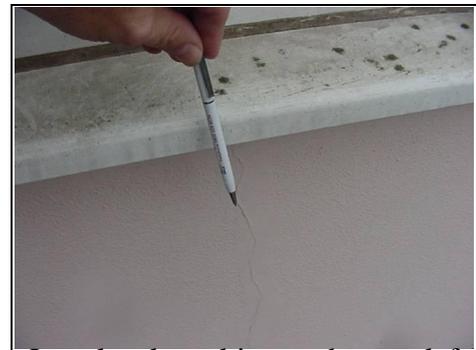
Low level cracking to the rear left hand side

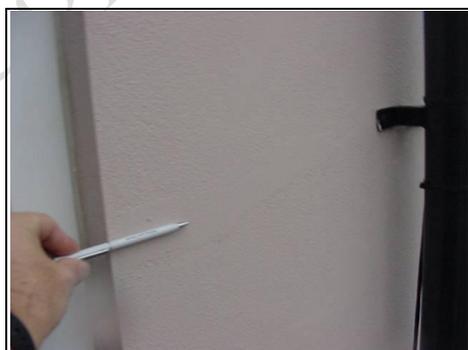
Covered up cracking

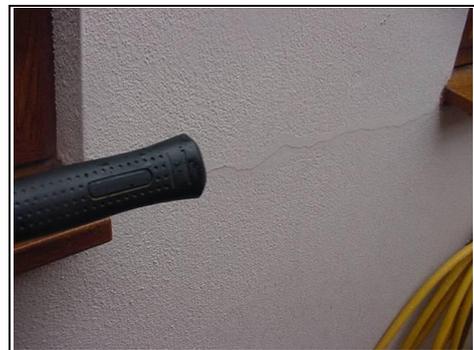
Cracking to the render

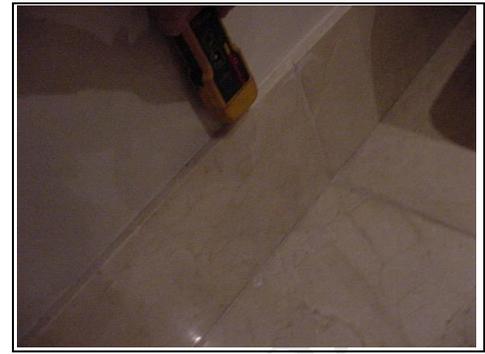
We have found rising damp on the right hand side of the property and we believe we would also find it to the rear if the walls weren't hidden by the kitchen units. This we believe is due to the high ground level.

Low level rising damp

ACTION REQUIRED: We would recommend in the first instance the lowering of the ground level around the right hand side and rear of the property. Unfortunately this would be quite a lot of work as the whole area has been paved which is part of the problem as they have been added over the existing ground level rather than lowering it. This has then allowed the dampness in.

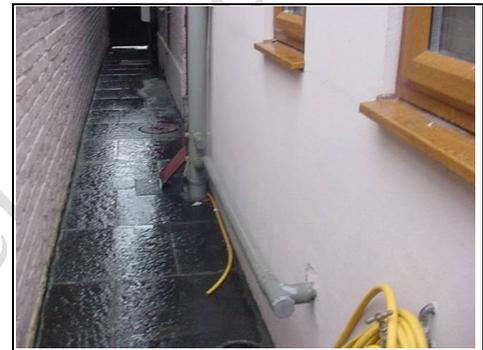
Right hand side is too high and needs the ground level lowering

ANTICIPATED COST: In the region of £10,000 - £20,000; quotations required.

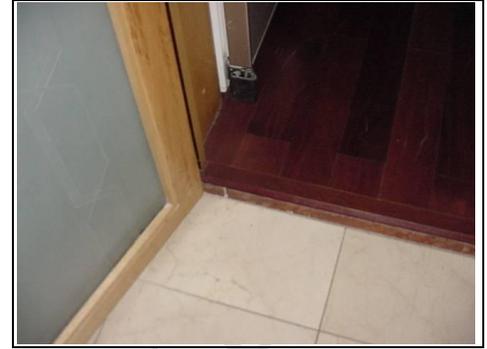
Throughout the property there are ceramic tiles onto wooden suspended timber floors. This mix of solid material in the form of the tiles onto a timber which deflects and moves with the seasons does get differential movement, which requires re-grouting. Over the years, the only way we have found around this is to have an expansion joint and sit on top of the tile coving which we don't see in this instance. If this isn't put into the original design, then it is very difficult to add it afterwards. Unfortunately we couldn't see it in this instance.

Tiles to wooden floor with a step on the ground floor

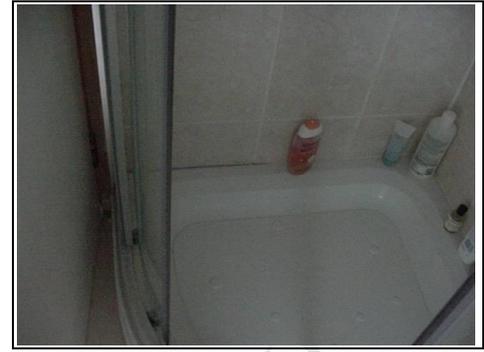
We could see some deterioration to some of the showers. This can often occur where the shower isn't bedded down properly and a hollow shower is used rather than a solid shower.

Deterioration to shower

ACTION REQUIRED: Each shower to be checked for deterioration and re-mastic.

ANTICIPATED COST: A minimum of a few hundred pounds. To replace could be thousands of pounds depending upon how easily it can be replaced; please obtain quotations.

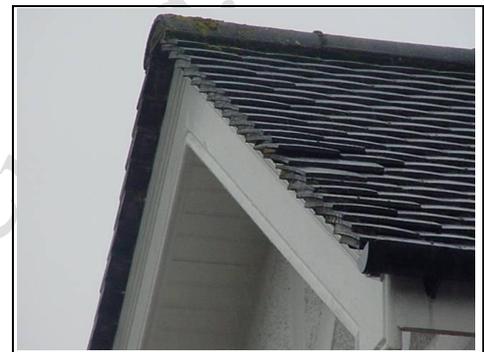
The main roof is hipped, pitched and clad with small concrete tiles and, from ground level, this looks in average condition considering the roofs age type and style. With this age of roof there will usually be a few missing or displaced tiles, this is nothing unusual. In this instance we could see some displaced tiles to the front gable end. These looked like they had been lifted by the wind and need replacing.

Tiles slightly displaced to the front

ACTION REQUIRED: A roofer to replace displaced tiles. Carry out periodic inspections and maintenance of the roof, as required.

ANTICIPATED COST: A few hundred pounds; quotations required.

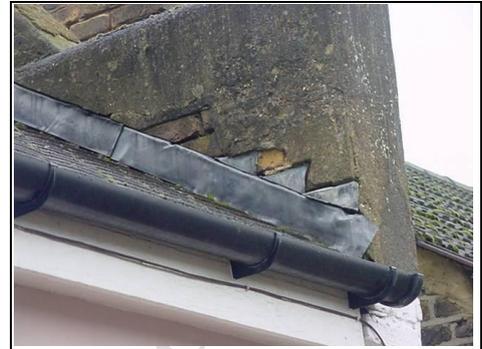
In this case there is a parapet wall to the left hand side. It is a brick built parapet wall that has been rendered and is in below average condition. Please see our comments in the Executive Summary.

Poorly fitted flashing to the rear left hand parapet wall

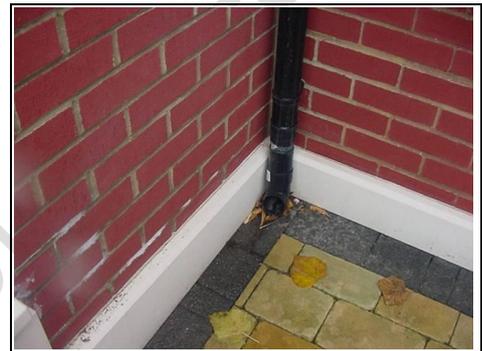
From ground level the gutters and downpipes are plastic and are in average condition. There may be some minor leaks, but we feel that most people could live with these. Carry out repairs within the next six to twelve months.

Plastic downpipe discharging onto the ground

ACTION REQUIRED: We would recommend you stand outside the property next time it rains heavily and see how well the drains cope with the rainwater particularly looking at the guttering and the joints. We would always recommend that the gutters and downpipes are cleaned out, the joints are checked and the alignment checked to ensure that the gutters fall towards the downpipes.

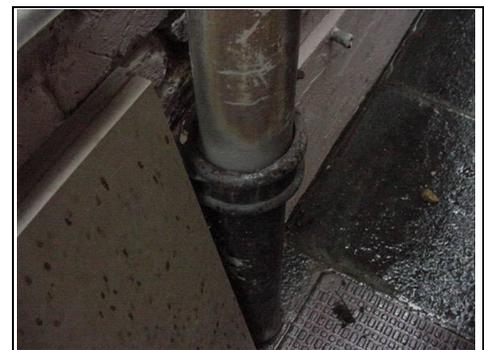
Cast iron of this age can crack and rust and needs regular maintenance.

Soil and vent pipe – cast iron to plastic

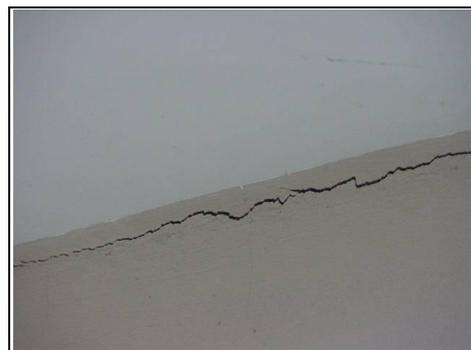
Close up of crack at high level

We would remind you that any hairline cracks that appear, which tends to be the case with render, need to be sealed as soon as possible to stop dampness and water getting in and causing blisters and hollow areas.

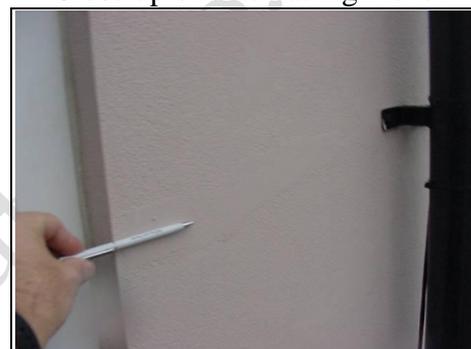
Old cracks that have been repaired previously

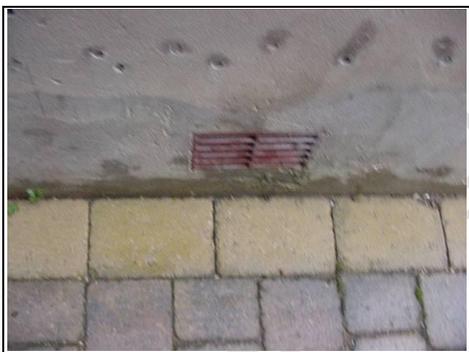
Airbrick acting as a gutter

ACTION REQUIRED: Please see our comments within the Executive Summary.

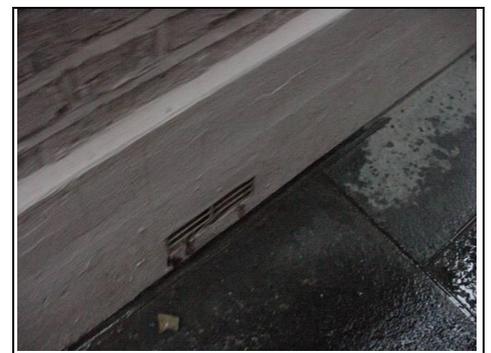
Airbrick acting as a gutter on the right hand side

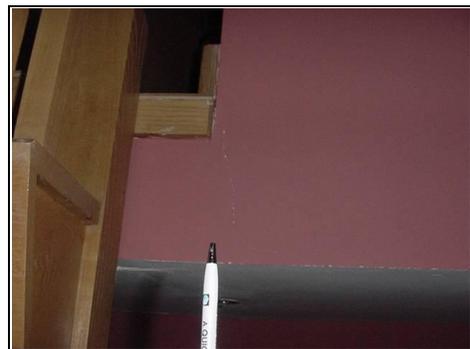
Hairline cracking on the stairway on top floor

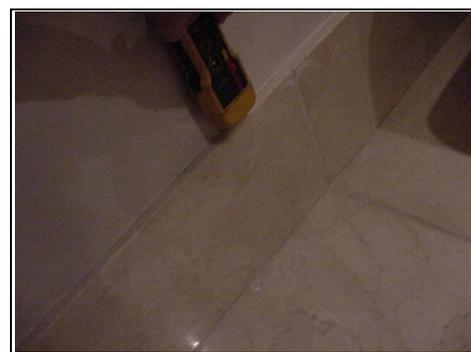
A random visual inspection and tests with a moisture meter have been taken to the perimeter walls. In this particular case we have found rising damp to the right hand side of the property.

Rising damp

ACTION REQUIRED: Please see the Executive Summary.

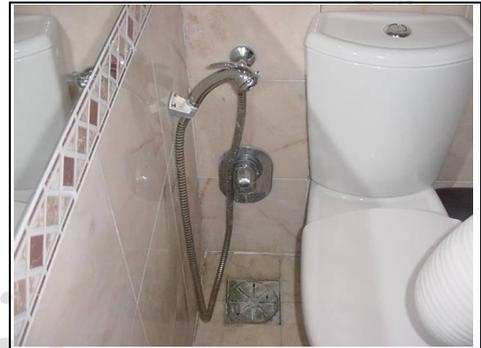
Washer unit in downstairs w.c. is leaking
