RESIDENTIAL BUILDING SURVEY

XXXXXXXXXXXXX,
Luton,
Bedfordshire,
LU3

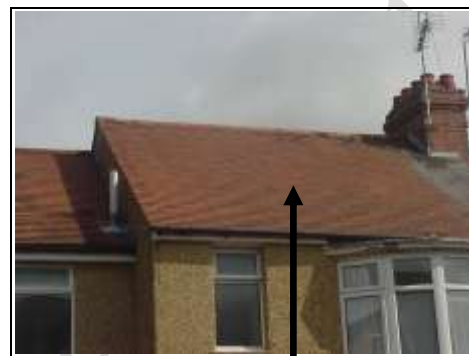
The original roof has nibbed tiles without a protective underlayer. This type of roof has been superseded by a modern roof with a protective underlayer. We would recommend that a protective underlayer is added to the roof.

Original roof

ACTION REQUIRED: Within the next five to ten years we would remove the existing roof and add a protective underlayer, re-batten and add the tiles. You will probably have in the region of thirty per cent waste so you will need to replace some of the tiles.

ANTICIPATED COST: In the region of £5,000 - £7,500 (five thousand to seven thousand, five hundred pounds) assuming that some tiles can be re-used. A substantial part of the cost for this type of work is for the scaffolding. Many insurers/companies now require the properties to have scaffolds not only to the sides but also to be roofed over to protect against weather damage; please obtain quotations.

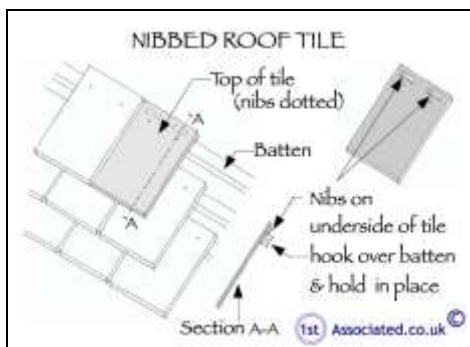
Nibbed tile

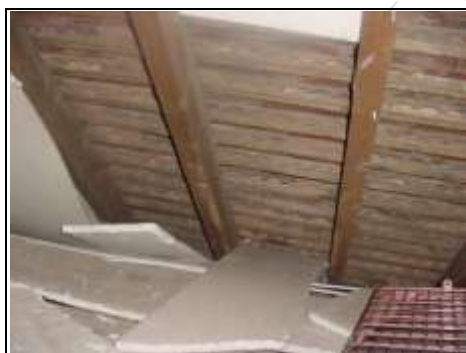
Nibbed tile with no underlayer

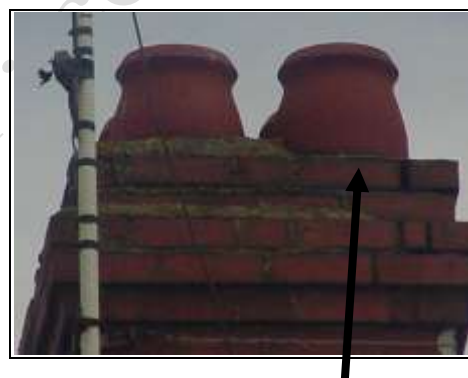
Some of the flaunching is missing. We believe this is where the damp is getting in.

ACTION REQUIRED: Repairs are needed to the chimney. Again this is likely to require scaffolding and this will be the most expensive part of the cost

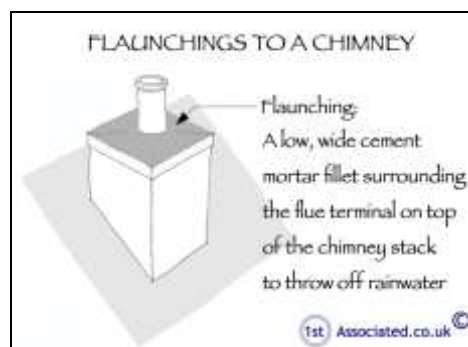
We would comment that we cannot see the flaunchings very well.

Flaunching

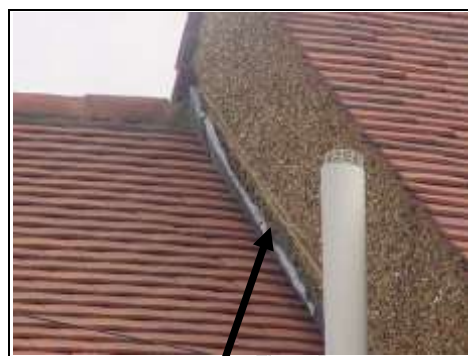
Flashing coming away where there is an up-stand between the two roofs.

ACTION REQUIRED: We would recommend a tradesman that is used to carrying out lead work is used. We prefer to see bonding in Plumbers Mate or equivalent mastic to bed the lead into the wall.

ANTICIPATED COST: Again scaffolding may be required which will increase costs, £750 - £1,500 (seven hundred and fifty pounds to one thousand, five hundred pounds); please obtain quotations.

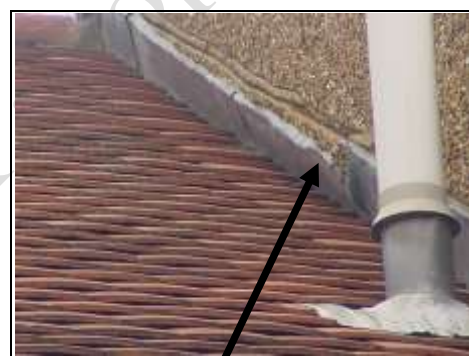
Close up of flashing coming away

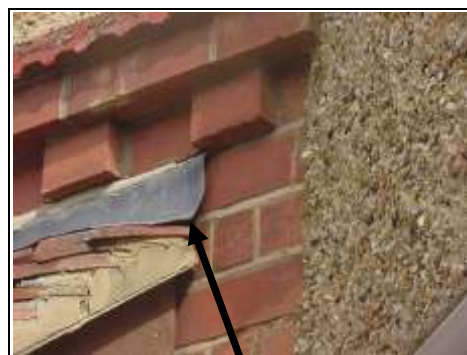
Lead coming away over front entrance

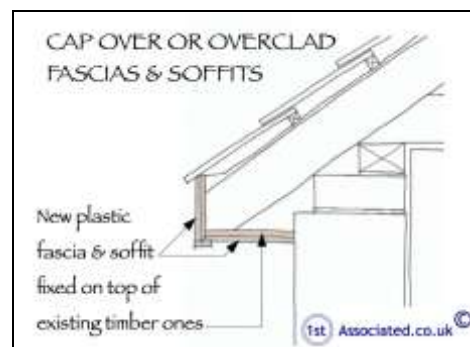
To the rear of the property we noticed some plastic fascias and soffit boards (these are at the base of the roof). These look as if they may be over cladding.

This is a practice that we are not at all keen on as it is usually put over the top of damaged or deteriorating timber fascias and soffits. Although it gives a clean look externally it can promote rot internally and in a worst case scenario can damage the roof joists.

Over cladding

ACTION REQUIRED: Drill and check to see if it is plastic over cladding. If it is then we suggest that it is all removed and replaced with a new fascia and soffit.

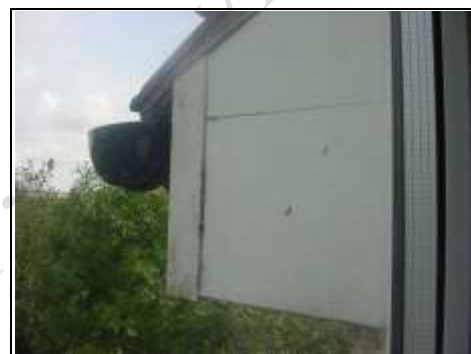
Plastic over cladding

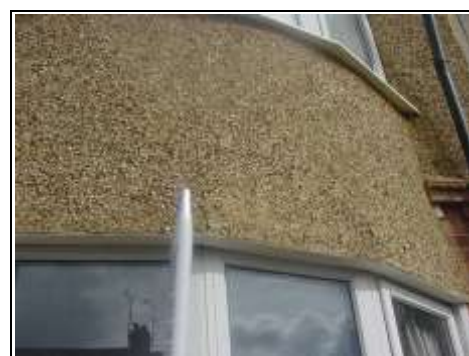
We can see cracking in the pebbledash render. In this age of render there is likely to be on-going maintenance.

Crack in pebbledash render on bay window

ACTION REQUIRED: To the front we would leave and repair the render in due course. To the rear we would open up above the windows and investigate to see what is there. As we discussed you have a business in double glazing. There may be no lintel in this area. The concern is that the windows slightly exceed the soldier course of bricks above them, which is unusual. There may be other problems that are revealed when the double glazing is removed.

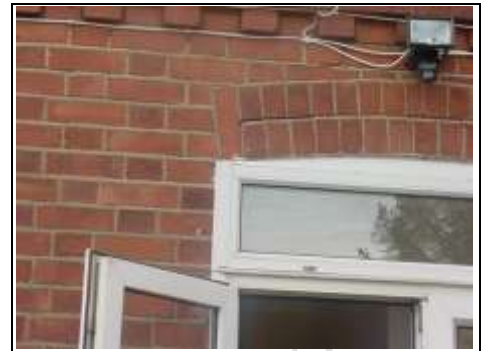
The cracks to the rear appear to relate to the plastic windows that have been put in. We would add that these windows are from the cheaper end of the market and as such may not have metal within the frame (to give additional stability).

Brick movement over the rear windows

ANTICIPATED COST: Likely to be thousands of pounds with further investigation required; please obtain quotations.

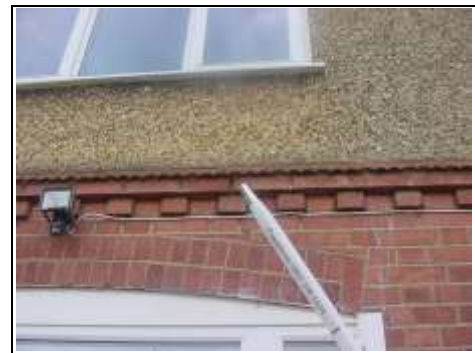
Cracking to rear window

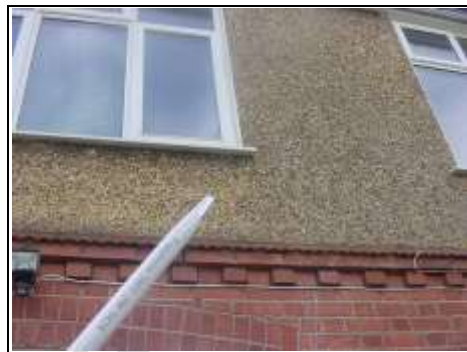
Cracking in render (rear)

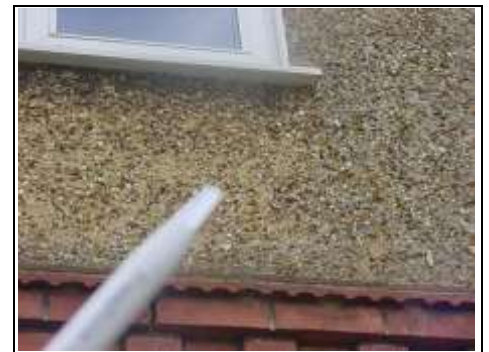
Closer view of cracking

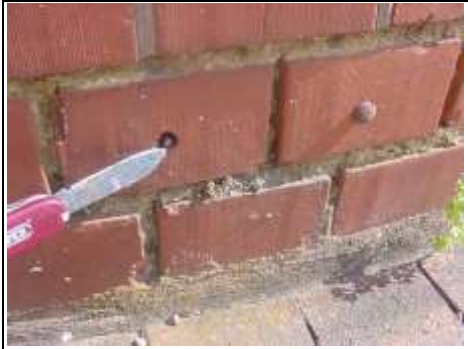
There is some dampness to the front of the property. We can see externally that a damp proof course has been added.

Inserted damp proof course in original property

ACTION REQUIRED: There has been a damp proof course inserted into the older part of the property. There may well be a guarantee with this.

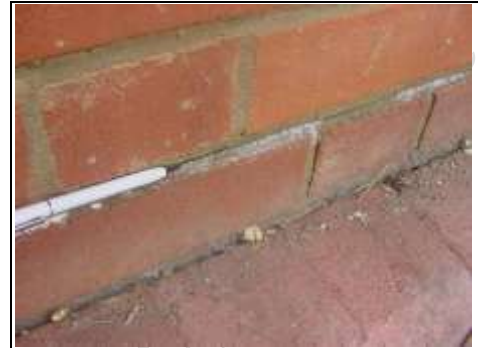
Damp proof course is too low to new extension

With regard to the damp proof course being too low, this is a general problem that we come across where brick paves are added to existing ground levels making it higher. In this case you only have one brick between the ground and the damp proof course.

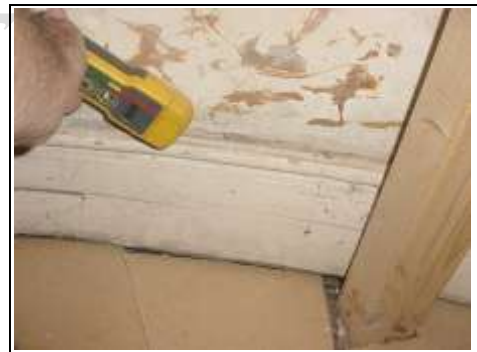
Taking damp readings in bay window area

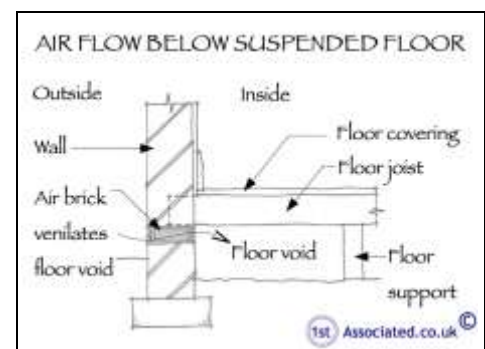
We believe the main problem regarding the dampness is a lack of ventilation underneath the property but we cannot be certain until the floors are opened up. These do need to be opened up to check the airflow goes from the front to the rear of the property. Please see our photos below that show some of the air bricks have been covered up. These need uncovering.

Suspended floor

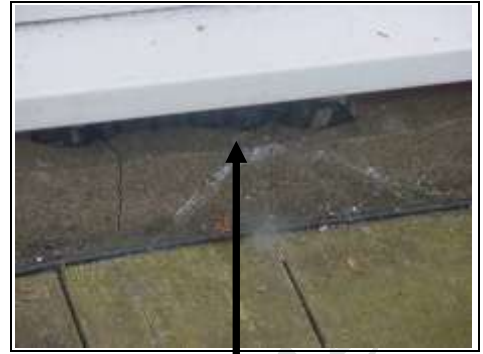
Covered over air brick (rear)
behind decking

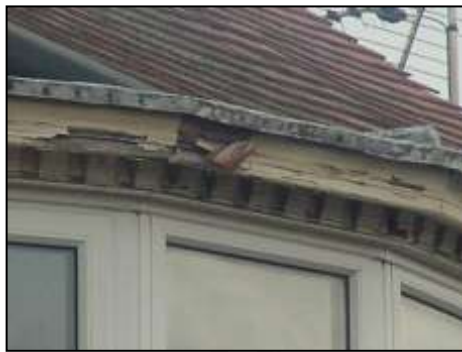
Dampness to the flat roof of the bay window

Bay window –shows how the
roof has failed

ACTION REQUIRED: Dampness is coming in via the fascias and soffits or the flat roof. Both need to be looked at. This is likely to need a tower scaffold to the front of the property.

ANTICIPATED COST: In the region of £750 - £1,500 (seven hundred and fifty to one thousand, five hundred pounds)

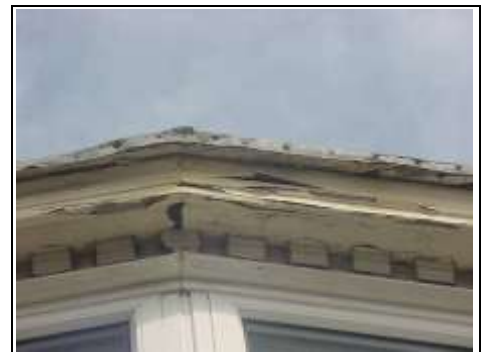
The fascia boards and soffit boards are in poor condition at the front of the property and look as if they are letting in dampness.

Deterioration to fascias and
soffits

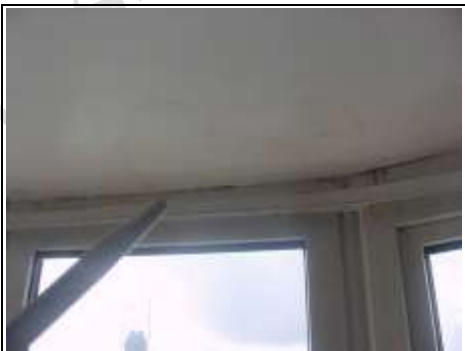
Dampness internally

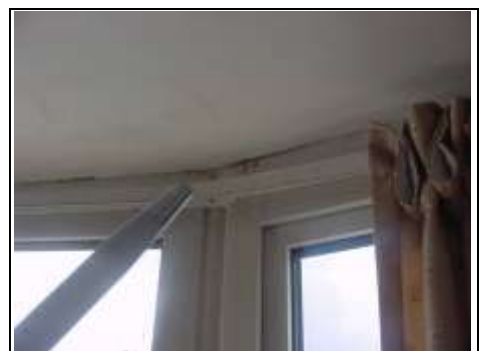
Dampness in bedroom

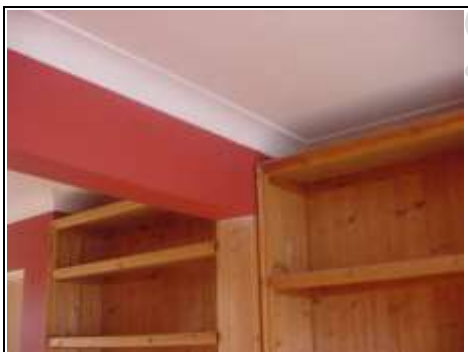
Two walls have been removed and this should have had Building Regulation approval to remove them.

Wall removed in through lounge
We cannot tell if this has been removed properly

ACTION REQUIRED: Your legal advisor to check and confirm if Building Regulation approval has been obtained.

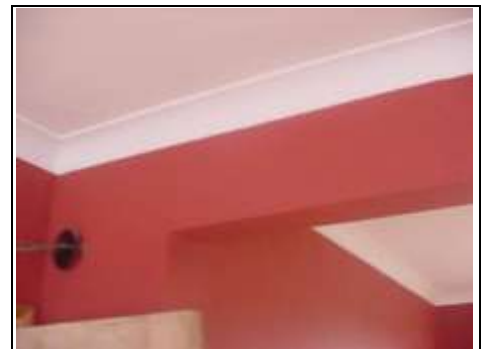
Wall removed as seen from the other side

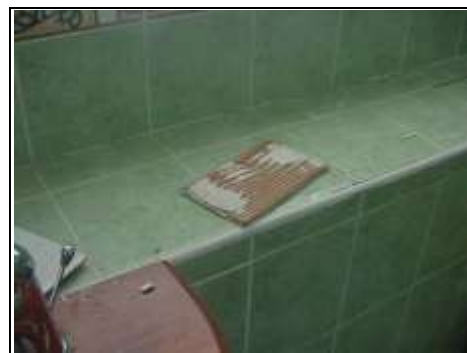
You commented that there had been damage caused in the shower room since you last visited (this is the shower room in the new part of the property). There looked to have been a leak of some sort that has been resolved by switching off the W.C. This does leave you with some damaged tiles that may be difficult to repair/replace.

Damaged tiles in shower room

ACTION REQUIRED: Replace the tiles if possible or if not you need to allow for re-tiling.

ANTICIPATED COST: In the region of £250 - £750 (two hundred and fifty pounds to seven hundred and fifty pounds); please obtain quotations.

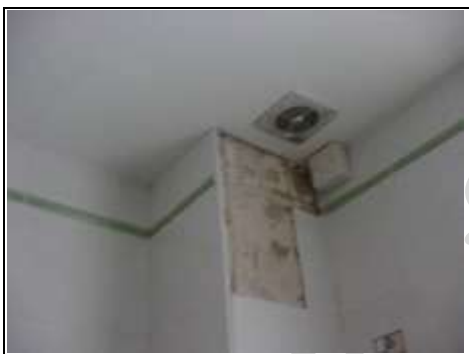
Tiles that have come away

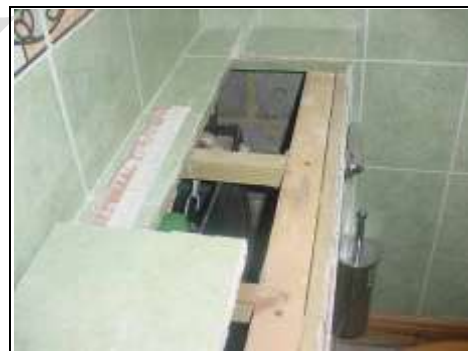
W.C needs repair

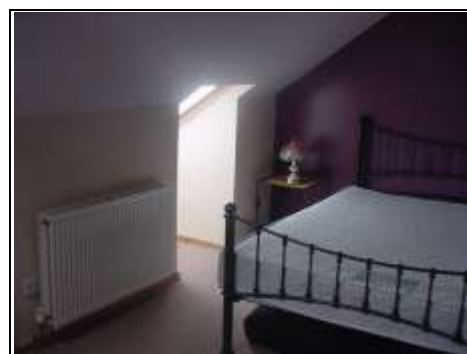
The loft has been converted and from what we understand Building Regulations and Planning Permission have not been obtained. This is only useable as a storage space/ normal roof as opposed to a habitable room. To bring this up to standard you would need to get Local Authority approval.

Room in the roof

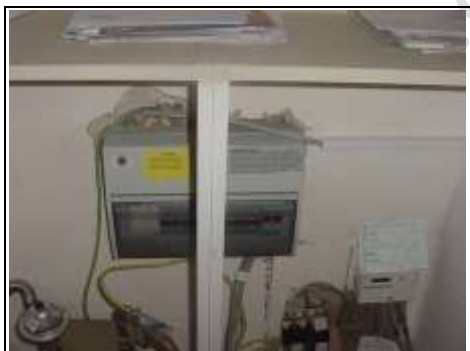
The fuse board looks to be dated circa 1980's/1990's and better are now available. We would suggest this is upgraded as we can see in some areas DIY electrics have been added.

Fuse board

ACTION REQUIRED: Have an Institute of Electrical Engineers standards (IEE) test and report carried out by an NICEIC registered and approved electrical contractor or equivalent.

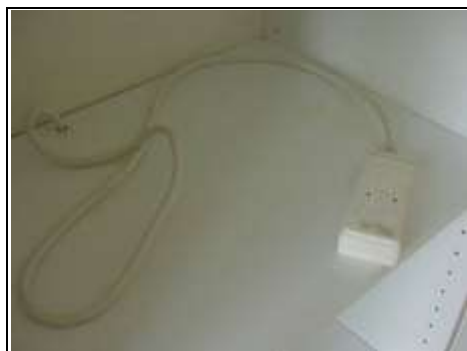
DIY electrics in cupboard in utility room
