JOB REFERENCE: RBSM2

RESIDENTIAL BUILDING SURVEY

**Dunstable
Bedfordshire**

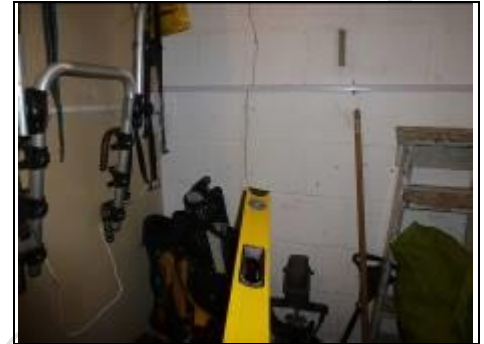
Garage crack

There is a vertical crack in the garage on the left wall visible at ground floor level behind the utility room.

Cracking

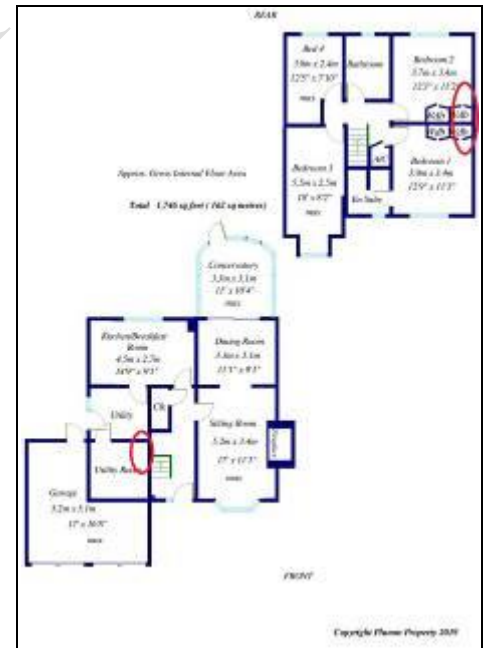
Roof cracks

There are cracks visible within the roof to the right gable. This, we believe, probably relates to initial settlement. We cannot be certain as this area is known for its brick making (clay) in Bedfordshire generally and also its sand in the Leighton Buzzard area.

Areas of cracking

ACTION REQUIRED: If we could only see the crack to the right side we would believe it relates to the chimney being worn and there being movement. However, there is a crack on both gables; therefore if you wish to be one hundred percent certain we would recommend the existing owners take out an insurance claim, advising that the cracking has been noted by a structural surveyor (this should cost them nothing other than time to write the letter/email). This usually means that the insurance company will carry out a monitoring exercise (the Building Research Establishment recommend monitoring any cracks for a minimum of one year) to establish if there is any progressive movement. Your future liability should be limited to the cost of the excess on the insurance providing the insurance company is happy for you to take over the insurance claim.

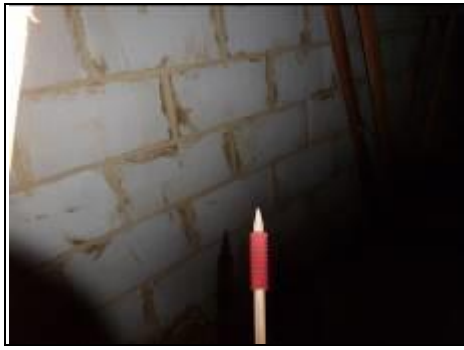
Right gable crack

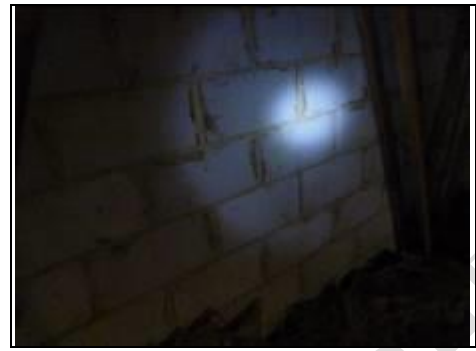
Crack from top to bottom

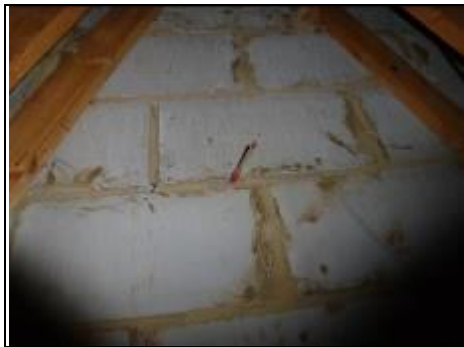
Horizontal crack

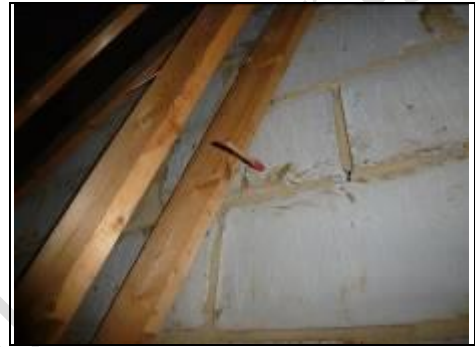
Raking crack

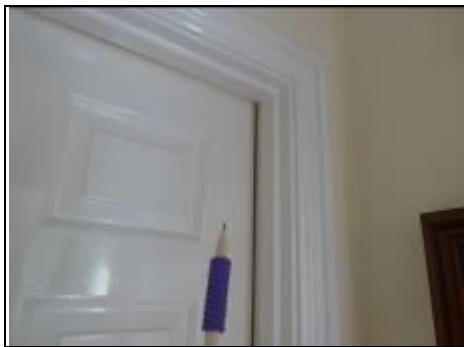
Within the property we cannot really see any major cracks; these could of course literally have been papered over, other than the door does not shut properly to the front left bedroom and there are some other minor hairline cracking. The cupboards limited our view of the right gable.

Door doesn't shut properly

ACTION REQUIRED: We would recommend you try the door to see if you are able to shut it, it may need easing and adjusting. In a worst case scenario it will need replacing; doors can be expensive.

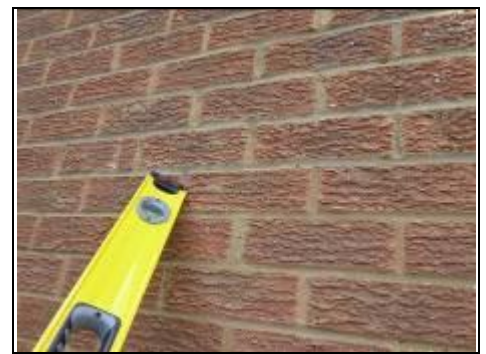
There are a few areas, particularly to the left gable, where we noted repointing had been carried out. It may have been in a worst case scenario to hide cracking.

Is this different repointing?

ACTION REQUIRED: Your legal Advisor to specifically ask in writing if there has been any repointing carried out and if so, why?

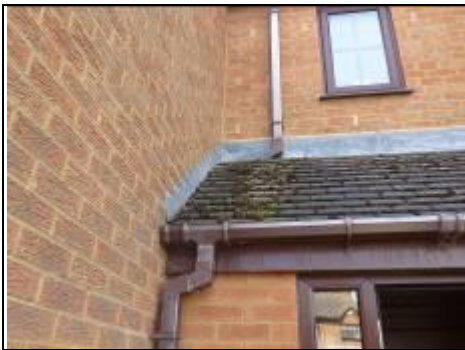
Leaking gutters and downpipes

ACTION REQUIRED: We would recommend you stand outside the property next time it rains heavily and see how well the drains cope with the rainwater particularly looking at the guttering and the joints. We would suggest an extra bracket is added to the unsupported gutters.

We also recommend that the gutters and downpipes are cleaned out, the joints are checked and the alignment checked to ensure that the gutters fall towards the downpipes.

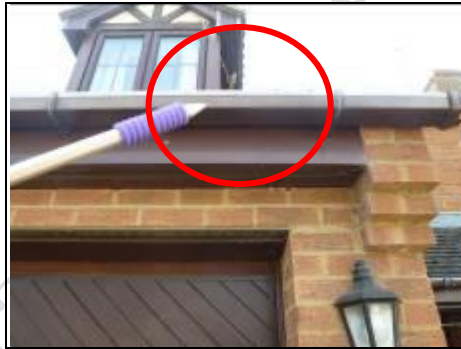
Plant growing out of gutter

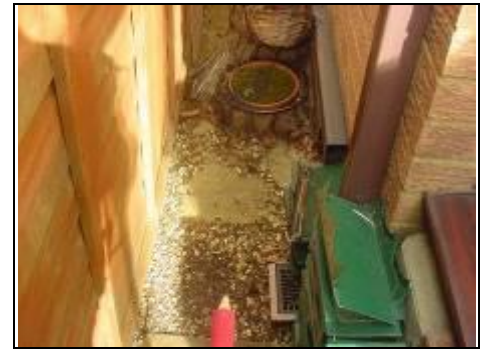
Some downpipes have gullys

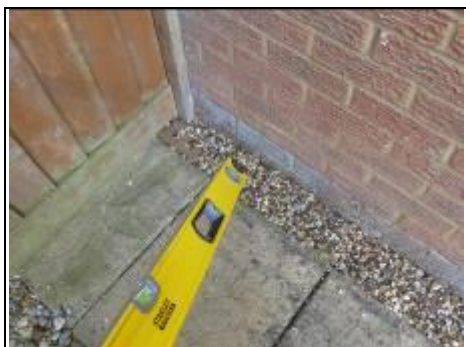
The bricks at the base of the property are starting to deteriorate from water, etc due to the sloping site.

Water damage to base

ACTION REQUIRED: You need to accept this as a characteristic of the property or add a French drain.

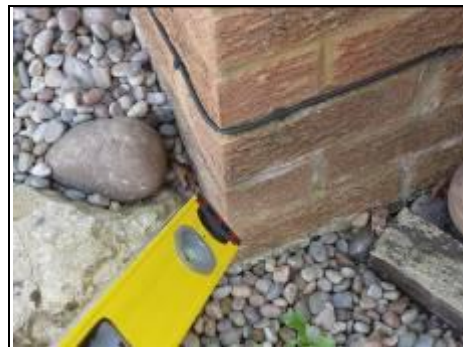
Water damage/efflorescence to base of brickwork

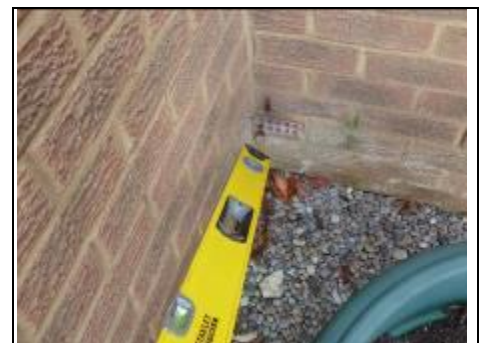
We only found one airbrick, we would have expected to find more

Airbrick to front right around chimney

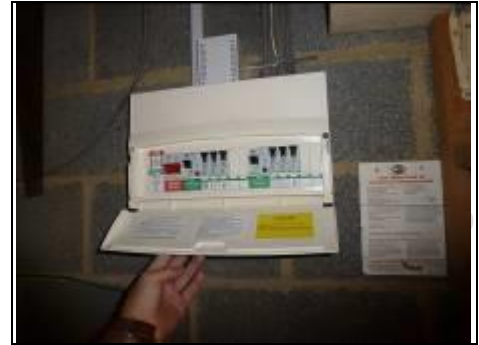
We noted extension leads being used indicating that the present system would benefit from an upgrade.

Fuse board

ACTION REQUIRED: We recommend an Institution of Engineering and Technology (IET) test and report to be carried out by an NICEIC registered and approved electrical contractor or equivalent.

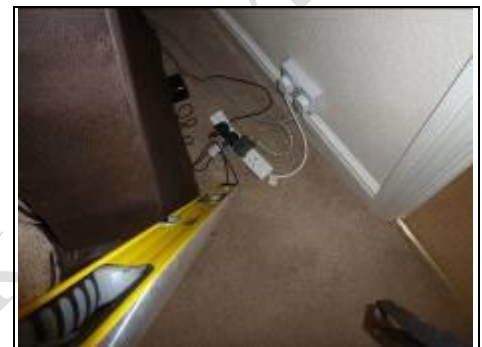
Additional socket points required

ANTICIPATED COST: £250 - £500 for a test and report plus any work recommended; in the region of £100 - £200 per additional socket point. Please obtain quotations.

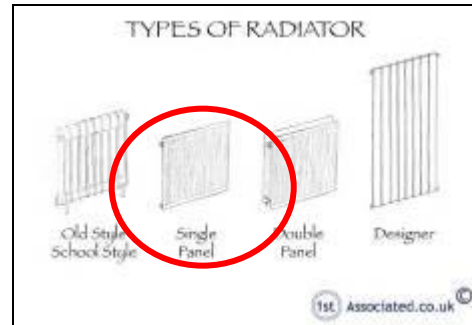
Replace single panel radiators with double panel convection radiators

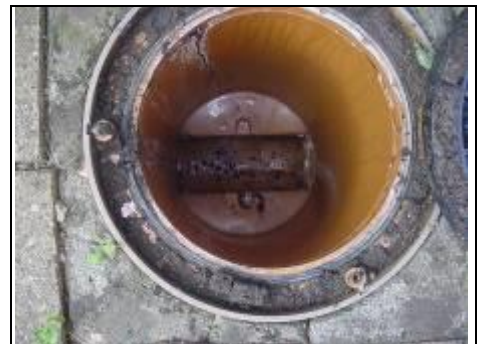
Slightly unusually, we did not find a manhole. It may be hidden underneath something in the garden (the property was empty therefore there was no-one we could ask). The sketch shows a typical layout of drainage. In this case we could only find a rodding eye close to number 1 on our sketch.

Opened rodding eye

ACTION REQUIRED: We would recommend a closed circuit TV camera report of the drains.

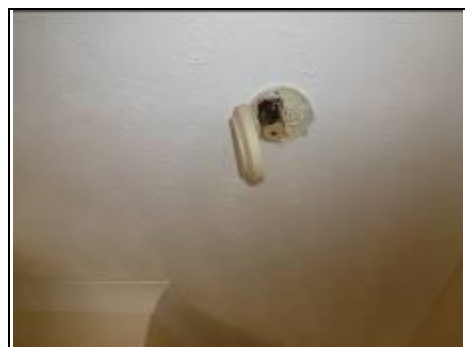
Smoke alarm

ACTION REQUIRED: We would recommend, for your own safety, that smoke detectors are installed. We would always recommend a hard wired fire alarm system and are also aware that some now work from a wireless signal which may be worth investigating. Whilst fire is relatively rare it is in a worst case scenario obviously devastating.

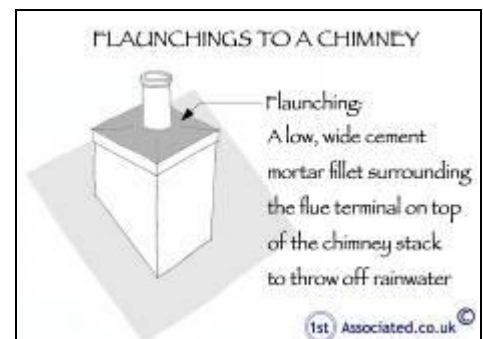
Unfortunately, we were unable to see the top of the chimney properly known as the flaunching, we therefore cannot comment upon them.

Flaunching

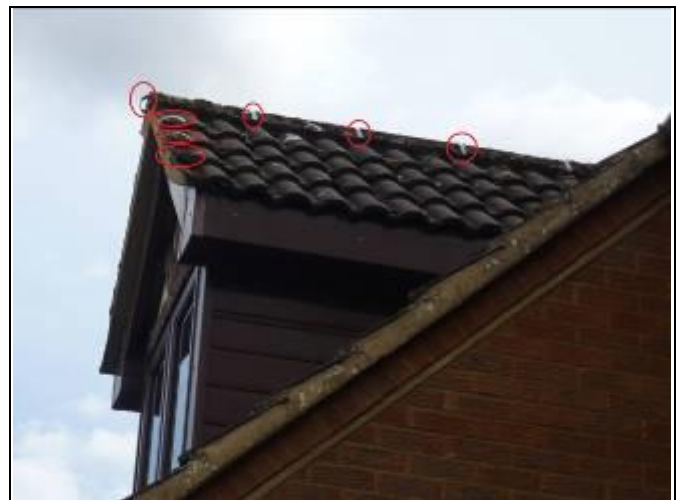
The dormer window roof is clad with concrete tiles as the main roof, the cheeks of the dormer are cladding and the windows are plastic. Generally, we would comment for their age, type and style they are in average condition. We would comment it is unusual to have so many clips on the tiles.

Dormer window has clips on tiles

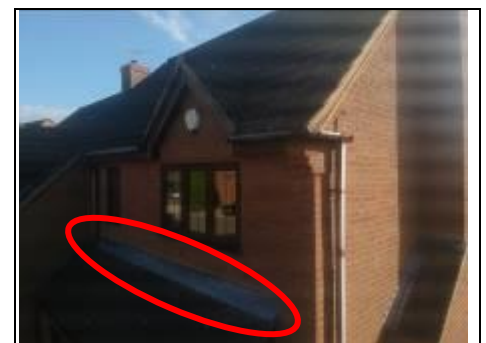
The main roof is pitched and clad with concrete tiles and, from ground level, this looks in average condition considering the roof's age, type and style. The lead flashing has been bedded in cement which comes away, we prefer plumber's mastic.

Cement mortar to lead flashing likely to come away

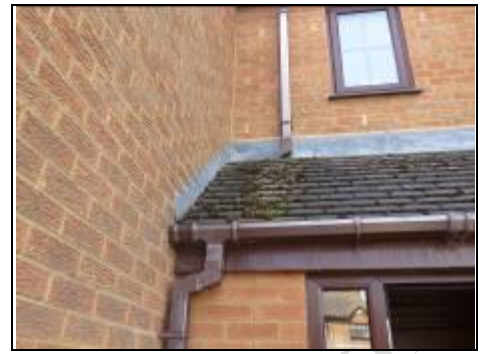
The roof has a fair amount of moss which will lead to deterioration of the tiles. We recommend removing moss with a soft brush, we do not recommend high pressure cleaning or chemicals are used on a roof.

Moss

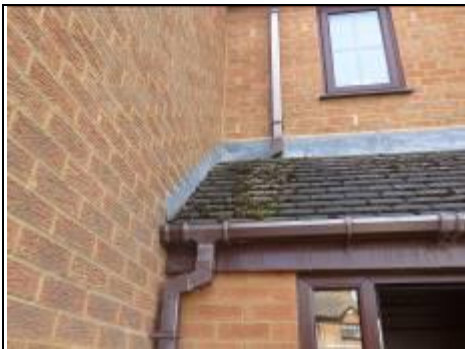
Leaking gutters and downpipes

ACTION REQUIRED: We would recommend you stand outside the property next time it rains heavily and see how well the drains cope with the rainwater particularly looking at the guttering and the joints.

We also recommend that the gutters and downpipes are cleaned out, the joints are checked and the alignment checked to ensure that the gutters fall towards the downpipes.

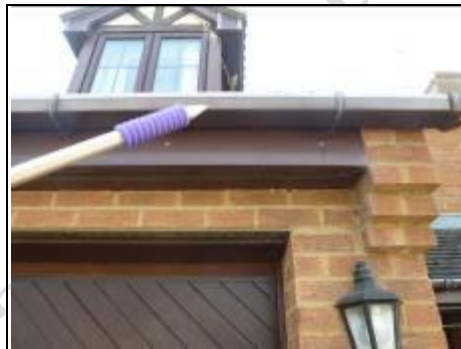
Plant growing out of gutter

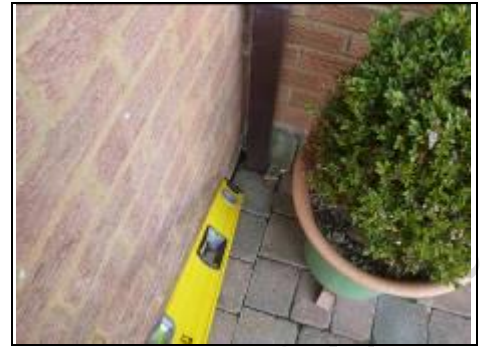
The property has a mixture of downpipes into gullies and downpipes which feed directly into the ground. This is a practice we are not particularly keen on; we would much prefer a gully as this allows you to unblock any blockages without digging up the piping.

Downpipes feed directly into ground

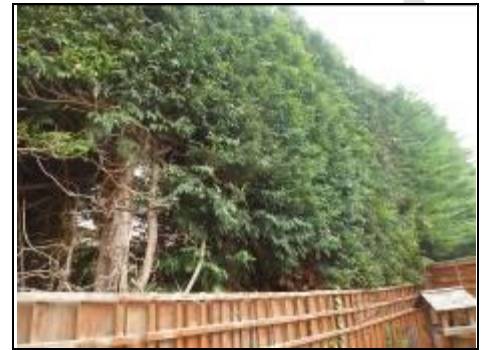
Conifers to rear right

We would recommend an arboriculturalist (not a tree surgeon) is asked to view the trees and give a ten year plan for maintenance of the trees.

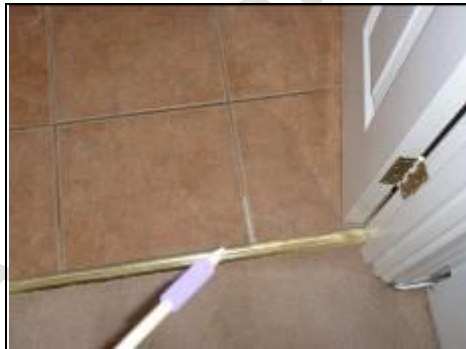
A hard material such as a tile onto a soft floor that deflects means that ultimately the joints will start to crack and deteriorate and you will need to repoint.

Repointing to en-suite tiles

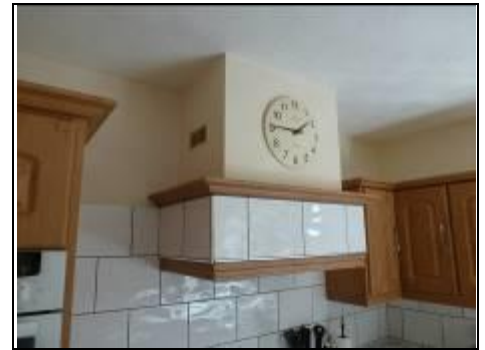
Air filter in kitchen, no extraction

ANTICIPATED COST: We would anticipate costs between £250 - £500 per large humidity controlled extract fan depending upon the wiring required; quotations required.

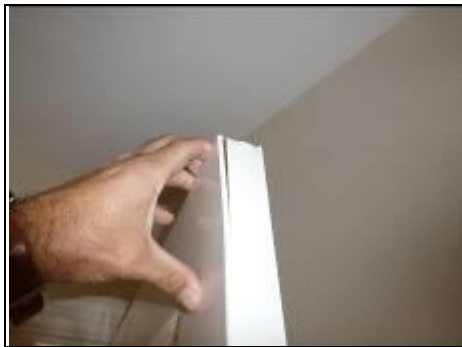
We noted the front left bedroom door is sticking and that the garage door has a door closer as garages are considered a high risk area from a fire point of view.

Damaged door

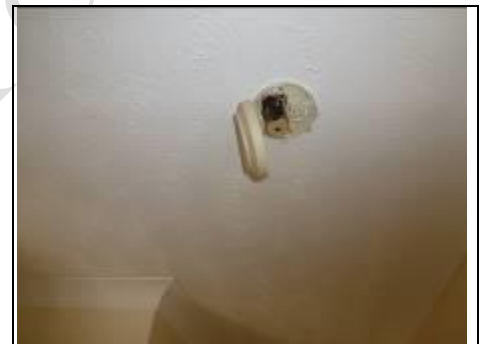
Smoke alarm

ACTION REQUIRED: We would recommend, for your own safety, that smoke detectors are installed. We would always recommend a hard wired fire alarm system and are also aware that some now work from a wireless signal which may be worth investigating. Whilst fire is relatively rare it is in a worst case scenario obviously devastating.

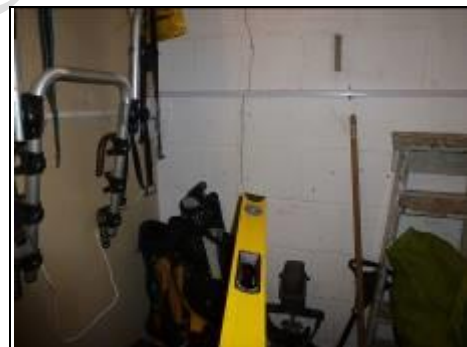
The garage has been part converted to incorporate a utility room, this should have building regulation approval. We noted cracking within the garage.

Cracking
