RESIDENTIAL BUILDING SURVEY

Ealing

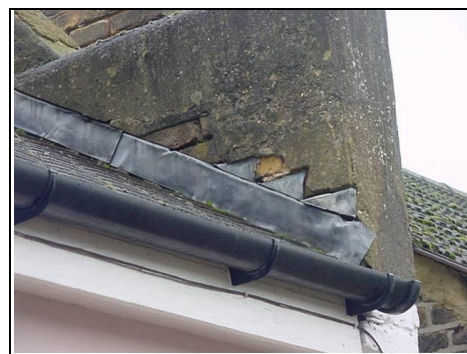
The flashing to the rear left hand parapet wall is poor and rather than stepping with the joint has been cut through the brickwork. There are also render repairs required.

Poorly fitted flashing to the rear left hand parapet wall

ACTION REQUIRED: Check lead flashing and carry out render repairs to the parapet walls. This may need scaffolding.

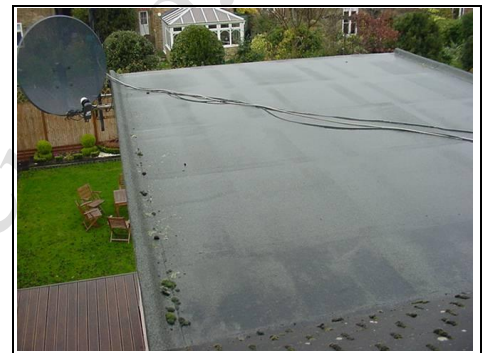
- i) There is a risk of water getting in below although we couldn't visually see any at the time of our inspection and
- ii) That the roof will deteriorate quicker than is typically expected, which in our experience has a life of fifteen to twenty five years.

Flat roof to rear of property

ACTION REQUIRED: With the felt roof you need to expect there to be an above average number of repairs sooner rather than later. With the wood decking covered roof, we recommend removing the wood decking to expose the roof to check the condition of it. We expect it could go one of two ways, either a perfect example of roofing with the exception of the flashing or a roof in poor condition.

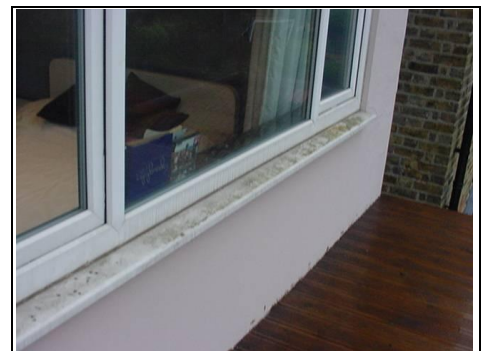
The second roof to the rear is covered with a wood decking meaning that we can't actually see the roof, however we can see that there is no flashing between the roof and the main building.

Wood decking covering the roof. Here we can see where the decking meets the main wall where there is no flashing

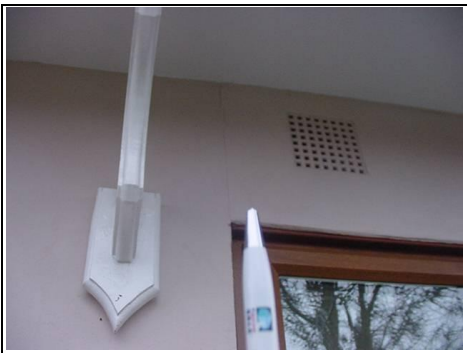
We can see throughout the rear of the property there is cracking to the render particularly on the left hand side at high level. We can also see that repairs have been carried out to cracking indicating that it is a known about problem. The cracking could be for many reasons, from movement to the cement being too hard at the rear of the property; however we feel that you need to specifically ask the current owners if any underpinning or structural work has taken place to the property.

Crack in the render to the rear

ACTION REQUIRED: To be on the safe side, we would recommend the present owners put in an insurance claim identifying this cracking was noted during the course of a building survey, but as it was a one-off inspection it couldn't be conclusive. The insurance company will then carry out monitoring over a period, usually a year (as recommended by the Building Research Establishment) and carry out work as necessary. This all needs to be in writing as this would then limit your cost to the excess within the insurance and any supplements they would then charge you if and when work was carried out.

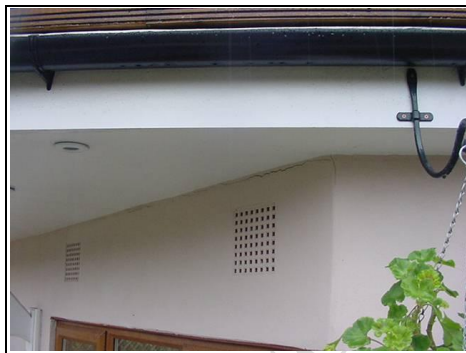
Crack at high level

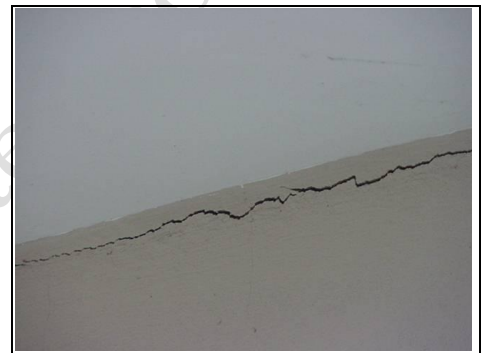
Close up of crack at high level

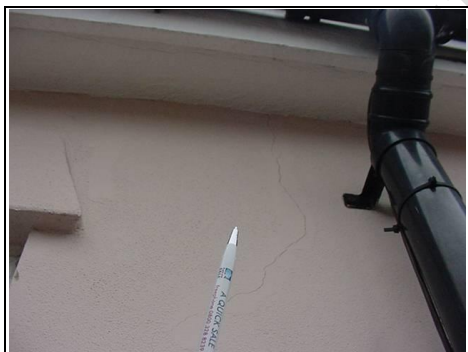
Cracking to the rear left hand side

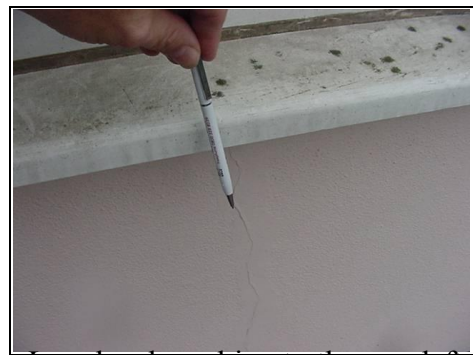
Low level cracking to the rear left hand side

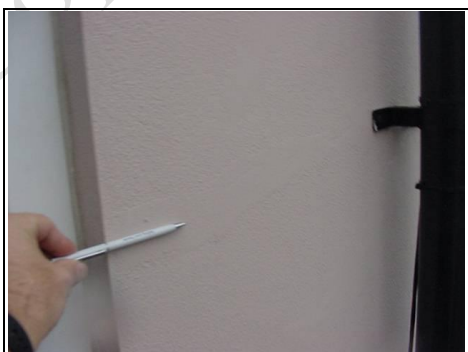
Covered up cracking

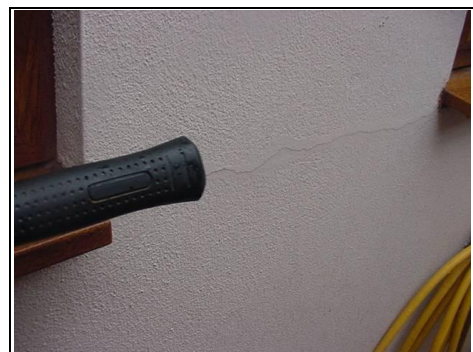
Cracking to the render

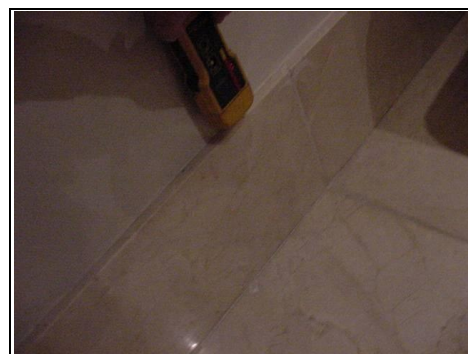
We have found rising damp on the right hand side of the property and we believe we would also find it to the rear if the walls weren't hidden by the kitchen units. This we believe is due to the high ground level.

Low level rising damp

ACTION REQUIRED: We would recommend in the first instance the lowering of the ground level around the right hand side and rear of the property. Unfortunately this would be quite a lot of work as the whole area has been paved which is part of the problem as they have been added over the existing ground level rather than lowering it. This has then allowed the dampness in.

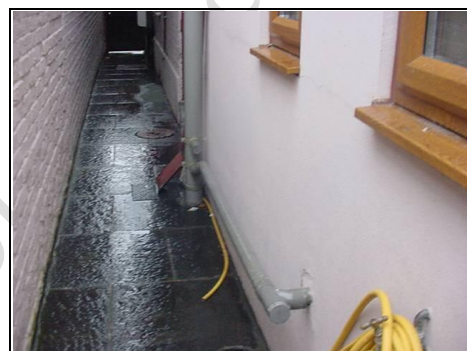
Right hand side is too high and needs the ground level lowering

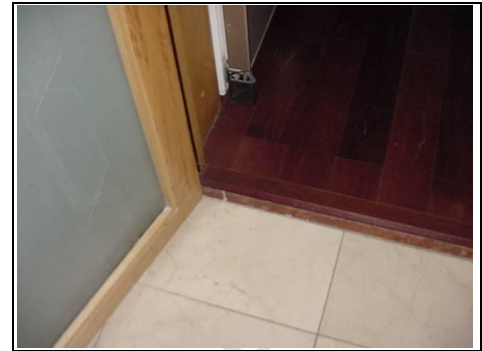
Throughout the property there are ceramic tiles onto wooden suspended timber floors. This mix of solid material in the form of the tiles onto a timber which deflects and moves with the seasons does get differential movement, which requires re-grouting. Over the years, the only way we have found around this is to have an expansion joint and sit on top of the tile coving which we don't see in this instance. If this isn't put into the original design, then it is very difficult to add it afterwards. Unfortunately we couldn't see it in this instance.

Tiles to wooden floor with a step on the ground floor

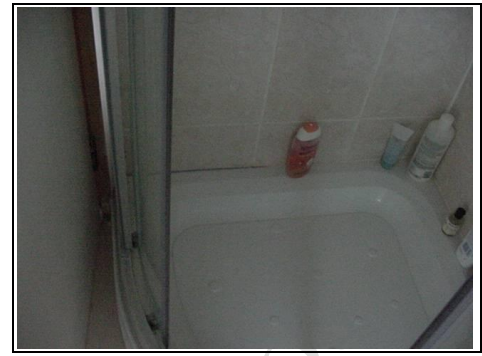
We could see some deterioration to some of the showers. This can often occur where the shower isn't bedded down properly and a hollow shower is used rather than a solid shower.

Deterioration to shower

ACTION REQUIRED: Each shower to be checked for deterioration and re-mastic.

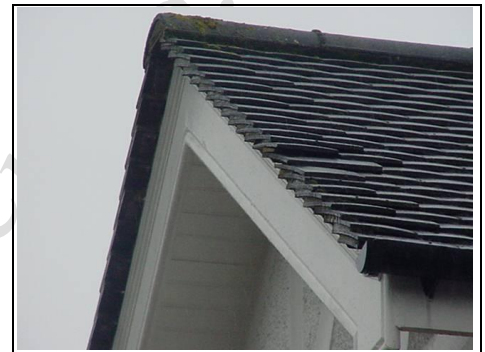
The main roof is hipped, pitched and clad with small concrete tiles and, from ground level, this looks in average condition considering the roofs age type and style. With this age of roof there will usually be a few missing or displaced tiles, this is nothing unusual. In this instance we could see some displaced tiles to the front gable end. These looked like they had been lifted by the wind and need replacing.

Tiles slightly displaced to the front

ACTION REQUIRED: A roofer to replace displaced tiles. Carry out periodic inspections and maintenance of the roof, as required.

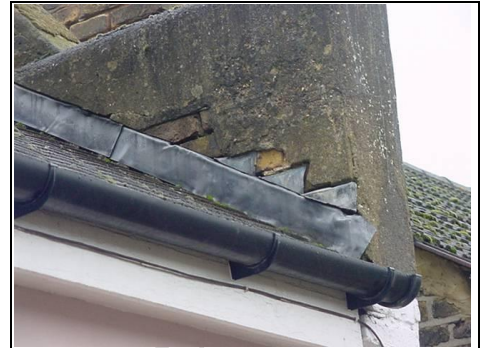
In this case there is a parapet wall to the left hand side. It is a brick built parapet wall that has been rendered and is in below average condition. Please see our comments in the Executive Summary.

Poorly fitted flashing to the rear left hand parapet wall

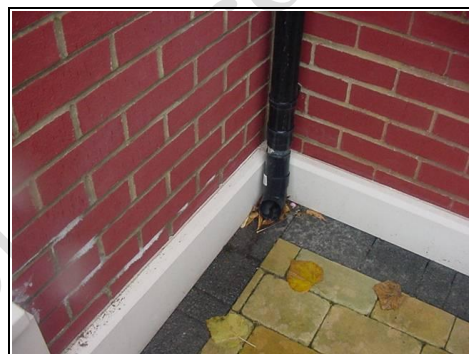
From ground level the gutters and downpipes are plastic and are in average condition. There may be some minor leaks, but we feel that most people could live with these. Carry out repairs within the next six to twelve months.

Plastic downpipe discharging onto the ground

ACTION REQUIRED: We would recommend you stand outside the property next time it rains heavily and see how well the drains cope with the rainwater particularly looking at the guttering and the joints. We would always recommend that the gutters and downpipes are cleaned out, the joints are checked and the alignment checked to ensure that the gutters fall towards the downpipes.

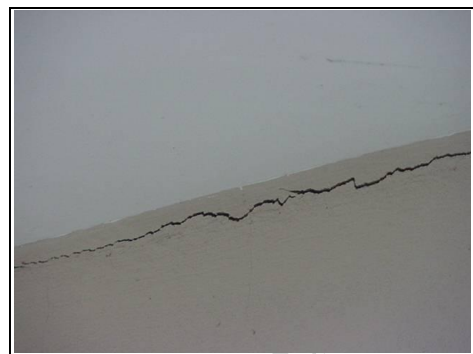
Close up of crack at high level

We would remind you that any hairline cracks that appear, which tends to be the case with render, need to be sealed as soon as possible to stop dampness and water getting in and causing blisters and hollow areas.

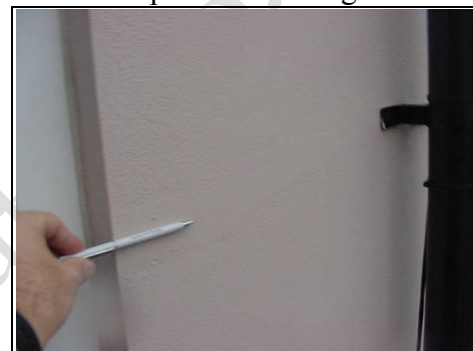
Old cracks that have been repaired previously

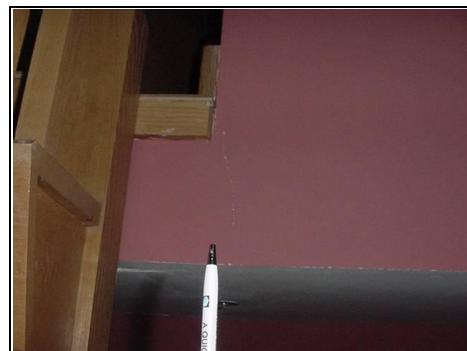
Hairline cracking on the stairway on top floor

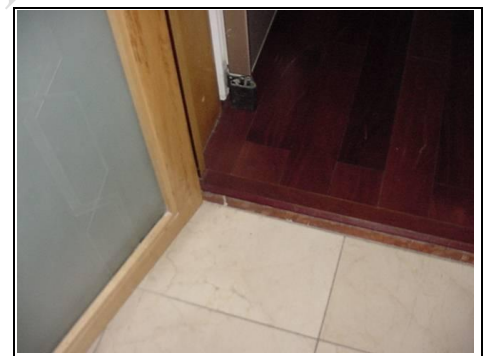
Tiles to wooden floor with a step on the ground floor

ACTION REQUIRED: Please see our comments within the Executive Summary with regards to the problems that can occur where ceramic tiles are laid over timber floors.

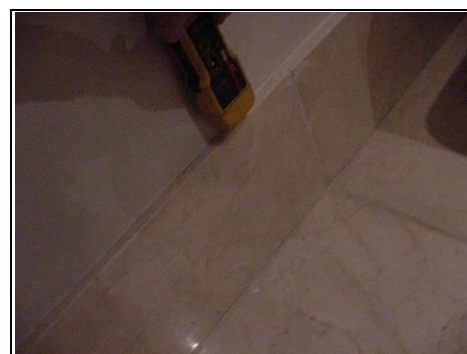
A random visual inspection and tests with a moisture meter have been taken to the perimeter walls. In this particular case we have found rising damp to the right hand side of the property.

Rising damp

ACTION REQUIRED: Please see the Executive Summary.

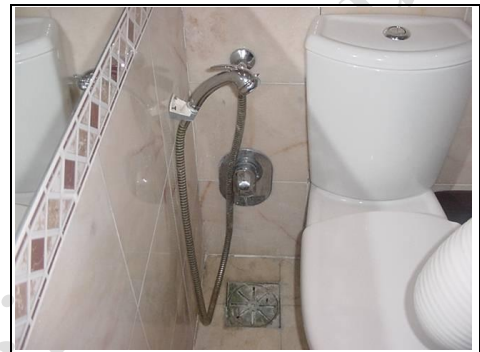
Washer unit in downstairs w.c. is leaking
