JOB REFERENCE: XXXX

RESIDENTIAL BUILDING SURVEY

London

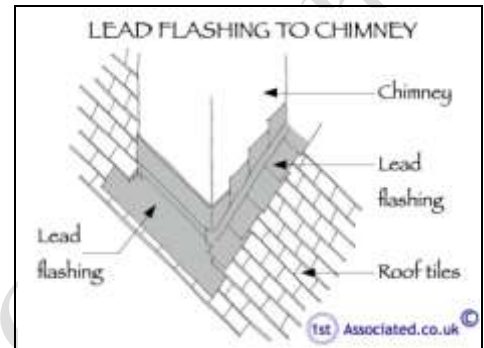
1.1) We could see that the front left hand chimney and also rear right hand chimney (all directions given as you face the property) requires work. To the front left hand chimney we believe re-pointing and possibly repair work to the flashings and to the rear right hand chimney we believe repairs are required to the flashings although we could not view the chimney properly.

Chimney flashing

ACTION REQUIRED: Repair as necessary the chimneys to make water tight. We believe it is likely re-pointing and adding/amending flashings required.

ANTICIPATED COST: The main cost relates to the scaffolding required, we would anticipate costs for the chimneys to be in the region of £1,500 to £4,000; please obtain quotations. If this work is left deterioration will occur to the roof structure.

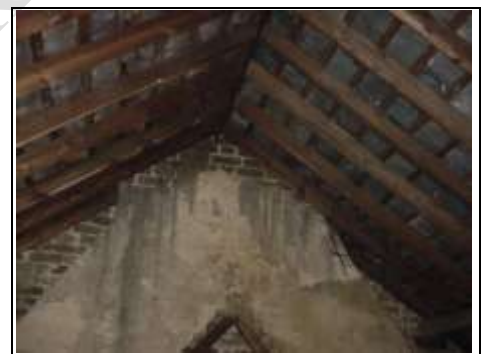
Dampness coming in around chimney to left hand side

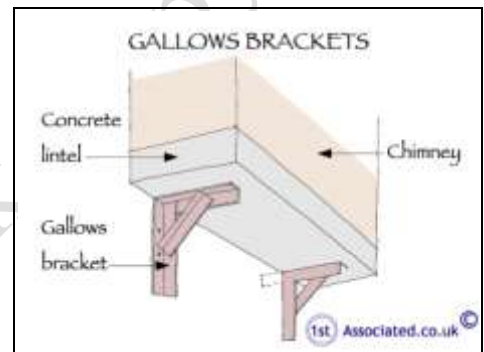
We could see from within the roof space the chimney breast has been removed and a gallows bracket added. This was a very common technique used for supporting chimneys when they were removed although this is no longer permitted, as we understand, by Local Authority Building Regulations. Having said this from a considered point of view we could see no stress fractures internally which would lead us to believe there are problems.

Gallows brackets

ACTION REQUIRED: When chimneys have been removed on one side of the property you need to check to see if the chimneys have been removed on the other side as the gallows brackets are effectively taking support from this wall.

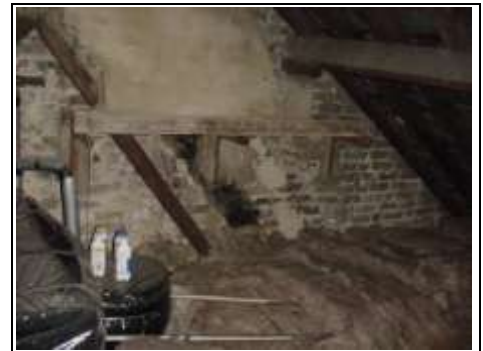
Rear left hand chimney being supported on gallows brackets

We knocked on the neighbour's door at the time of our survey but did not receive a response. We would recommend a return visit to speak to the neighbours to ascertain if they have also had their chimney removed or not. If they have you will need to remove the upper section of your

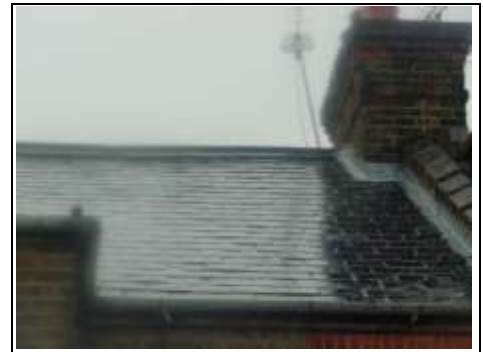
Rear roof undulates

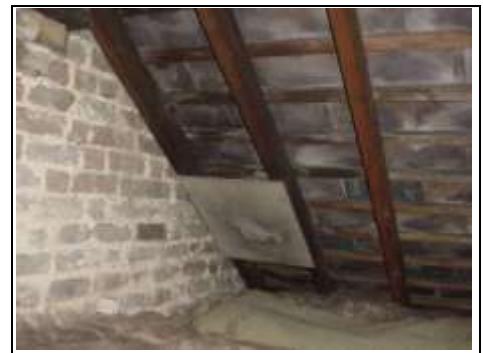
Underside of roof showing slates and piece of asbestos

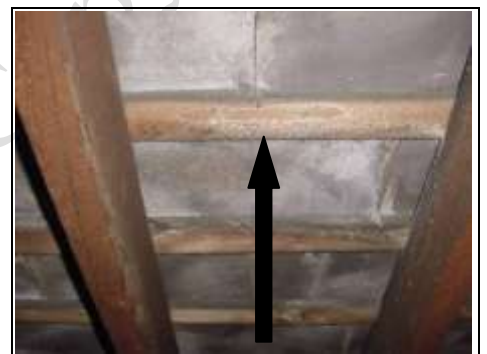
Close up of timber batten showing white salts which is a sign of dampness

ACTION REQUIRED: As a short term measure we would suggest boarding out the roof with a board with a solid insulation back (such as Celotex or Kingspan) which would then give a pseudo second line of protection for any dampness penetrating through the slates and

also allow you to establish exactly where the major roof leaks are and have these repaired.

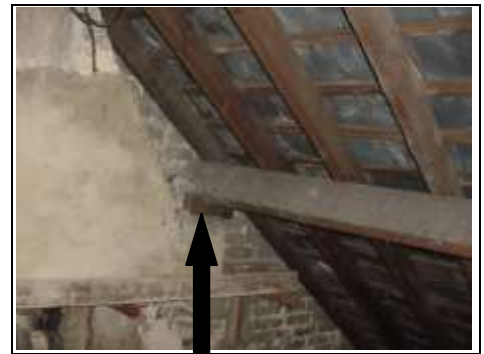
Whilst no doubt the roof has stood like this for many years we would be happier if the purlin to the rear left hand side (all directions given as you face the property) was secured better particularly as it is near the chimney that has been removed. This could take the form of a timber at a diagonal giving a brace off a ceiling joist over a wall.

Purlin needs securing at rear left hand corner as balanced on a brick

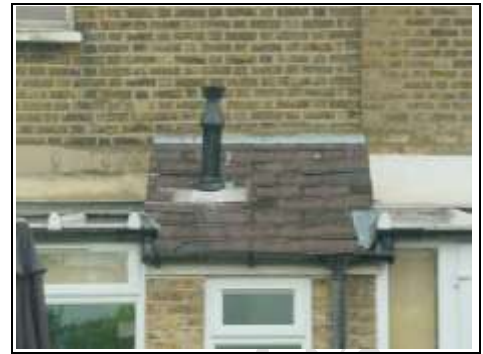
- 3.1) Whilst the rear roofs did not leak during the course of our inspection they are a miss mash of different types, styles and ages of roofs. These roofs, we would say, will suffer from problems in years to come probably starting with the middle tiled roof where the tiles already look to be uneven and displaced.

Rear low level slate roof

ACTION REQUIRED: Next time it rains heavily observe how the roofs cope with heavy downpours if you intend to keep them and then employ a roofer to carry out repairs during dry weather and also obtain a supply of the slates.

ANTICIPATED COST: Regular maintenance of a few hundred pounds until you decide what to do with the roofs; please obtain quotations.

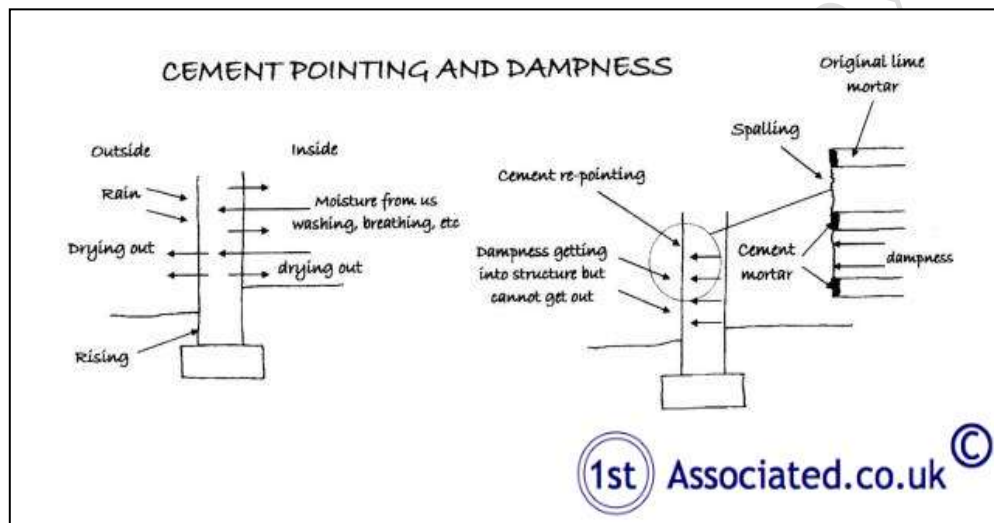
Unfortunately the cement re-pointing, whilst well meaning, is not appropriate for this type of construction. A cement mortar has been used rather than a lime based mortar. We recommend you use lime mortar in any future repairs regardless of what the builders say! Using lime mortar will limit further damage to the brickwork, which is almost impossible to repair successfully. However, we would add that many, if not most, of the properties that are re-pointed are re-pointed wrongly; it is only in recent years that we have discovered the problems that can occur from it.

Dampness and pointing

The re-pointing work should be carried out in lime and we certainly would not recommend carrying out this work without being trained first as lime can burn.

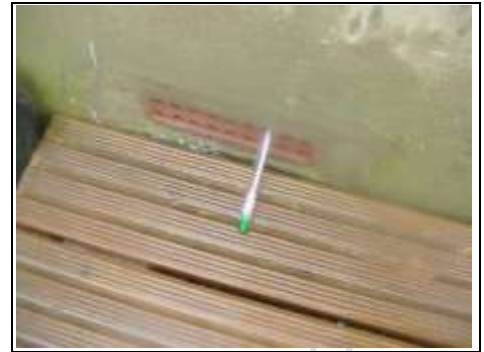
Airbrick to rear

As a side note the decking to the rear is touching the render in some areas which will be causing a bridge and capillary action which will bring dampness into the property. We would recommend that the decking is moved away from the property.

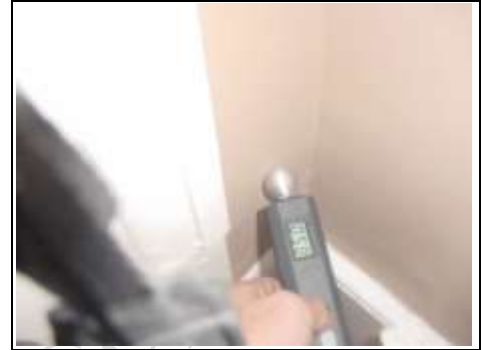
We found higher than we would typically find damp meter readings to the entrance door. We believe this is probably due in part to the cement re-pointing and in part to the weather being a wet day on the day of our inspection and possible condensation.

ACTION REQUIRED: Re-pointing as previously recommended.

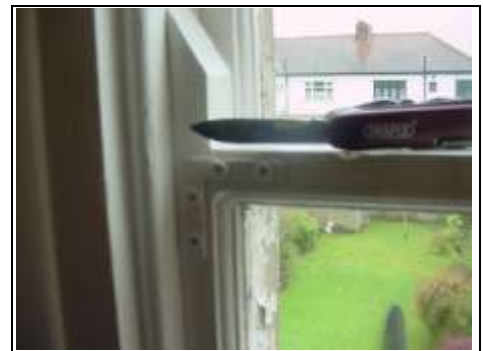
Some of the windows have seen better days particularly the rear right hand window (all directions given as you face the property) which is currently held together with metal brackets. If you recall we showed you these brackets internally.

Window held together by metal straps

ACTION REQUIRED: We recommend re-decoration of windows and repairs as necessary.

ANTICIPATED COST: Likely to be in the region of a few hundred pounds to have repairs carried out professionally per window; please obtain quotations.

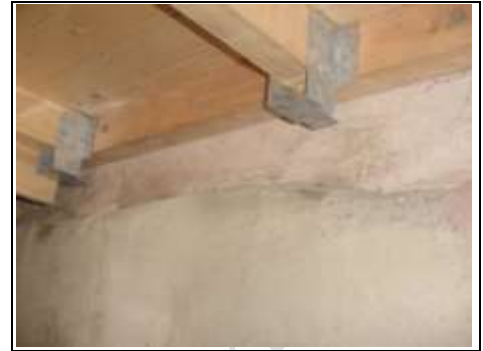
When we went into the cellar area we noted the timbers had been removed. Also we think we noted minor woodworm and we mean minor woodworm in the roof space, our view was very limited due to the mass of insulation that had been literally placed all over the roof space.

Woodworm or wet rot previously to the floor

ACTION REQUIRED: We would therefore recommend that you live in the property to see if there are any signs of woodworm in the form of flight holes with frass.

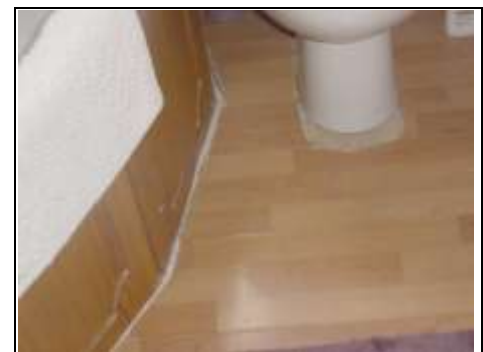
The laminate boarding that has been fitted is very poor in some areas and worn particularly in the bathroom.

DIY laminate flooring

ACTION REQUIRED: From our understanding you intend to upgrade the flooring.

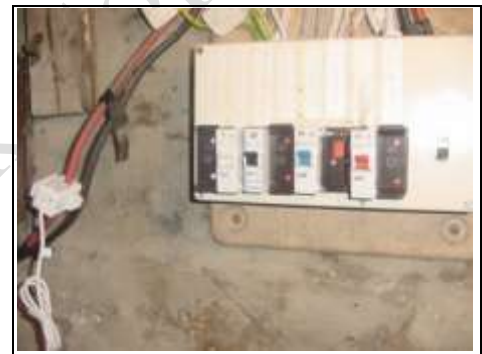
Fuseboard

The fuseboard is dated which to us also means it is likely the electric system is dated. We carried out an earth test in the kitchen which was satisfactory however this is not the same as having a qualified electrician carry out a test. For the electrics we would recommend an Institute of Electrical Engineers standards (IEE) test and report carried out by an NICEIC registered and approved electrical contractor or equivalent, which is recommended whenever a property changes occupancy.

ACTION REQUIRED: Replace fuseboard.

ANTICIPATED COST: £250 to £500 to replace the fuseboard; please obtain quotations. We would also recommend additional power points are added as today we have a higher demand for socket points than in the past.

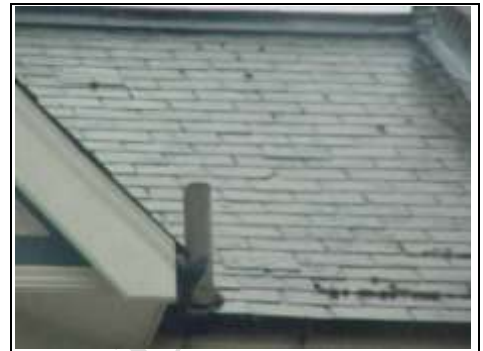
Possible asbestos flue to front right hand side

ACTION REQUIRED: We always recommend all asbestos is removed as not only does it have the potential for problems it does tend to affect value as some people simply will not buy a property with any asbestos present.

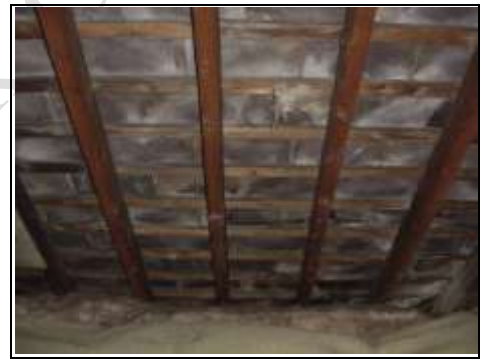
This photo shows the common rafters (the ones that form the pitch of the roof) and no protective underlayer. White salt stains indicate dampness is getting in.

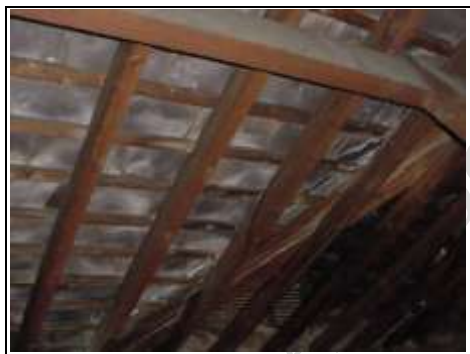
Dampness visible to timbers

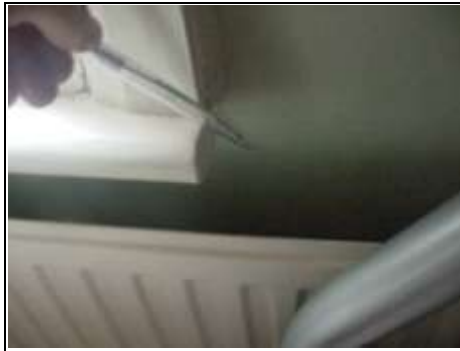
We noted some hairline cracking to front left hand bedroom plaster and rear left hand bedroom (all directions given as you face the property). Whilst there has been movement in the property we believe this cracking relates specifically to a modern gypsum plaster being applied, please see our sketch.

Hairline crack to rear left hand bedroom

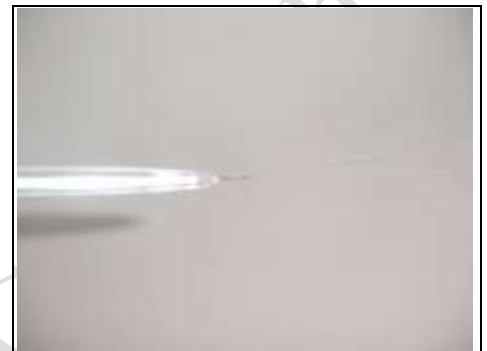
Cracking in plaster front left hand bedroom

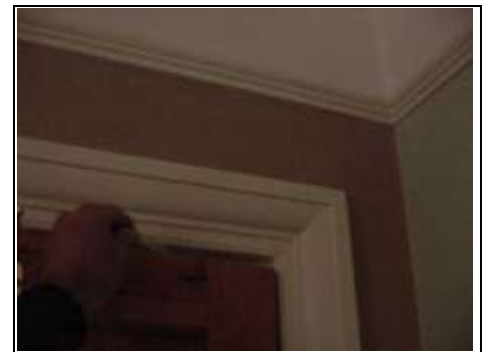
We could see there has been movement in the property to the rear left hand door which is out of square.

Movement in rear left hand bedroom door

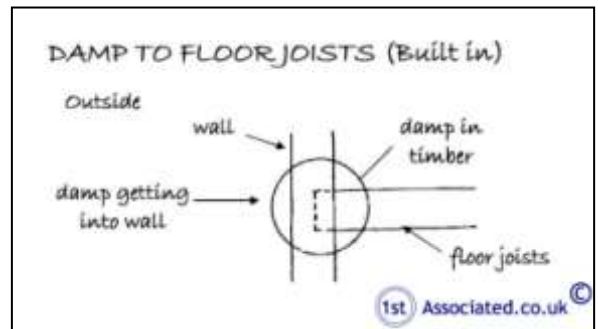
Damp to built in floor joists
