RESIDENTIAL BUILDING SURVEY

Stanmore,
HA7

INDEPENDENT CHARTERED SURVEYORS

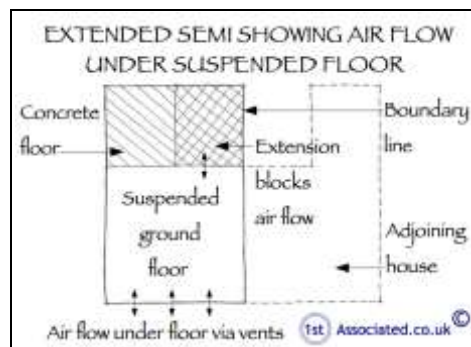
Patio doors with blocked air bricks

This sketch is not exactly the same as this property but it shows how the extension blocks the air flow

ACTION REQUIRED: We recommend that you double check that there are airbricks to both the front and the rear of the property to allow a through flow of air. Next time the carpets are replaced (or before 2014) we recommend you open up a section of the floor to check the condition of the timbers underneath.

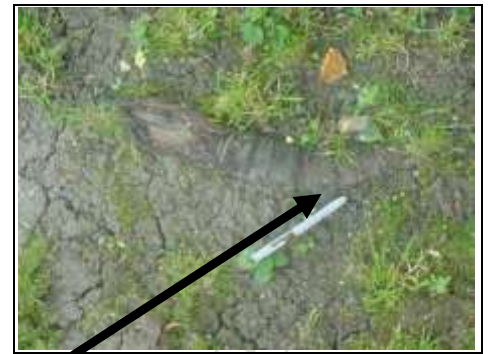
Drain (rear) with tree roots coming through

Tree roots coming through in the garden

ACTION REQUIRED: Your Legal Advisor should specifically ask in writing if the owners have had problems with roots in the drains in the past. We would recommend a closed circuit TV camera report to establish the condition of the drains to check if there are roots within them.

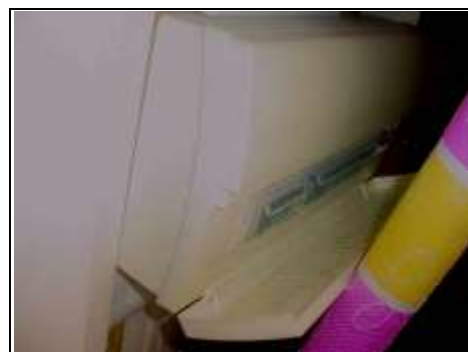
Dated fuse board

ACTION REQUIRED: We would recommend replacement of the fuse board.

The fuse board is dated and better are available. We would recommend an Institute of Electrical Engineers standards (IEE) test and report, carried out by an NICEIC registered and approved electrical contractor or equivalent, which is recommended whenever a property changes occupancy.

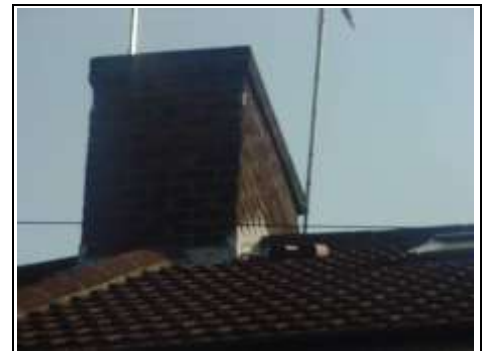
Chimney (left)

This chimney is brick finished with a lead flashing and no chimney pots. From what we could see, as we had a limited view, it looked in average condition considering its age, type and style.

There is a large aerial on the chimney supported by wires. In this case if the wire does get displaced it could cut into the brickwork, like cheese wire into cheese!

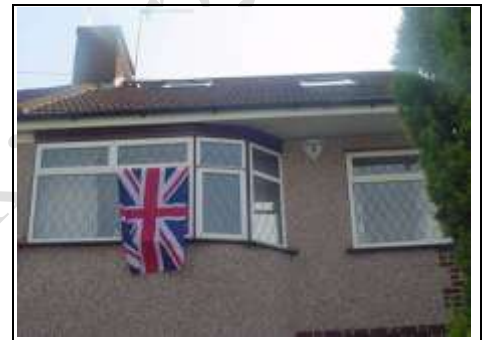
Main roof

The main roof is pitched and clad with a small concrete tile (we are not one hundred per cent certain of this) and, from ground level, this looks in average condition considering the roof's age type and style. With this age of roof there will usually be a few missing or displaced tiles, this is nothing unusual.

ACTION REQUIRED: Carry out periodic inspections and maintenance of the roof and clear roof of moss occasionally or as required. We would not recommend the roof is pressure cleaned.

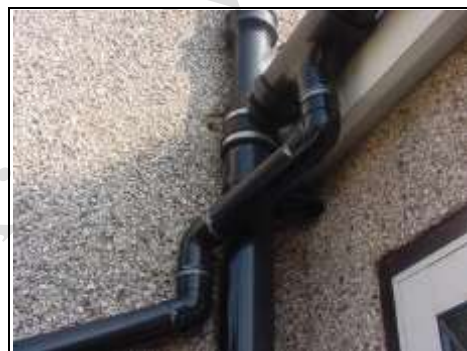
Plastic downpipes with wide joints, we assume that these leak

We would always recommend that the gutters and downpipes are cleaned out, the joints are checked and the alignment checked to ensure that the gutters fall towards the downpipes.

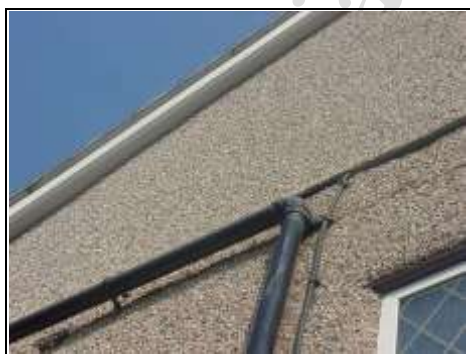
Awkward bend in downpipe

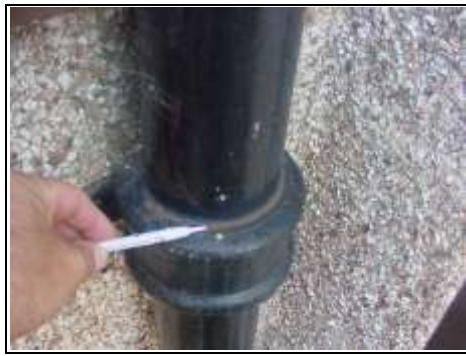
Minor rusting on soil and vent pipe that is expected on cast iron

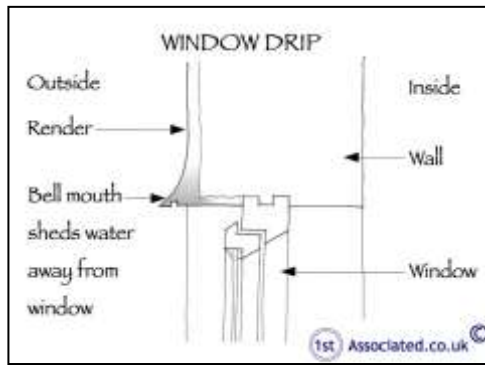
In this case we found no drip detail to the windows.

No drip detail over the window

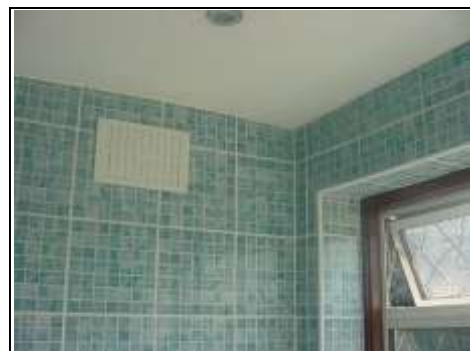
Large humidity controlled extract fan required in bathrooms and kitchen

ACTION REQUIRED: We would recommend humidity controlled extract fans be added to kitchens and bathrooms.

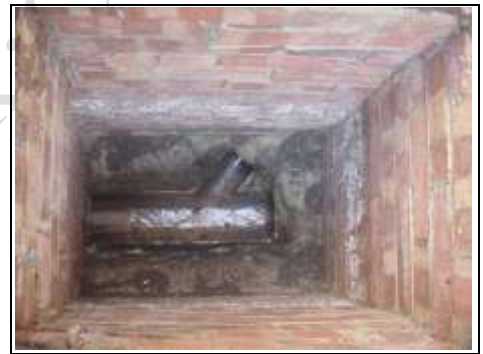
Manhole (middle right)

From what we could see it is brick built and has some deterioration.
