# RESIDENTIAL BUILDING SURVEY

XXXXXXXXXX,  
XXXXXXXXXX,  
Bedfordshire,  
MK41 xxx

Prepared by:  
[XXXXXXXXXXXXXXXXXX](#)  
INDEPENDENT CHARTERED SURVEYORS

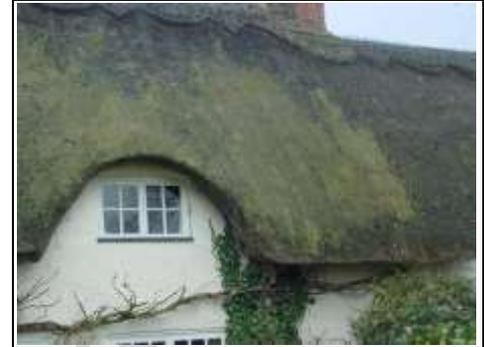
Moss in the thatched roof

**ACTION REQUIRED:** Obtain quotations for the thatch work. We would leave it to the Thatcher's discretion as to what they feel needs doing. We would obtain three quotations. You advised that you knew a Thatcher and from our discussions with the neighbours Dobsons Thatchers were employed to carry out the work on their property. We would recommend having a discussion with the neighbours about the quality of work etc.

**ANTICIPATED COST:** £7,500 to £15,000; please obtain quotations.

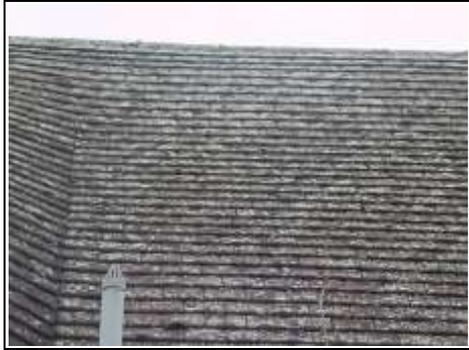
The concrete tiled roofs to both the modern building and the garage have a heavy coating of moss indicating to us that the surrounding trees may limit sunlight and air movement.

Moss to the front is not as bad as at the rear

**ACTION REQUIRED:** In the summer months use a soft brush (so that the surface of the tile is not damaged) to remove the moss from the roofs. If this causes damage to the tile surface then we would recommend that you stop and call us and we will advise further. We would also recommend that the trees are maintained as often as needed as this will help with the level of sunlight in the area as well as air movement, both of which should help to reduce the moss.

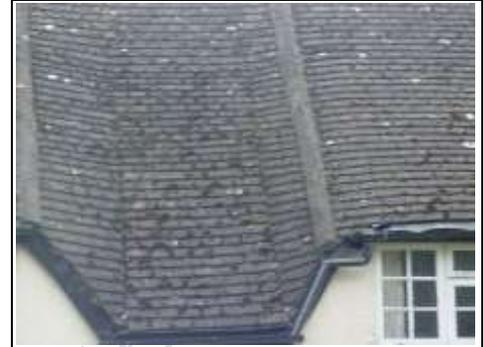
Moss to the rear of the roof

This is a shallow pitched roof and as such the tile finish will be particularly prone to damage from the moss.

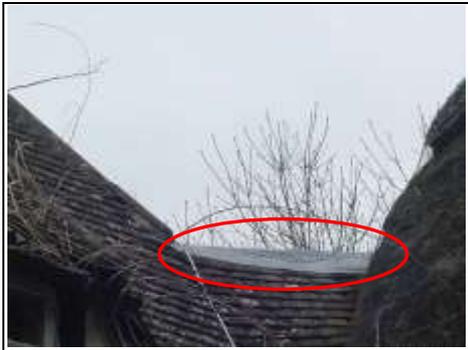
Lead visible

This roof was difficult to view but from what we could see it looks to be lead with an awkward wedge of tiles on edge between the old and the modern building.

**ACTION REQUIRED:** We would begin by adding lead externally to make this area watertight and then carry out investigations internally, by this we mean opening up the structure. We would also add a drip detail to the rear of the property but having said that there may still be problems with pattern staining as this is quite an awkward detail.

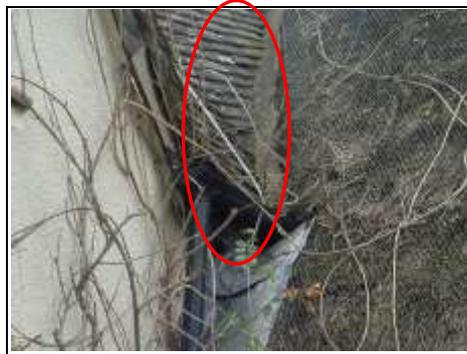
Cement fillet

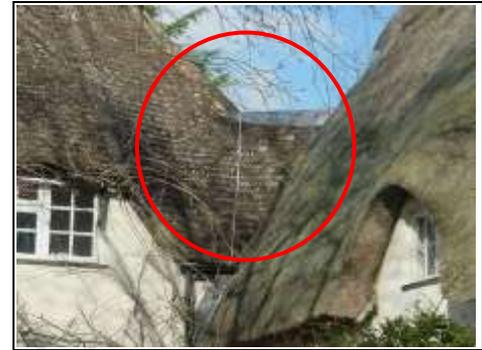
Roof linking the buildings together

This will have damaged the hidden timbers in this area but there may also be other timbers that have been damaged from leaks that are not visible.

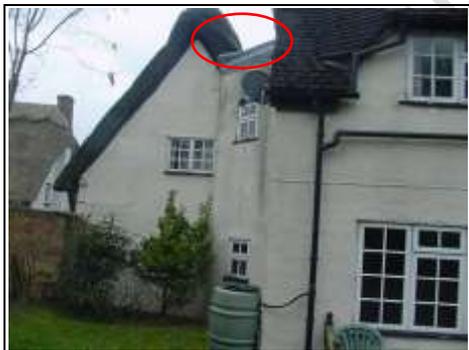
Link roof

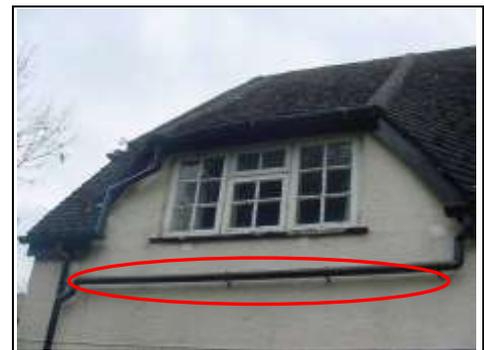
Our first thought with regards to the gutters and downpipes is that there has been little thought given to how they have been positioned on the building.

However, we do think that the eyebrow roofs make it difficult to add guttering on to this property. That said, there may be room for improvement particularly if a different material with more strength is used such as a metal guttering. We would also look into how the downpipes drain away.

Eye brow roofs make it awkward to run the guttering  
Very horizontal downpipe (red)

**ACTION REQUIRED:** We would recommend that it is worth checking on a rainy day to see how the gutters perform and as mentioned this may be improved with a metal gutter with more integral strength. You also need to check how the water discharges, ideally a soakaway should be added for the water to discharge into, if one is not in place already. You can check this on the original Building Regulation drawings.

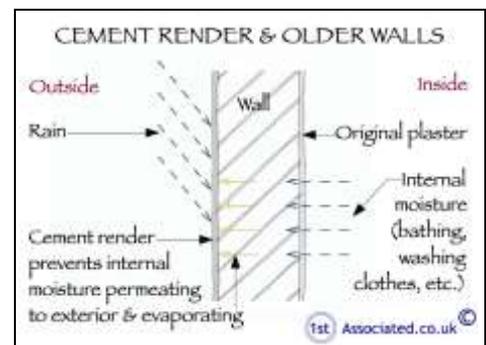
As with older properties the render has been altered and amended over the years. There is, we believe, a combination of old lime render and new cement render.

The cement render, as you are aware will stop the building from breathing and will affect the timber frame beneath. On the older building it is particularly important that any cement mortar is removed.

Cement render

Unfortunately cement rendering is not appropriate for an older construction. We recommend you use a lime render in future regardless of what the builders say!

**ACTION REQUIRED:** Initially we would recommend that drips are added to the render above the windows and bell mouths are added to the base of the property.

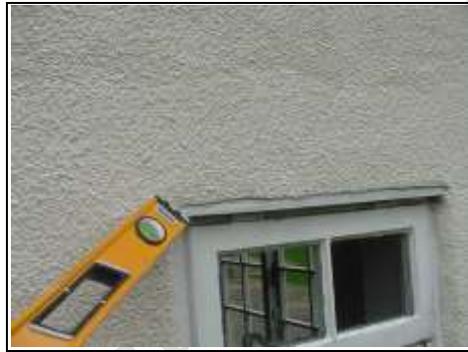
The original drip in the wood has been lost due to the render

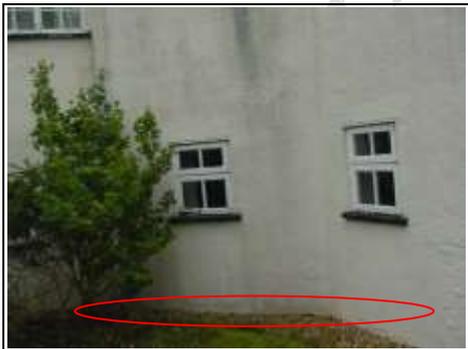
Where the old building links to the new building  
No bell mouth to render (red)

As mentioned earlier we would also recommend adding a bell mouth detail to the base of the render.

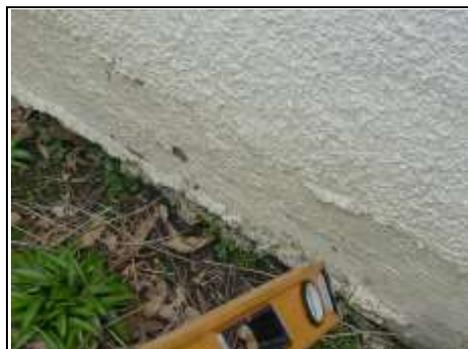
No bell mouth to front of modern property

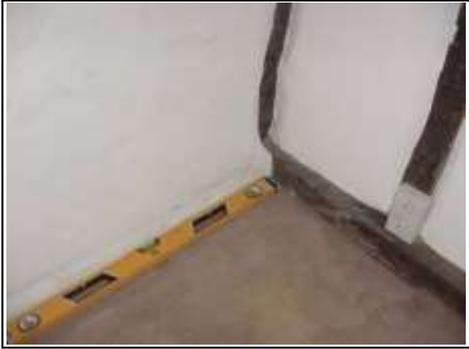
Sole plate not visible to left hand side -level indicates where it should be

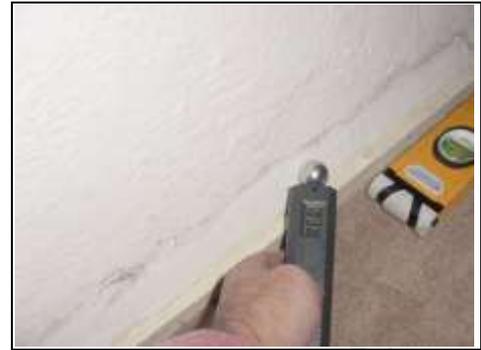
Damp readings taken where the sole plate should be are slightly high

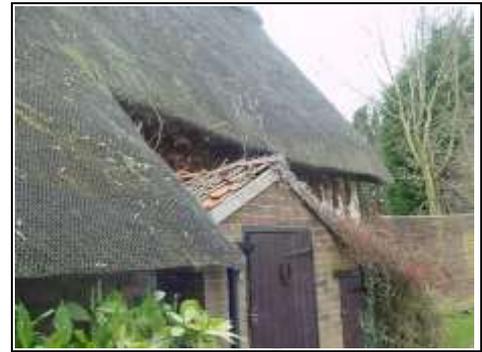
Rear of neighbours property

To the rear of the neighbouring property is an awkward detail with regards to the pitched roof of the shed that the neighbours have. We would have a cup of tea meeting with them to discuss work required on their side. Initially if they are not keen on this then you have a problem due to the dampness in this area.

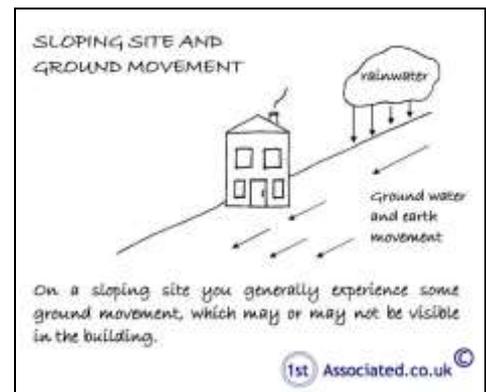
Sloping site

The property sits on a slightly sloping site which tips water against the rear of the property, particularly the newer building. On the day of the survey the timber decking was covered in water and we could tell it has been covered in water many times and was particularly slippery.

As we discussed there may be a drain in the corner that is blocked by the leaves from all of the trees.

**ACTION REQUIRED:** We are finding that decking areas are good places for rodents to live and we are generally recommending that they are removed.

In this case we are also recommending that a French drain is added which can be combined with the gutters and downpipes

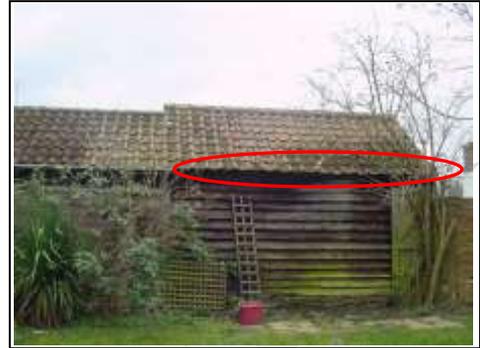
Neighbours outbuilding has no gutters

We also mentioned adding a French Drain earlier to the older building on your neighbours land. We would suggest that you offer to add guttering to their outbuilding as this would hopefully help them to decide to allow you access to your property from their land. Ultimately you legally have a right to maintain your property but it is always far better, in our opinion, to do things on a friendly basis.

**ANTICIPATED COST:** £1,000 to £3,000 pounds for a new soakaway assuming you can get some form of mechanical digger around the back, otherwise this would need to be dug by hand; please obtain quotations.

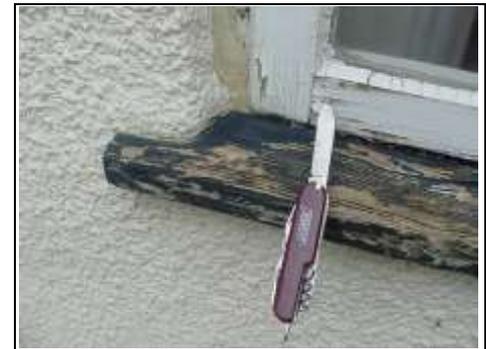
Window needs redecorating

**ACTION REQUIRED:** We do believe that the windows are saveable, however with some of them it may be more economical to replace. You do need to repair or replace them before the winter of 2014 as most are already showing bare timber in parts;

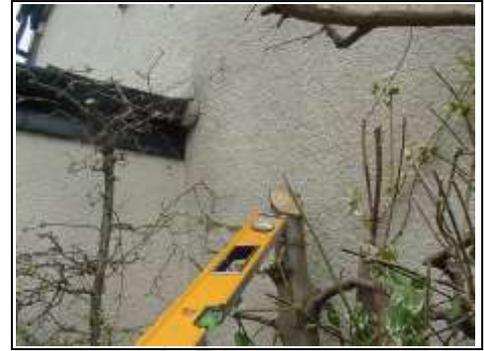
Plants have been cut down around the property

**ACTION REQUIRED:** Generally as long as you maintain the trees and prune them yearly, there should not be any adverse effect. As discussed you do need to consider how the trees affect the natural daylight and also how they give you privacy.

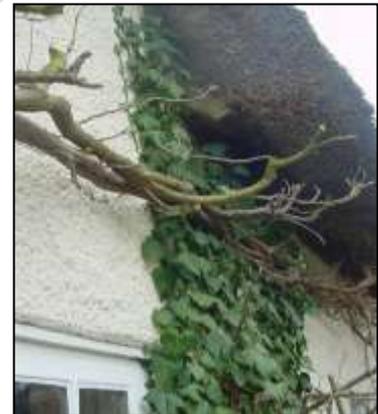
Ivy growing on the wall

With regards to the plants, climbers etc. growing on the property we would recommend that trellis work is put behind them to give them something to hold onto other than the actual building.

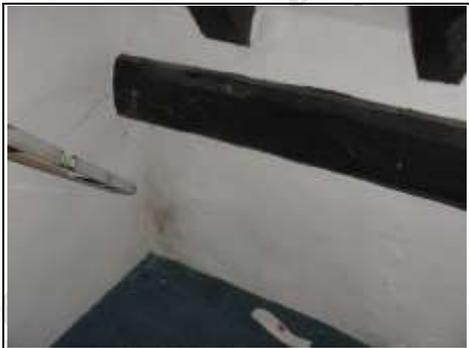
At the time of the inspection there were areas of black mould that had formed in the lesser heated areas of the property, this is known as cold bridging.

Cold bridging to cupboard in the small bedroom

**ACTION REQUIRED:** There are things you can do to help such as add large humidity controlled extract fans in the bathroom, the kitchen and any rooms that you use for drying. There is a small extract fan in the bathroom but we would prefer to see this replaced with a larger extract fan.

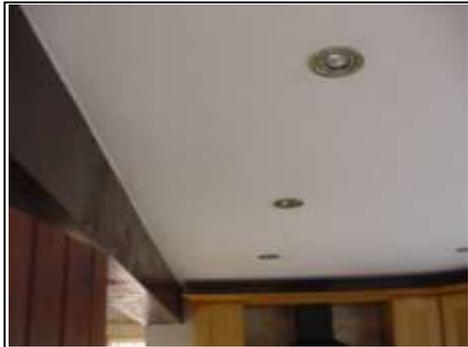
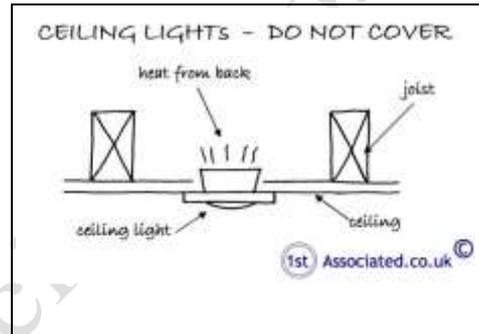
The property has some flush ceiling lights. In some instances these can cause problems as the heat given off has in some cases lead to outbreaks of fire (we have experienced this a few times).

**ACTION REQUIRED:** We recommend these are replaced with LED lights or similar low heat lights.

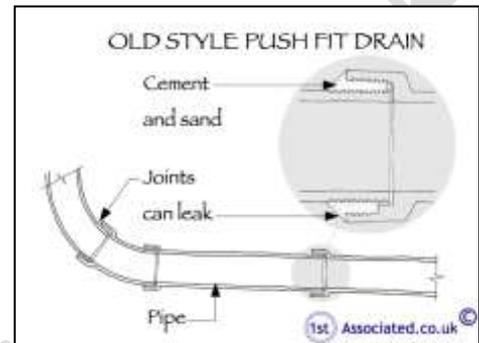
In older properties, such as this, drainage was often push fitted together rather than bonded together which means that they may leak over the years.

Push fit drain

The location of the drains needs to be established. Whilst we ran the tap for 15 minutes without any build up or blockages the only way to be 100% certain of the condition of the drains is to have a closed circuit TV camera report.

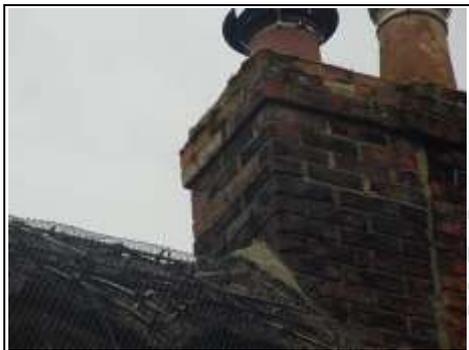
This chimney is brick finished with a cement flashing and chimney pots. From what we could see, from ground level, it looked in average condition considering its age, type and style. We did note that there is some moss which indicates it is starting to deteriorate. We could also see areas of light coloured mortar indicating that work has been carried out recently.

Moss just starting to grow on the chimney

**ACTION REQUIRED:** Periodically inspect the chimney.

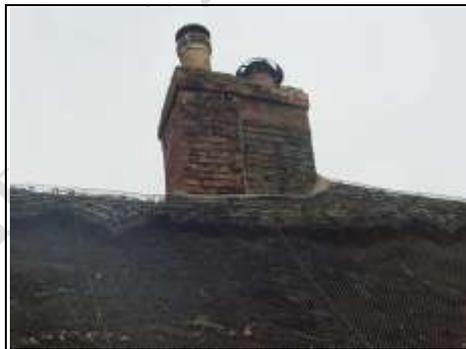
Rear of the chimney has a crack between the two chimneys

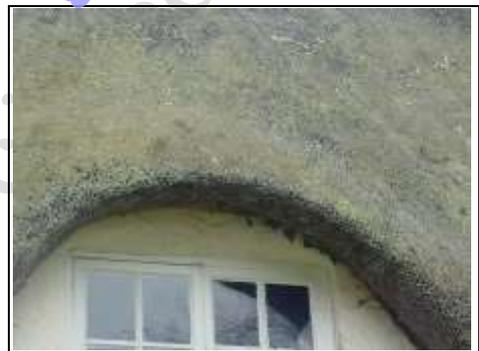
Moss on the thatched roof

**ACTION REQUIRED:** Ideally before you commit to purchase the property we would recommend obtaining quotations from a local thatcher and negotiate based upon these costs. Thatching is not cheap but at least today you can find Thatchers whereas at one time it was a problem.

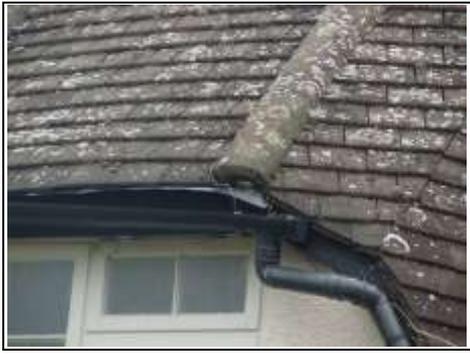
Tiled roof

We do feel upon reflection that the roof has been built in keeping with the thatched building. It will be interesting to ask a Thatcher how much it would have cost to thatch the original building. The roof, from what we can see at ground level, looks to be in slightly below average condition due to the moss.

**ACTION REQUIRED:** Please see our comments within the Executive Summary about removing the moss but please do not use any chemical sprays as we would say that the jury is still out on what damage these can cause.

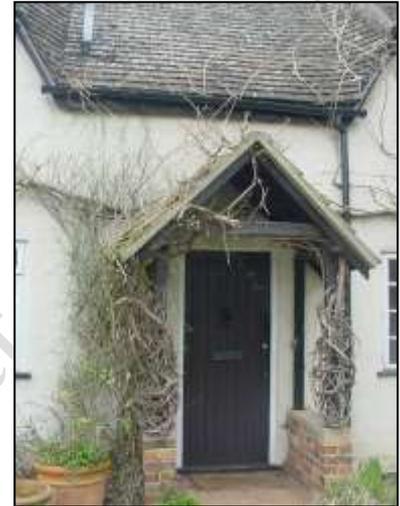
No gutter on this roof

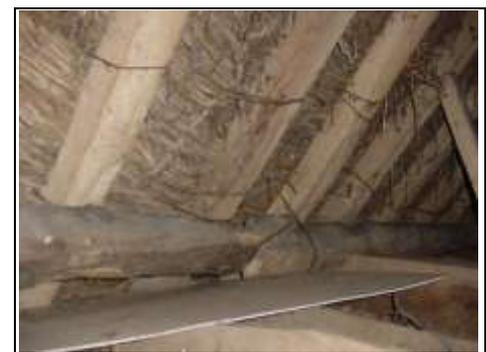
Old purlin with relatively modern timbers

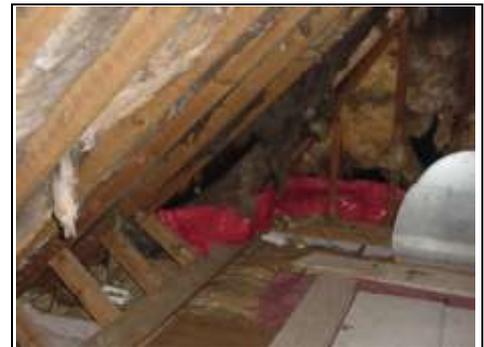
Cut timber roof with props added, often after roof spread

We cannot make up our minds whether the bracing has been added to stop roof spread or whether it was just the way the roof was constructed. The roof has an unusual construction as we would have expected to see an A Frame on the main roof truss.

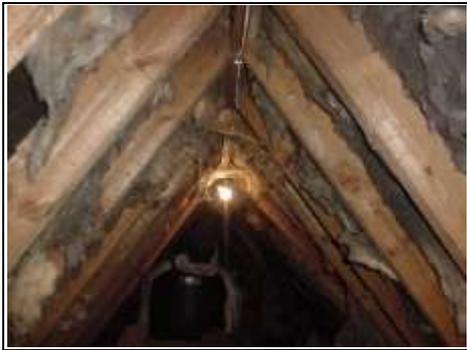
We would have expected to see an A Frame truss

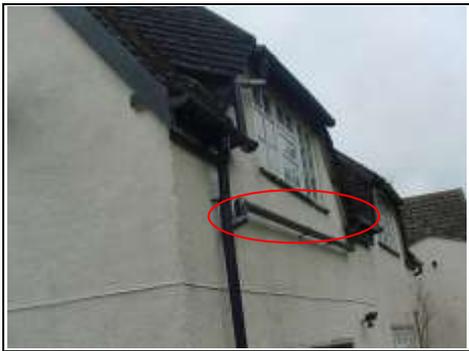
Very horizontal downpipe

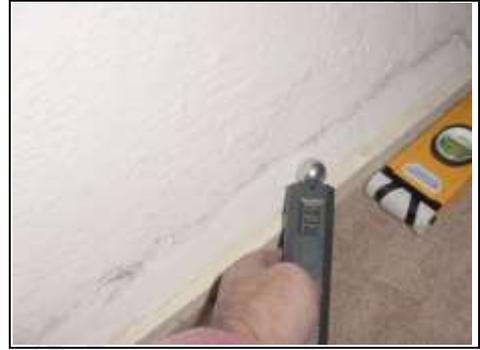
Our concern here is the sole plates at the base of the structure which can rot and deteriorate and cause defects in the building. In many buildings they have been replaced over the years, in this case we are not certain. We would recommend opening up the structure to the rear where the dampness is before lowering the ground level to see the construction.

Damp readings taken where the sole plate should be – slightly high

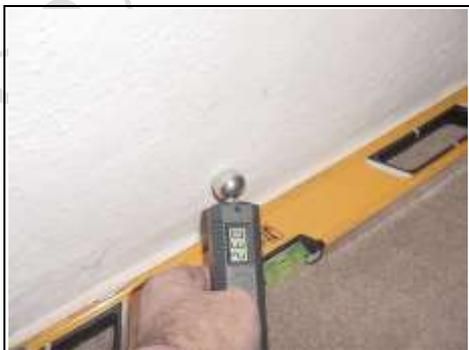
Taking readings above where the sole plate would be

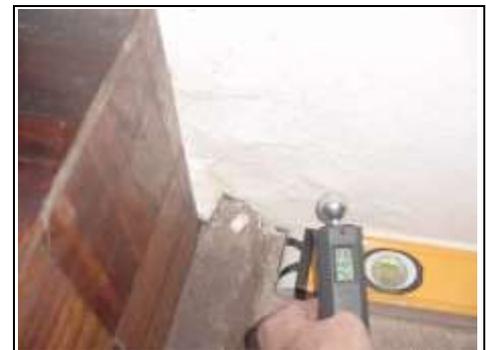
High readings near where staircase has been removed

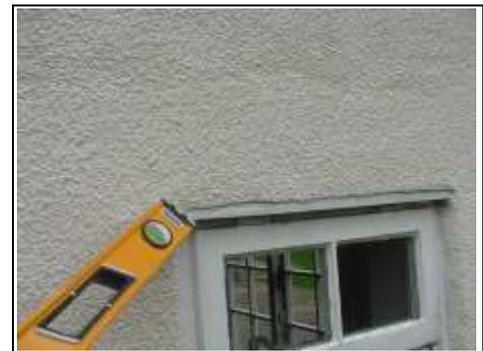
In this case we found no drip detail to the windows.

No window drip

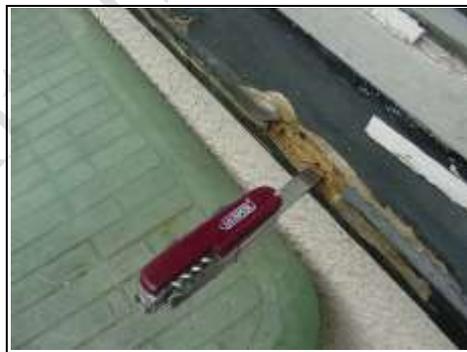
We have tested the timber windows by pushing a knife into a random selection. We generally tend to do the lower windows as access is easier. In this case we could push the knife right into some of the windows.

Knife test in window – timber has deteriorated

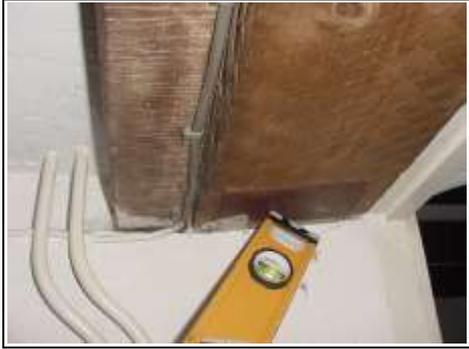
Metal brace added to the timbers  
in the ground floor lounge

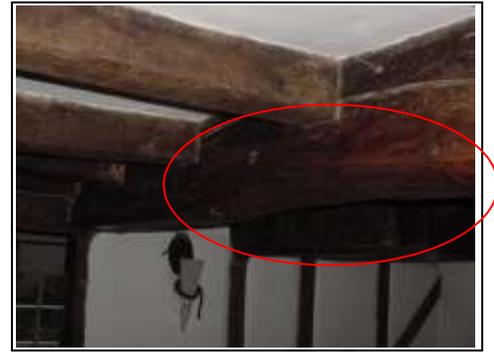
Spine beam has been cut  
away to increase head room  
on the old staircase

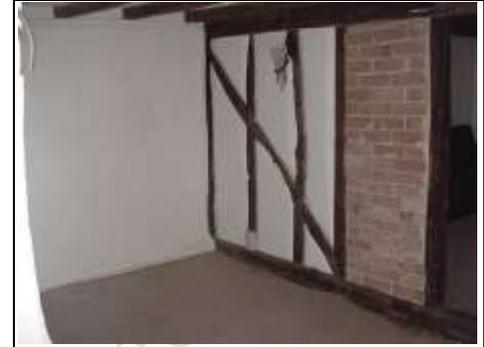
As we discussed there is a relatively modern brick panel in one of them. We would also comment that the small brick around the brick is not the original. These properties seem to have many alterations over the years which the occupiers at the time considered to be improvements.

Brick panel

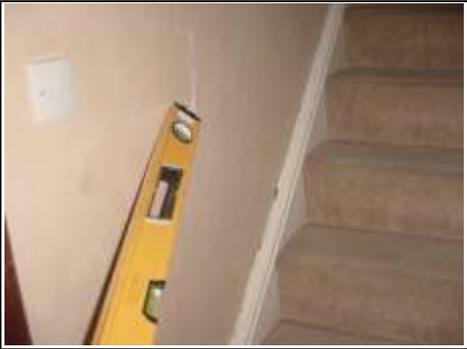
Cracking near the stairs

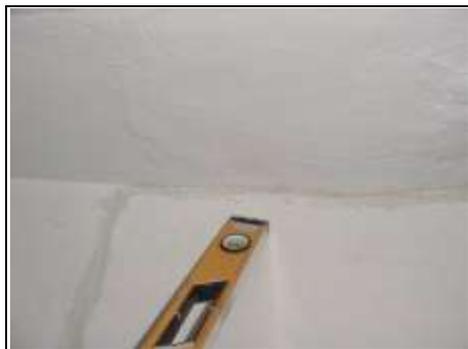
Cracking to small bedroom  
in older building travels  
between the wall and the  
ceiling

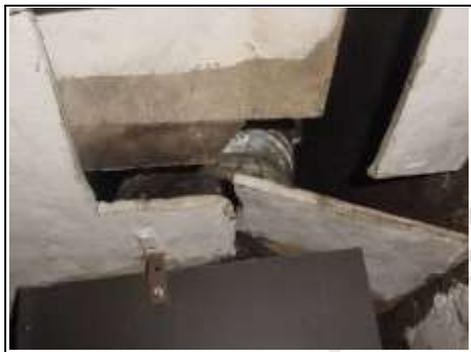
We also noted possible Asbestos.

Possible asbestos in the chimney

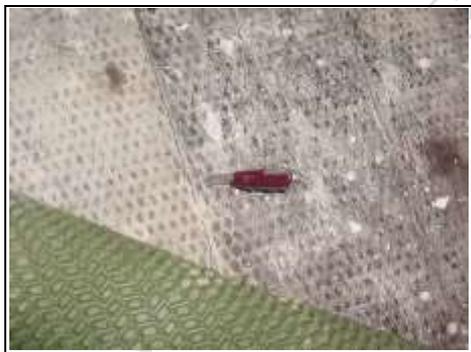
Knife test into the floorboards

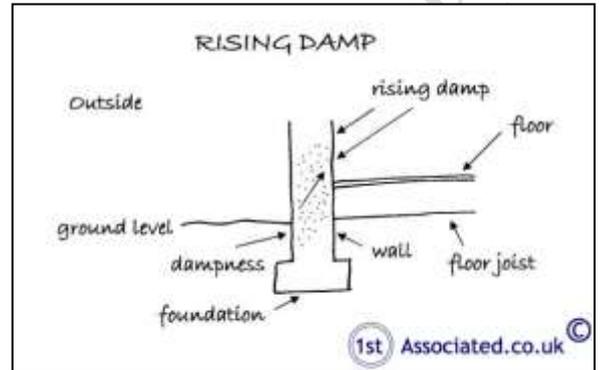
Rising damp

A visual inspection and tests with a moisture meter have been taken to the perimeter walls. In this particular case we have found significant rising damp to the rear of the property.

**ACTION REQUIRED:** Please see the Executive Summary.

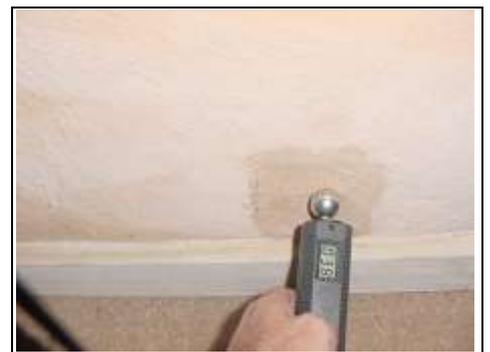
Ground floor testing area of plaster that has come away in hallway-

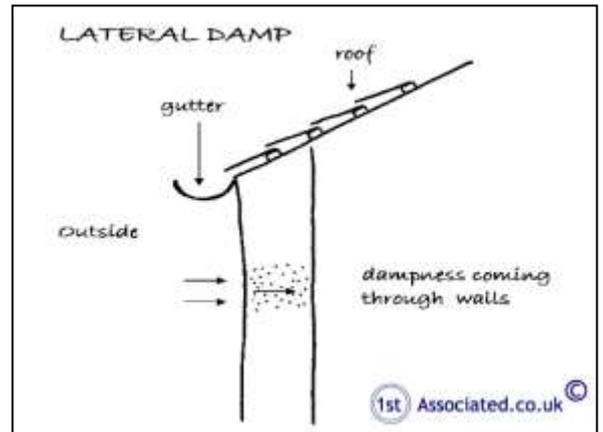
We used a resistance meter on the external walls. We have found some dampness but we feel that is due to the property being empty for some time.

Lateral dampness

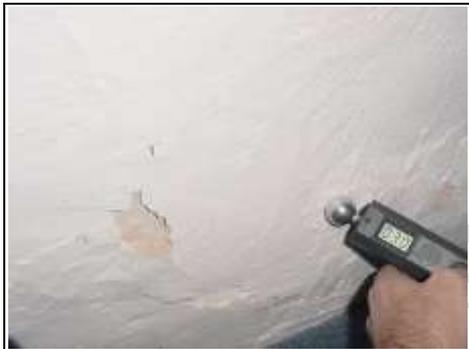
Checking damp in master bedroom

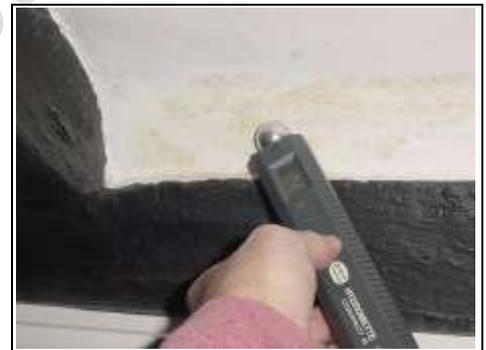
Checking for damp above eyebrow window in master bedroom

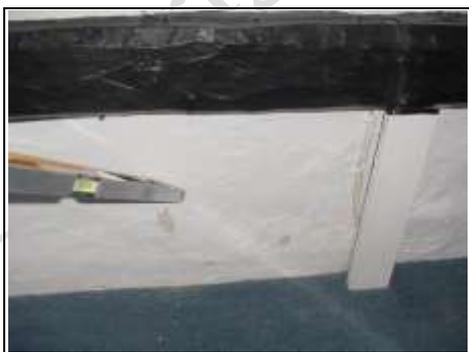
This area has been damp but was not at the time of the survey

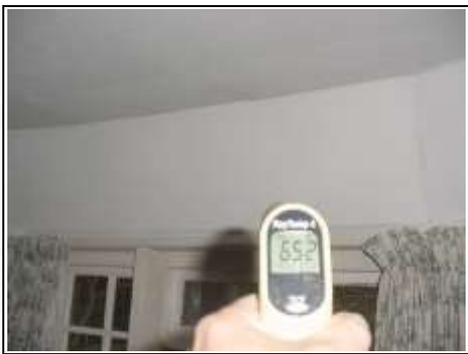
At the time of the inspection there were areas of black mould that had formed in the lesser heated areas of the property, this is known as cold bridging.

Checking surface temperature

To minimise this common sense is needed with a balance between heating, cooling and ventilation of properties and opening windows to air the property regularly. We believe that you need to extract any humidity from the source areas, the kitchen, the bathroom and any areas where clothes are dried as soon as possible.

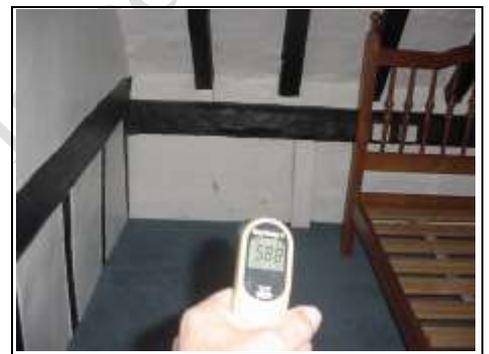
Consistent readings

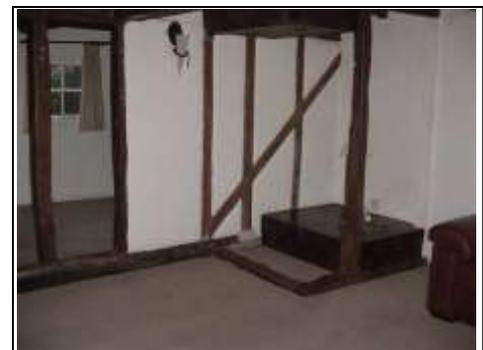
We think the staircase used be here

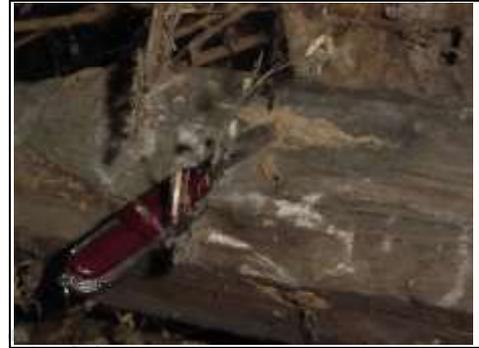
The roof is the main area that we look for woodworm as well as the actual traditional timber structural frame. Within the older roof we found some minor woodworm but no signs of what we would term as ‘structurally significant’ damage. In this roof, as with most older properties, there is an element of woodworm that is not active. We were unable to see any frass to indicate that it was active. We only viewed the older roof from the loft hatch as we did not feel it would take our weight and the ceiling could come down.

Testing for woodworm

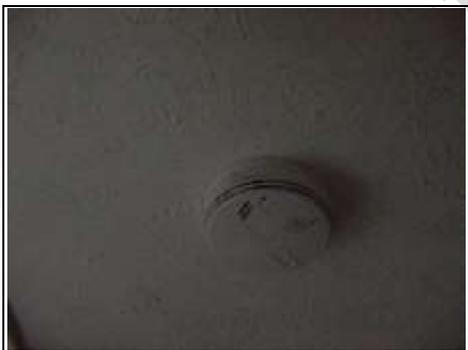
Some smoke detectors were noted. The current Building Regulations require that they be wired into the main power supply. Obviously in a property of this age this is difficult, as it would mean having surface mounted wires or cutting wiring into the plaster.

Smoke alarm

**ACTION REQUIRED:** We would recommend, for your own safety, that smoke detectors be installed. We would always recommend a hard wired fire alarm system and are also aware that some now work from a wireless signal which may be worth investigating. Whilst fire is relatively rare it is in a worst case scenario obviously devastating.

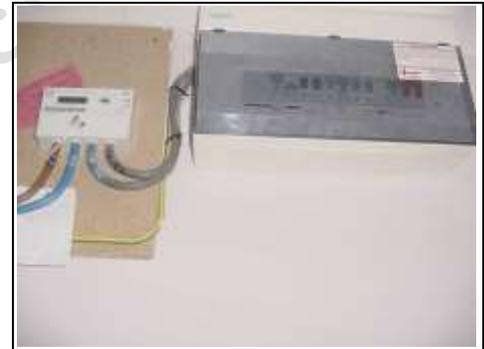
Fuse Board

The electric fuses and consumer units were located in the cloakroom which is an unusual place for it to be located and we feel it needs a half hour fire protection box. The fuse board looked relatively new 1970's/1990's but better are now available. In an older timber framed property defective electrics can be particularly dangerous.

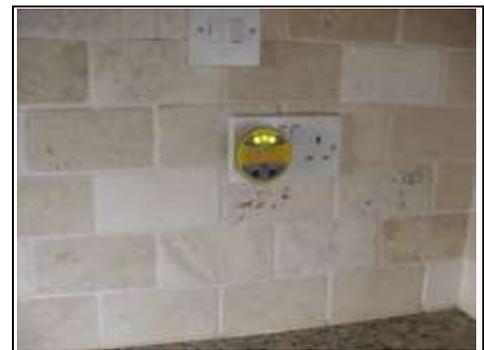
Earth Test

We carried out an earth test in the kitchen area to the socket point that is normally used for the kettle, this proved satisfactory.

**ACTION REQUIRED:** As the property is changing occupancy an Institute of Electrical Engineers (IEE) test and report is required, carried out by an NICEIC registered and approved electrical contractor or equivalent.

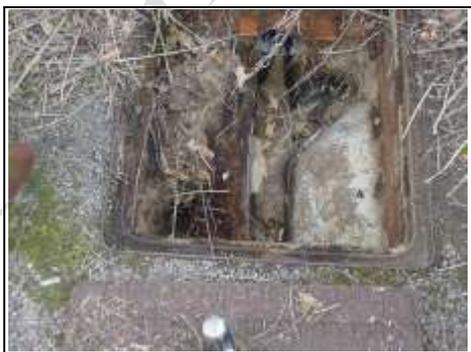
Manhole -front

We duly lifted the cover and found it to have roots growing within in.

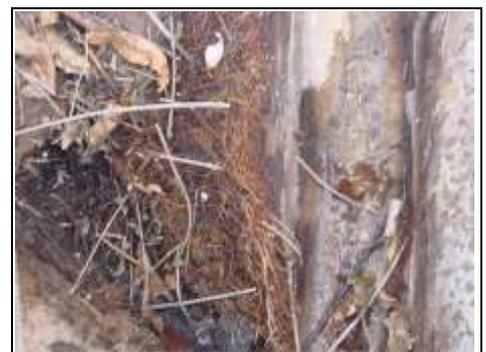
Roots in manhole

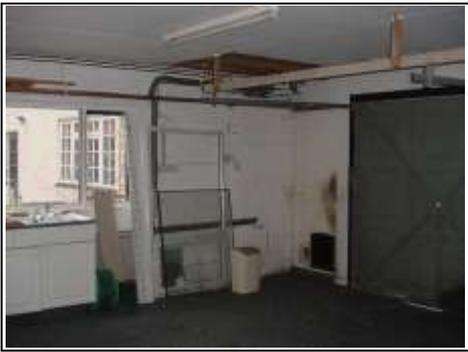
Garage doors- not tested

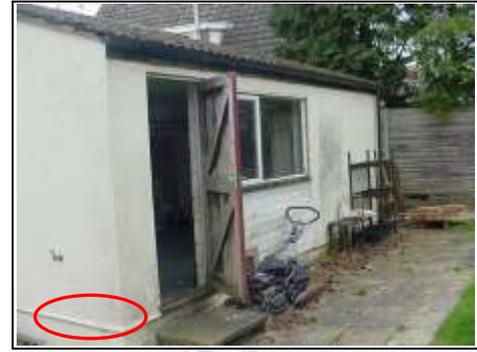
Render to the garage has a drip detail
