RESIDENTIAL BUILDING SURVEY

Edgware, Middlesex

Post War
End of Terrace
Property

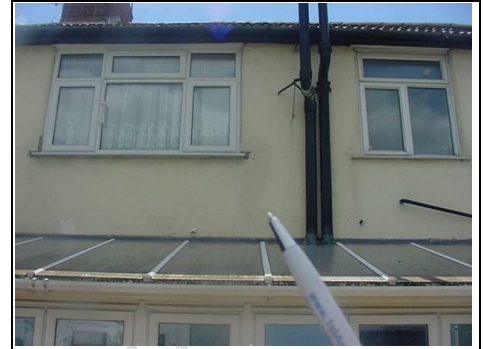
There has been movement to the property with cracking indicating problems to the rear left hand corner (all directions given as you face the front of the property). The movement may have something to do with drainage problems.

We would add that when we were in the roof we could see that there has been movement to the hips of the main roof. It is very unusual to see this amount of movement and it did look like the purlins may have been replaced.

ACTION REQUIRED: Existing owner to put in an insurance claim with regard to subsidence, by doing this you will have a limit on your liability of the excess, typically a few thousand pounds. The insurance company will monitor for a year as recommended by the Building Research Establishment which is far better than our one off inspection.

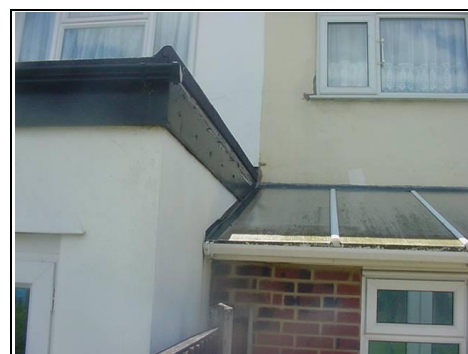
The boundaries do not line up to the rear right hand side. The end wall of the conservatory has been taken to next doors extension yet the fence still sits in to the property.

ACTION REQUIRED: Check to see if a Party Wall notice has been agreed and of course Building Regulations and Planning Applications have been approved. You may have to come to some form of agreement with the neighbour who unfortunately wasn't in at the time of our survey.

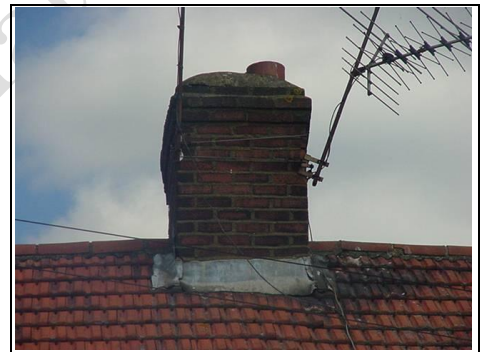
Chimney One – located to the front right hand side

This chimney is brick finished with a lead flashing and one chimney pot. From what we could see the chimney is in slightly below average condition and the lead flashing looks to have lifted slightly. In addition we have found that the wires that hold aerials can sometimes cut into chimneys like cheese wires.

ACTION REQUIRED: We would recommend periodic inspections are carried out.

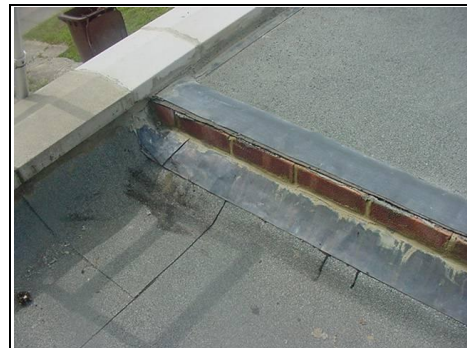
In this case there are parapet walls to the poor roof detail and this is a poor parapet wall detail. Please see our comments in the Executive Summary about the side roofs and the garage roof in general.

Poor detail to parapet wall

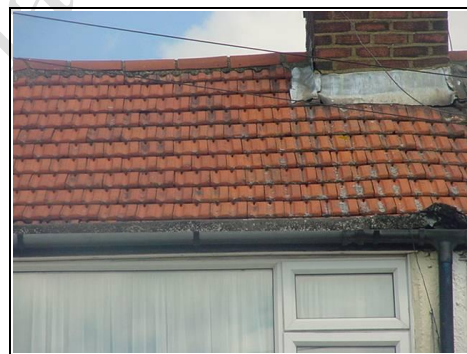
Main roof

The roof is pitched and clad with a clay nibbed tile often known with this pattern as Roman tiles. From ground level, this looks in average condition however from looking at it internally we believe there are some problems. With this age of roof there will usually be a few missing or displaced tiles, this is nothing unusual.

ACTION REQUIRED: Please see our comments in the Executive Summary.

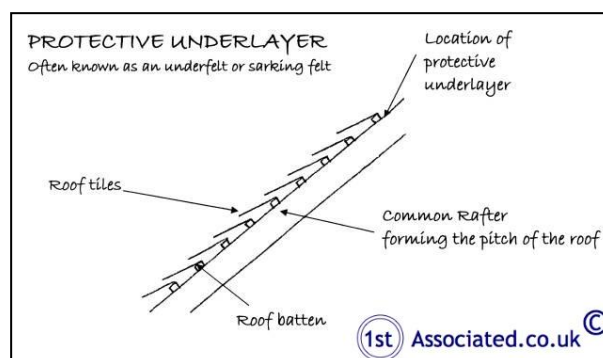
When we inspected the loft space we found there was no underfelt and it is therefore possible that during periods of heavy and prolonged driving rain some water penetration could take place through the roof coverings.

At the time of our inspection it was not raining and we could see light shining through indicating that rain could get through too.

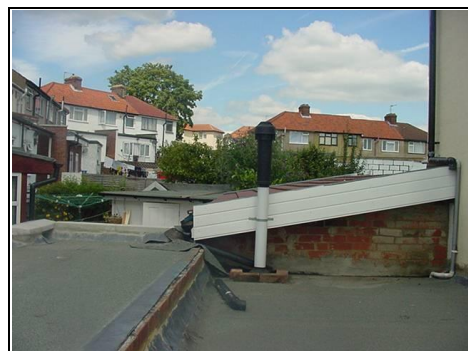
Garage roof

The property has a felt flat roof, typically this type of roof has a life of between 20 and 30 years, depending upon the quality of workmanship, materials and decking.

ACTION REQUIRED: Please see our comments in the Executive Summary. We feel this flat roof should have more of a fall for the water to get off the roof.

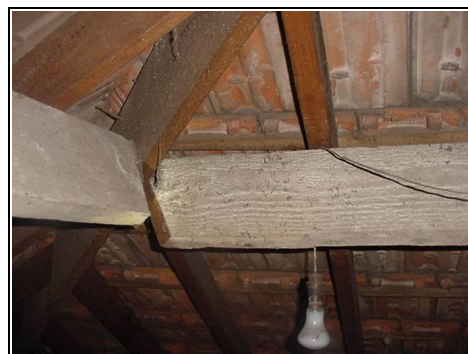
Hipped roofs are known for slippage/movement which in this case has occurred which is why it leads us to believe that there may have been structural movement in this property and your seller needs to be very honest with you about this.

Slippage in main roof

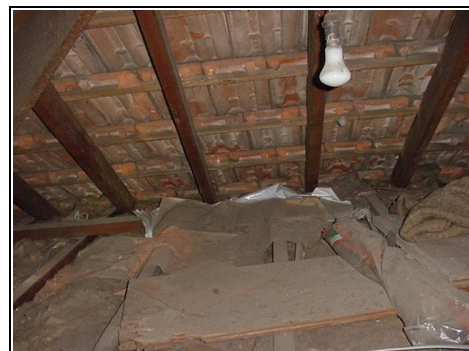
Lack of roof insulation

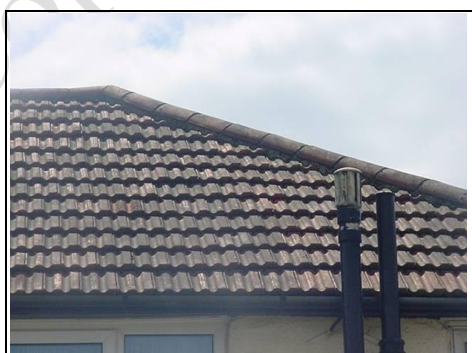
A cast iron soil and vent pipe remains to the rear of the property which has had the conservatory built around it. There is also a plastic soil and vent pipe to the side roof which we assume relates to the shower area.

Soil and vent pipe

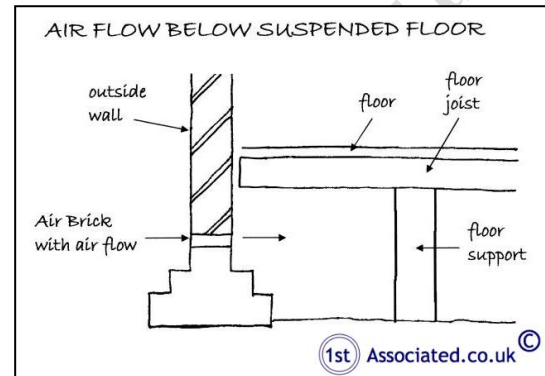
Airbricks give air ventilation to the wooden floor; an extension has been built with a concrete floor. We were unable to conclude if ventilation has been carried on through the concrete floor.

ACTION REQUIRED: Open up the floor and check the condition of the timber floor.

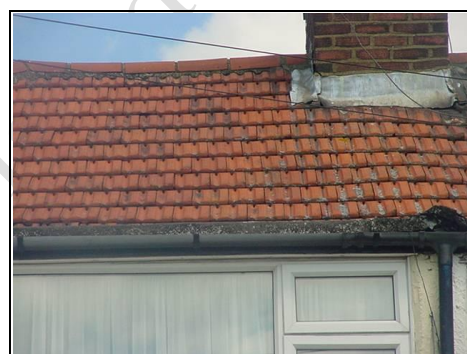
Timber fascia

The property has painted timber fascias and soffits and these are in average condition, (which means there is likely to be some rot) although much of the fascia is hidden by the guttering. There may be some minor leaks which have caused deterioration to the fascias but we couldn't see anything specifically as they are hidden by the gutters.

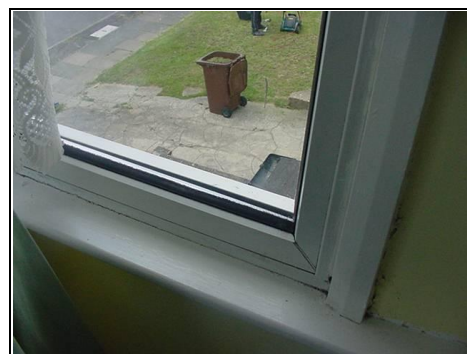
Windows

The property has plastic casement windows, which are double glazed. However, we believe they are from the cheaper end of the market. With this type of window some minor settlement often occurs. The windows do not have trickle vents.

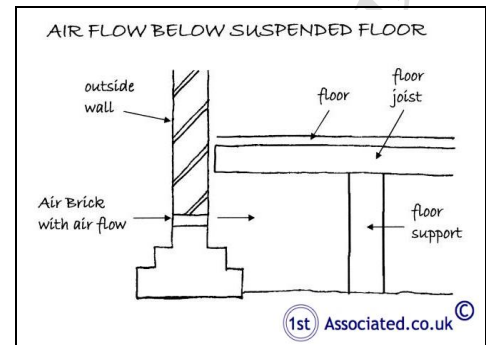
Based on our knowledge of this age of construction we believe that the ground floor construction is predominantly a suspended timber floor. This type of floor needs air circulation under it to reduce deterioration from wet rot and dry rot; please see our comments in these sections.

The remainder of the floor, kitchen onwards, is solid underfoot and assumed to be concrete.

ACTION REQUIRED: Please see our comments in the Executive Summary about the blocked airflow.

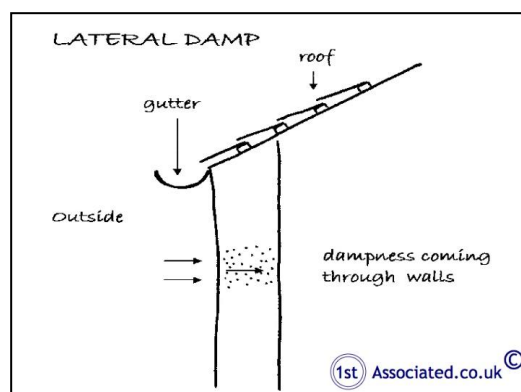
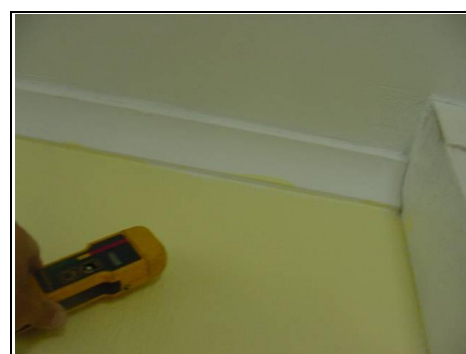
Checking for lateral damp

Tests were taken with a moisture meter at random points to internal walls, floors and other surfaces. We did get readings which we believe relate to the poor quality detailing of the flat roof, etc.

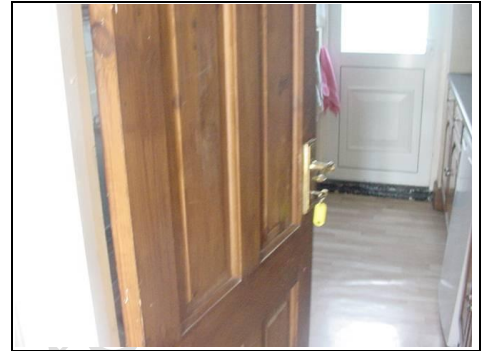
Internal doors

The property has an older style door, you may or may not like them and you may like to keep them as a feature of the house or not!

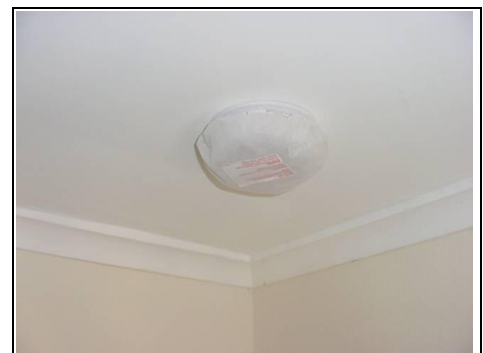
Smoke alarm

Some smoke detectors were noted, they were however covered over at the time of our inspection. The current Building Regulations require that they be wired into the main power supply. Obviously in a property of this age this is difficult, as it would mean having surface mounted wires or cutting wiring into the plaster.

ACTION REQUIRED: We would recommend, for your own safety, that smoke detectors be installed.

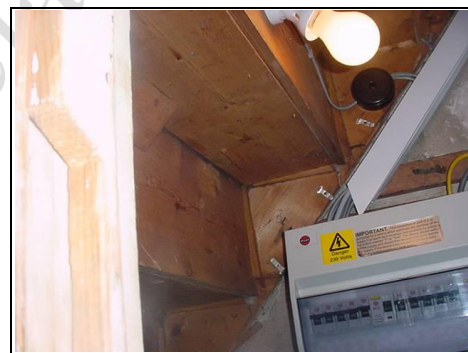
Electrics

Please see our comments in the Executive Summary with regards to the unusual amount of surface mounted electrics.

ACTION REQUIRED: We would recommend that the fuse board is replaced.

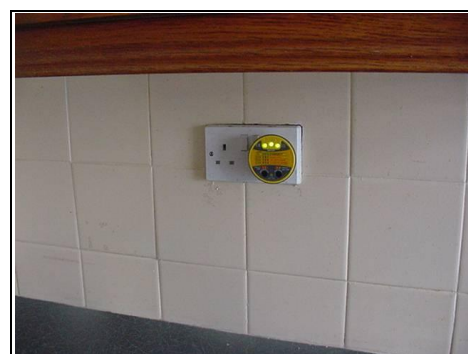
Earth test

We carried out an earth test in the kitchen area to the socket point that is normally used for the kettle and this did not cause the electrics to trip.

Neither of these indicators can give certainty as to the condition of the rest of the wiring.

ACTION REQUIRED: It is recommended that the installation be tested by a competent electrician (NICEIC registered) and all recommendations implemented. Thereafter, the installation should be re-tested every five years.

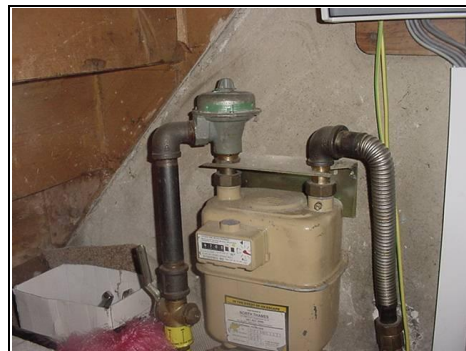
Gas meter

All gas appliances, pipework and flues should be the subject of an annual service by a competent engineer, i.e., a member of Gas Safe; works to gas appliances etc., by unqualified personnel is illegal. Unless evidence can be provided to confirm that there has been annual servicing we would recommend that you commission such a service prior to use to ensure safe and efficient operation.

ACTION REQUIRED: As a matter of course it is recommended that the entire gas installation is inspected and made good, as necessary, by a Gas Safe registered contractor. Thereafter the installation should be serviced annually.

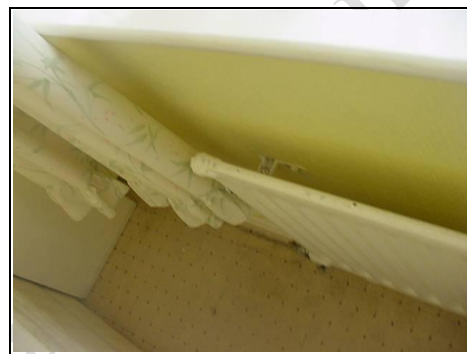
Single panel radiators

We noted that there are a fair number of single panel radiators. These may not warm the property to the heat that you desire. In most modern installations double panel radiators are used and often double panel convection radiators, which are more efficient, are utilised.

Our limited inspection of the hot water and central heating system revealed no evidence to suggest any serious defects but we would nevertheless recommend that the system be tested and overhauled before exchange of contracts and that a regular maintenance contract be placed with an approved heating engineer.

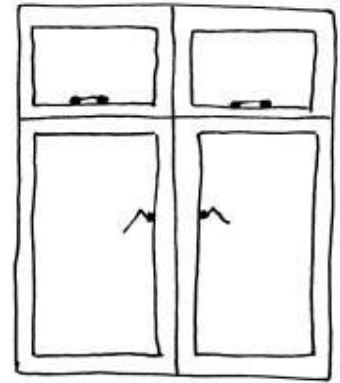
The original timber windows had been replaced with a plastic double glazed windows and whilst this had benefits on the thermal properties and acoustic, as they had some quieting properties too, they certainly did not help the structure. This is because the original timber windows (as we did check they were timber windows previously) also had structural properties, which meant in part they supported the structure. They were also flexible and moved with the structure as it moved throughout the year, because all properties of this age have some element of movement.

These two factors meant that the building adjusted over the different seasons and therefore the cracking didn't occur. With the new plastic windows that are much more rigid the wall and the render couldn't move as much and therefore cracked and this is the hairline cracking that the owners was getting concerned about. In this case it was just surface cracking.

We would recommend that the surface cracks are sealed with a filler that allows for movement (a hard filler would simply fall out sooner or later) and then redecorate. We also recommend that one of the cracks is opened up and the render hacked off, just to check that it doesn't carry on through the brickwork beneath.
