# RESIDENTIAL BUILDING SURVEY

**Bedford  
Bedfordshire  
MK41 xxx**

INDEPENDENT CHARTERED SURVEYORS

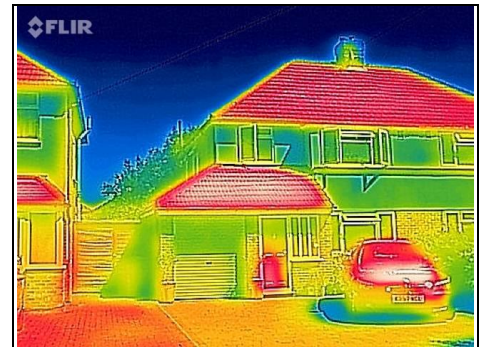
Thermal photo  
Showing the warm roof in red

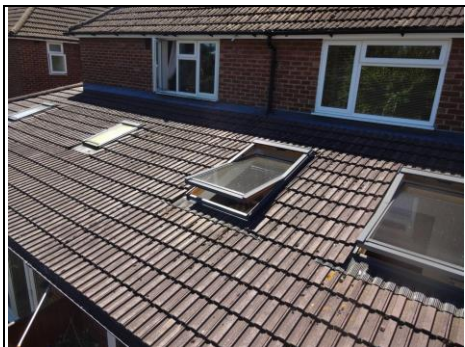
There were no signs of this at the time of our inspection and in our experience it tends to be something that happens over a long period of time. We do appreciate this is an interlocking tile which we would say are about the best you can get for a shallow pitched roof.

Shallow pitched roof to the rear of the property  
Ariel view – 360 photo

**ACTION REQUIRED:** Periodic inspection.

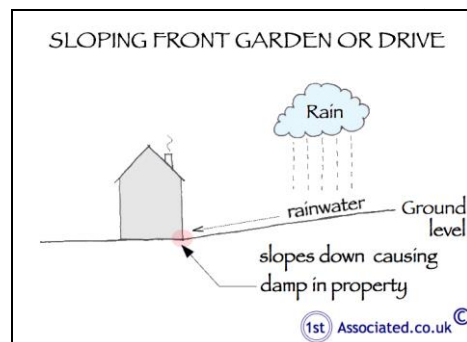
Sloping site to the front of the property

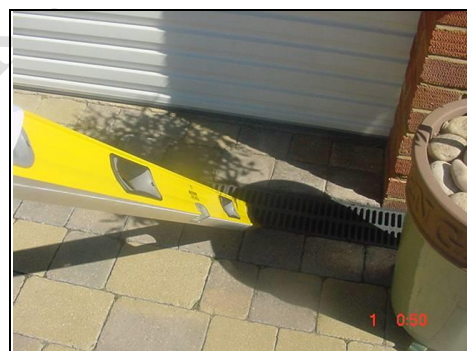
Running gully to the front of the garage

**ACTION REQUIRED:** Ensure this is kept clear otherwise you will get dampness into the property.

**ANTICIPATED COST:** DIY type work, you do need to remember to do it particularly if you keep anything precious in the garage area; please obtain quotations.

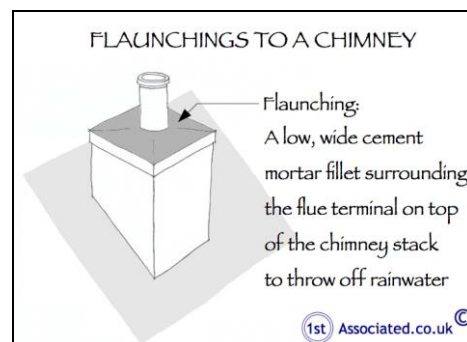
Unfortunately, we were unable to see the top of the chimney properly known as the flaunching, we therefore cannot comment upon them.

Flaunching

**ACTION REQUIRED:** Periodically inspect the chimney.

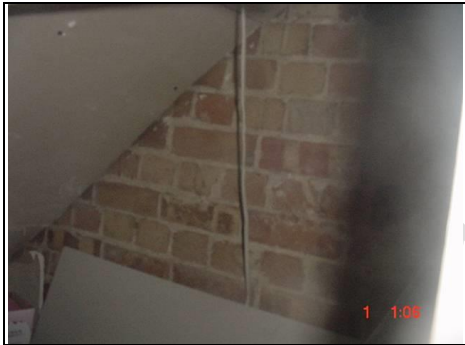
We can hardly see any of the roof because the room is being formed in the roof. From what we could see via the small cupboards in the top floor bedroom that it was lined with plasterboard so we were unable to see the protective underlayer.

Unable to see the protective underlayer due to the plasterboard in the roof

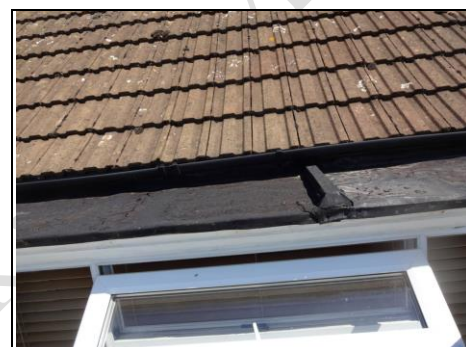
From what we could see there looks to be splits in the felt to the front boxed bay window roof.

Split in the felt to the front flat roof above the boxed bay window

**ACTION REQUIRED:** Please see our comments in the Executive Summary.

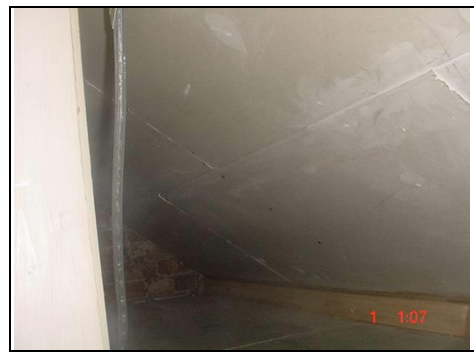
As a room has been formed in the roof then access is via some small access doors. Within these accesses we could see that the loft has been completely boarded / plastered which means we cannot see any of the roof structure.

Roof structure cannot be seen due to plasterboard

**ACTION REQUIRED:** The only way to be 100 per cent certain would be to have the boarding removed so we can actually inspect the roof structure.

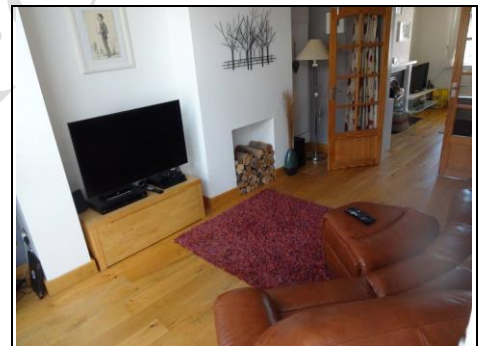
Decorative fireplace with timber stored in it to the rear reception room

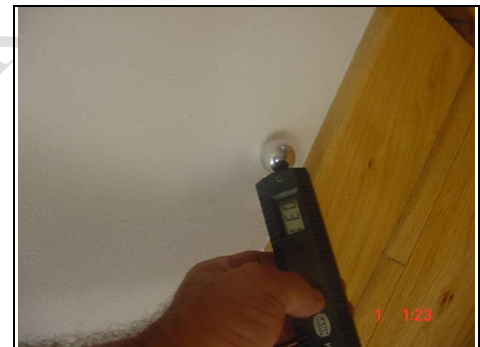
A visual inspection and tests with a moisture meter have been taken to the perimeter walls.

In this particular case we have found no significant rising damp.

Testing for rising damp

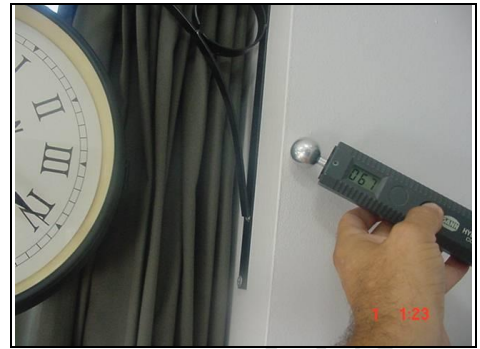
We used a resistance meter on the external walls.  
We have not found significant dampness.

We found it to be in line with what we would expect for this age, type and style of property.

Testing for lateral dampness

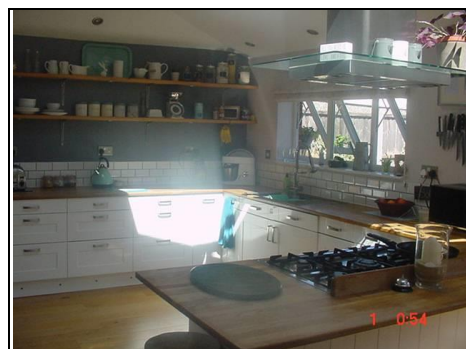
We found the kitchen in average to good condition, considering its age type and style and subject to some wear and tear as one would expect.

Kitchen area

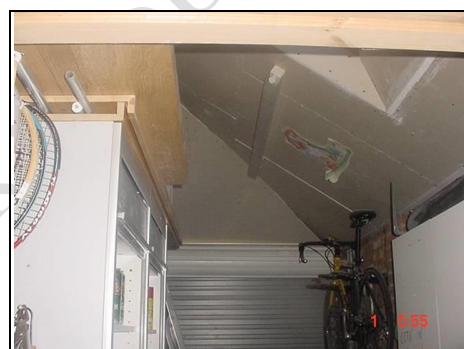
Even in the garage where we would normally see the roof it has been boarded over.

Boarded roof to the garage

**ACTION REQUIRED:** If you wish we can expose the timber to the main roof which is where the older timbers will be.

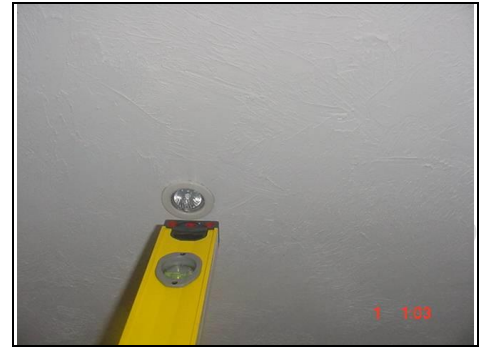
The property has textured paint to the ceiling (commonly known as artex). Early versions of this are said to have had asbestos, this looks like a later version but you do need to be aware of this.

Textured paint to the ceiling

**ACTION REQUIRED:** We would recommend that a plaster coat is applied to it (specialist plasters are available) and an asbestos report carried out.

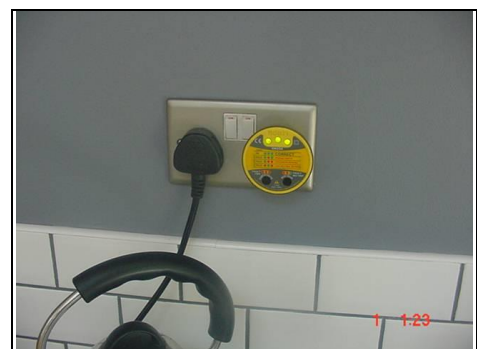
We carried out an earth test in the kitchen area to the socket point that is normally used for the kettle, this proved satisfactory.

Earth test

**ACTION REQUIRED:** As the property is changing occupancy an Institution of Engineering and Technology (IET) test and report and any recommendations should be carried out by a NICEIC registered, or equivalent, approved electrical contractor or similarly approved.

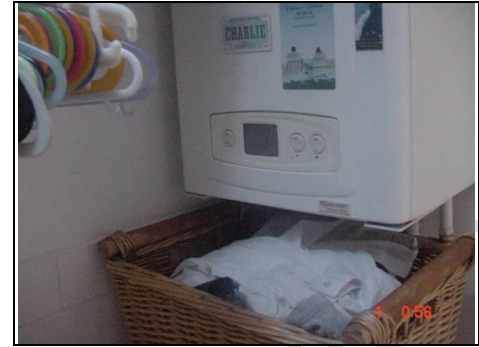
The boiler was located in the utility room, it is manufactured by Glow worm and the model type is Ultracom 38.

Our limited inspection of the hot water and central heating system revealed no evidence to suggest any serious defects but we would nevertheless recommend that the system be tested and overhauled before exchange of contracts and that a regular maintenance contract be placed with an approved heating engineer.

Boiler

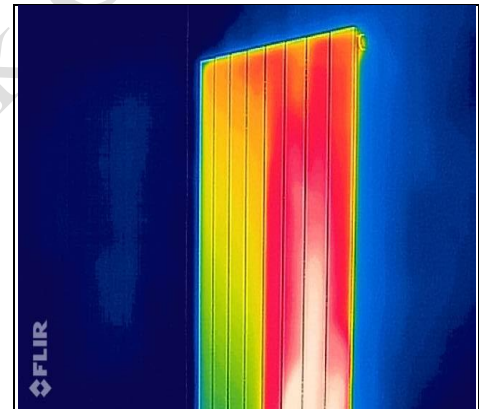
The owner at our request turned on the heating for approximately ten minutes. We checked the radiators on the ground floor and these were warm.

Thermal image of the radiator

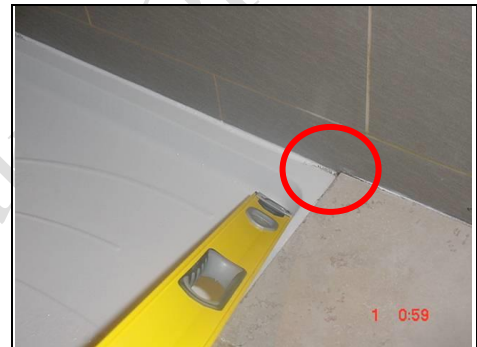
The property has an internal three-piece shower room to the ground floor, which looks in average to above average condition. We did notice some minor mould to the shower tray which we would comment it may be necessary to improve the extract fans.

Mould to the shower tray in the shower room

**ACTION REQUIRED:** We would recommend a large humidity controlled extract fan is added. By large extract fans we mean 150mm.

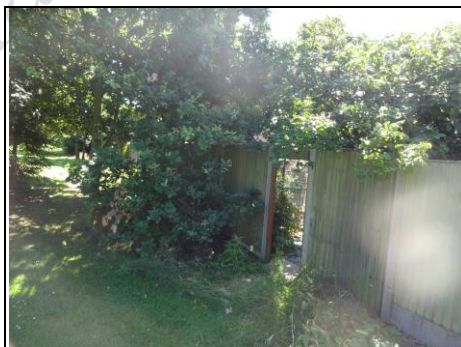
The garden to the rear has access to the park.

Gate access to the park at the rear  
of the garden  
Ariel view – 360 photo

You need to check and confirm that this is a legal right of access that you have even if it may or not be important to you.
