RESIDENTIAL BUILDING SURVEY

xxxxxxxxxx,
Beckenham,
London
BR3 xxxx

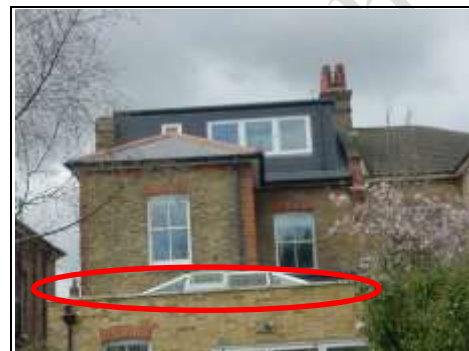
Rear flat roof

The parapet wall detailing on the rear flat roof is incorrect as far as we could see. The coping stones do not sit correctly on the walls and do not have a sufficient drip. This means that this drip will allow water to drip into the walls ultimately causing dampness.

ACTION REQUIRED: Whilst the coping stones are not causing an immediate problem in the long term we think that dampness will get into the parapet walls. We believe you should be able to obtain a coping stone that would position the drip correctly.

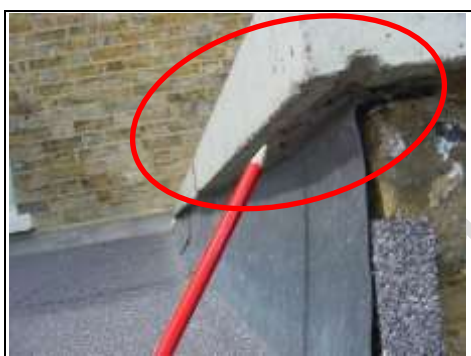
The coping stone does not have a sufficient drip

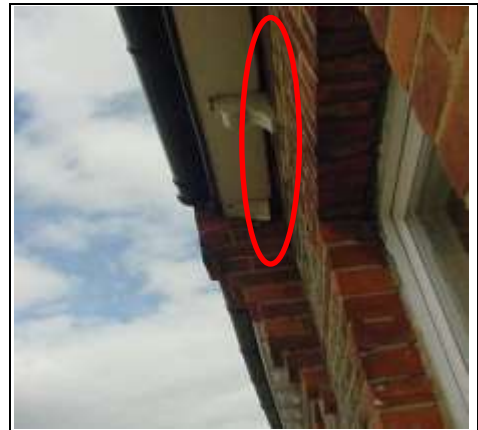
There is a gap between the wall and the fascias and soffits. We are not certain if this was done intentionally because of the loft conversion or poor workmanship originally or whether it is due to movement in the property. We do feel we should mention it as the gap between the main walls and the fascias and soffits is larger than we would expect.

There is a gap between the wall and the soffit.

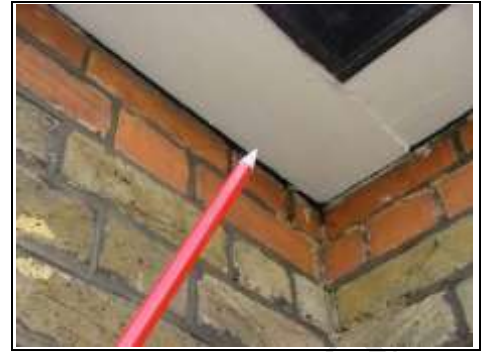
Soffit board a fraction away from the building. Is this intentional for the room in the roof or due to movement?

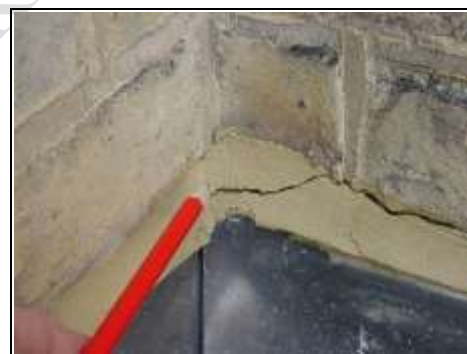
The property has been re-pointed in cement rather than in a lime mortar. In addition to this the cement that has been used is relatively hard and is starting to crack already. If you recall we showed you where it was cracking on the flashings.

Cement mortar has been used to point in the lead flashing. We much prefer mastic as it's longer lasting

ACTION REQUIRED: You need to remove all the cement mortar (it will eventually fall out on its own but a stiff brush will help it). We recommend you find the oldest, time served brick layer that you can who is able to carry out the re-pointing in lime mortar and to gradually replace sections of the cement mortar with lime mortar over the years.

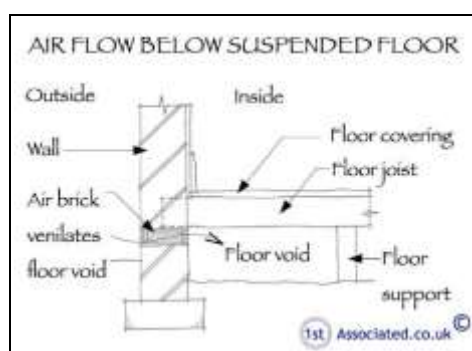
Suspended timber floor

The property has suspended timber floors which need airflow underneath them to minimise wet rot and dry rot. We can see air bricks to the front area (but not enough).

ACTION REQUIRED: In summary we would say that there are not enough air vents and more need to be added. We would add them to the side of the property and to the step and underneath the stairs. When the opening underneath the stairs is made you need to check the condition of the floor beneath.

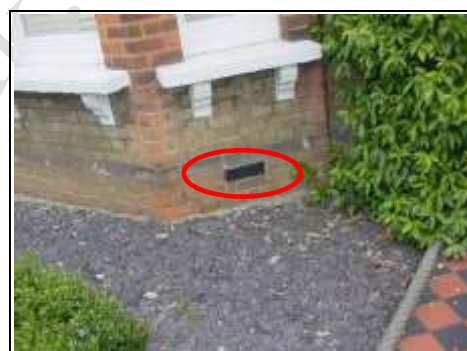
Air brick to front bay window area with air flow underneath

As mentioned we noted some air bricks to the front of the property. We noted only one air brick to the right side of the property (this is partially blocked) compared with several air vents on the neighbouring property.

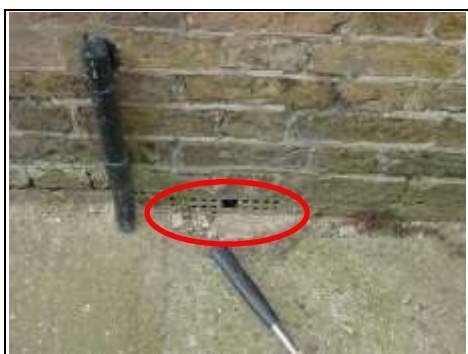
Partly blocked air brick on this property (right)

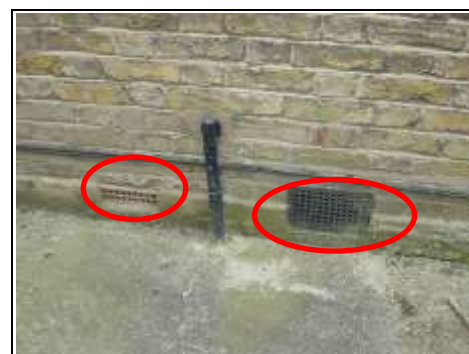
Two of several air bricks to the neighbouring property

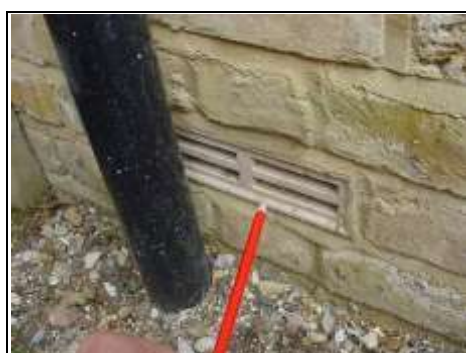
We also noted one air brick to the rear which may be a vent through the concrete floor that is blocking the timber floor.

Air brick to the rear

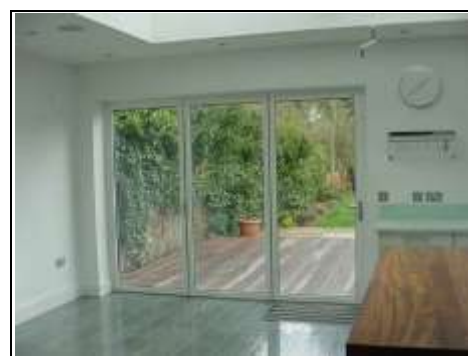
We would also mention that whilst the sliding folding doors are very popular at the moment we have heard complaints that it is relatively cold near them in the winter months (which we have a fair number of). We have seen wooden shutters being used on these glass sliding doors or good quality thick curtains.

Glass sliding, folding doors

We would recommend that you look at some sort of blinds or shuttering system. However, in our view, we are aware that blinds can be surprisingly expensive for what they are.

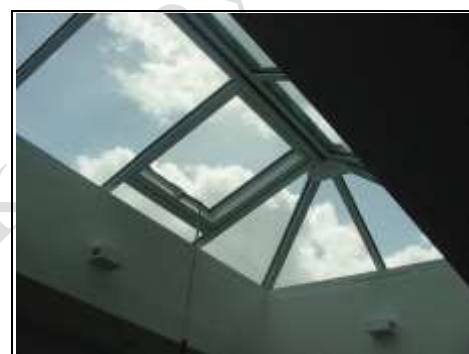
There is also a glazed area/ roof window in the roof that as well as letting light through can also let a considerable amount of heat out during the winter months even though it is double glazed.

Glazed area/roof window in kitchen

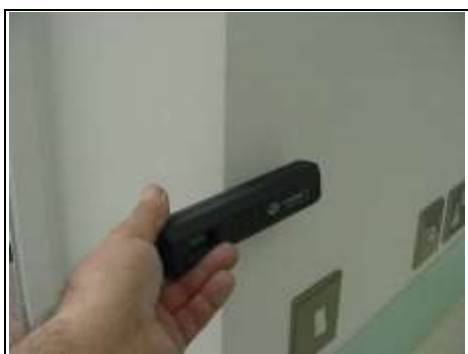
There was rising damp found to the right hand side of the property with meter readings in the 80's and the 90's. We suspect it will also be to the rear but the construction is dry lined (false walls) meaning that we cannot carry out tests with an electronic damp meter without opening up the structure.

We could not take damp readings because the walls are dry lined here

ACTION REQUIRED: A French drain (please see our article in the appendices) to be run along the right hand side of the property as well as air vents being added. We suspect the suspended timber floor may be in poor condition which is why we are recommending that you open up the floor underneath the staircase to check its condition. Ideally this should be carried out before you purchase the property.

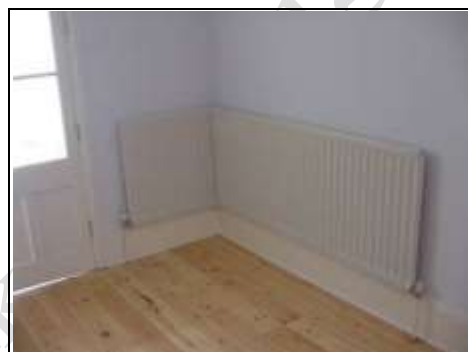
Internal single panel radiator

ACTION REQUIRED: We feel the house will benefit from having new modern double panel convection radiators.

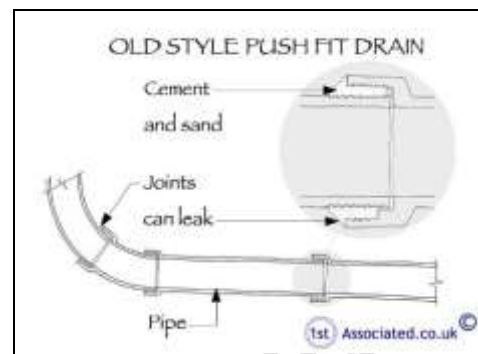
Whilst we have lifted the manhole cover to the right hand side of the property the only true way to find out the condition of the drains is to have a closed circuit TV camera report carried out. Drains in this age of property tend to be push fit drains and there will often have been leaks over the years.

Push fit drain

ACTION REQUIRED: We would reiterate that we recommend with regard to all services that you have an independent check by a specialist contractor.

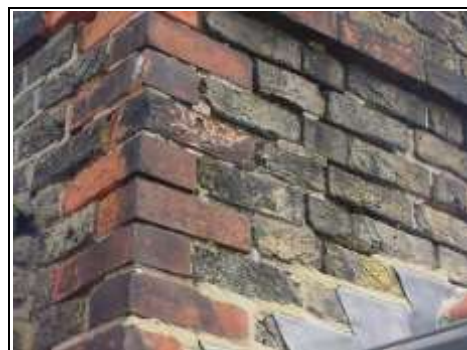
This chimney is brick finished with a lead flashing and several chimney pots (half of which are yours). From what we could see from ground level it looked in below average condition considering its age, type and style and needs re-pointing.

Chimney needs re-pointing

ACTION REQUIRED: Carry out re-pointing; this needs doing in the next three years. We are surprised this work was not carried out when they carried

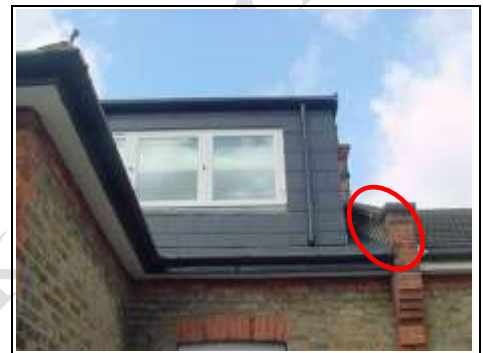
In this case there is a parapet wall to the left hand side of the main roof that transfers down onto the roof below. It is built from brick with a coping stone. Our concern is that the lead flashing looks to have been pointed with a cement mortar which will crack relatively quickly. We much prefer a plumbers mastic to be used where a lead flashing is present.

Left parapet wall (rear)

ACTION REQUIRED: It may take some time but ultimately you will need to re-bed the lead flashing.

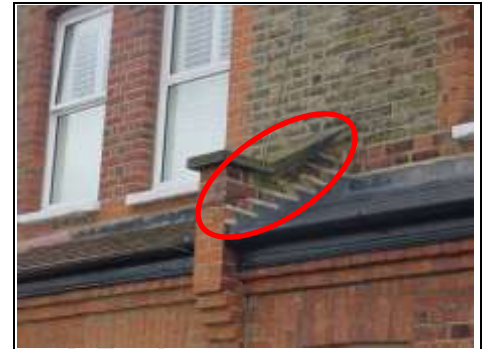
Parapet wall re-pointed in cement mortar. Just a reminder that you may have to re-point this

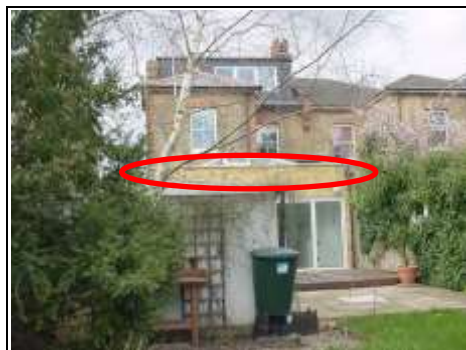
Rear flat roof

We would have preferred to see a steeper fall on this flat roof particularly with such a large roof window in the middle. We tend to find that roof windows such as this can mean that the centre of the roof sinks and you get ponding around the base of the roof window, you need to look out for this.

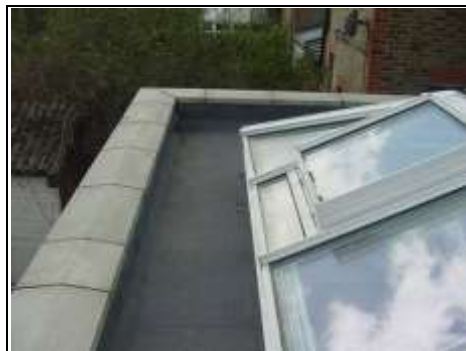
Roof window / glazed area over kitchen

ACTION REQUIRED: We would recommend that you have a look at the roof window, to the flat roof over the kitchen, when it next rains from the bedroom window to see if you can see any ponding.

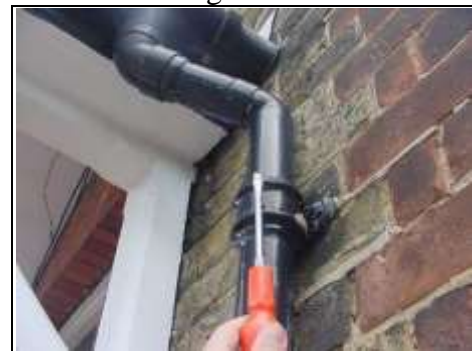
Narrow downpipe from the front porch roof

Dampness to upstairs bathroom window possibly caused by overflowing gutters.

ACTION REQUIRED: We would recommend setting aside the sum of £1,000 to re-organise the gutters and downpipes.

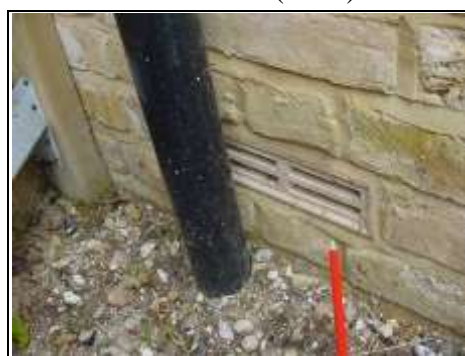
The property needs more airbricks. The property has a timber suspended floor but not enough air bricks. Air bricks are essential to have a through flow of air as this helps to reduce the chances of wet rot, dry rot and woodworm.

Air brick (rear)

ACTION REQUIRED: Please see our comments regarding the suspended timber floor within the Executive Summary.

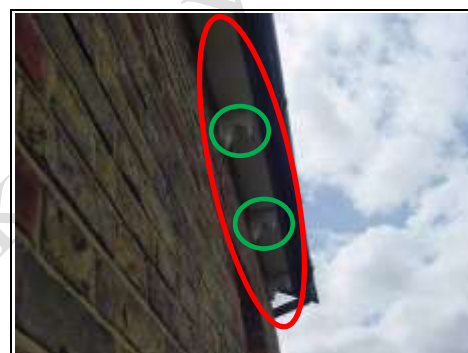
The fascias, soffits and corbels are timber. They are painted and we would comment they are in average to slightly below average condition for their age, type and style.

Fascia and soffit (red oval)
Corbels (green circles)

ACTION REQUIRED: We would recommend redecoration in the summer of 2014. Make sure gutters and downpipes are watertight before carrying out any work on fascias and soffits.

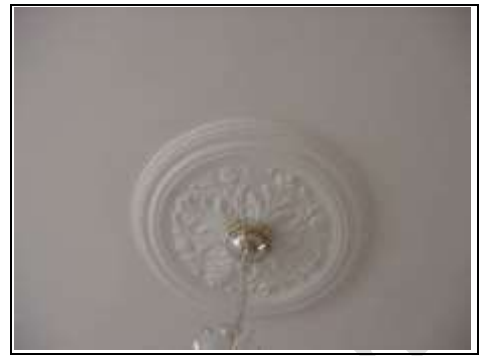
Ceiling rose. We think this may have been added

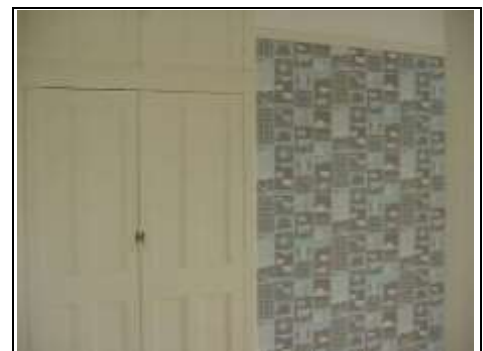
Hidden chimney

Your Legal Advisor needs to specifically check with the Local Authority for removed chimneys and associated chimney breasts and Building Regulations Approvals and advise by e-mail immediately if chimney breasts are found to have been removed. We would recommend opening up the structure to check the condition. If we are not advised we will assume the relevant Building Regulations Approval has been obtained.

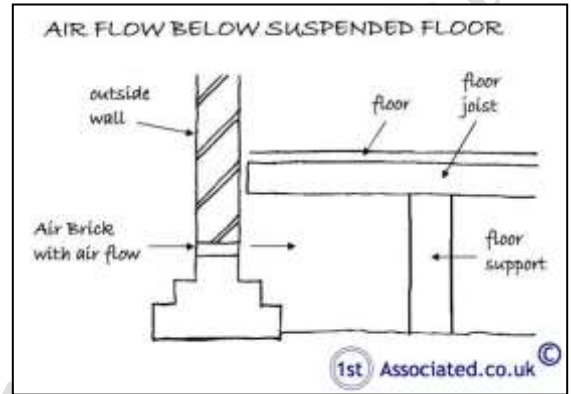
The original property will have a suspended timber floor and the rear kitchen/dining area extension has a solid floor. This is based upon us literally walking on the floor. A suspended timber floor requires air movement underneath to minimise wet rot, dry rot and woodworm.

Suspended timber floor

ACTION REQUIRED: Please see our comments within the Executive Summary where we advise about the lack of airflow underneath floor.

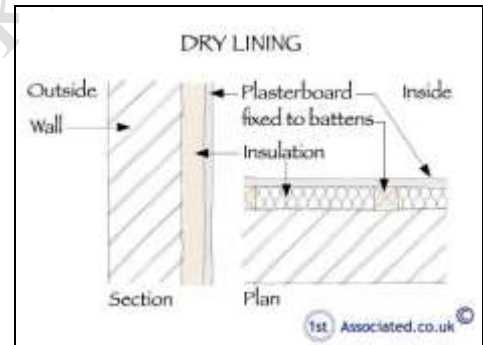
We used a damp meter on the external walls. We have not lateral found dampness but we were surprised that we didn't find it. We could not take readings in all the usual places because of the dry lining

Dry lining

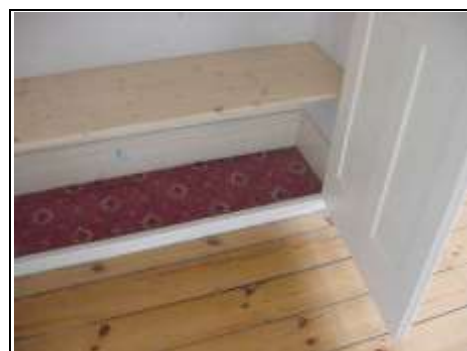
The property has built in cupboards which come in very handy. However please note our earlier comments with regard to the cracking in the built in cupboards.

Built in cupboards complete with a sample of the old carpet!

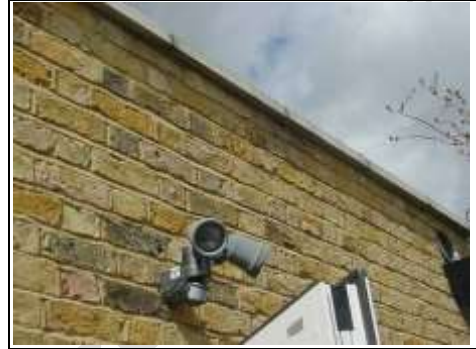
No security system was noted and no code was required for us to enter the property. It is a personal decision as to whether you feel one is necessary. We are not experts in this field and therefore cannot comment further except to say we would be more comfortable if there was a security system. We suggest you contact a member of NACOSS (National Approval Council for Security Services), obtainable through directory enquiries, or your local Police Force for advice on a security system.

Security lights

ACTION REQUIRED: We would recommend adding a security system particularly with the rear sliding, folding doors and the roof windows which may allow an intruder to gain access at first floor level or into the kitchen

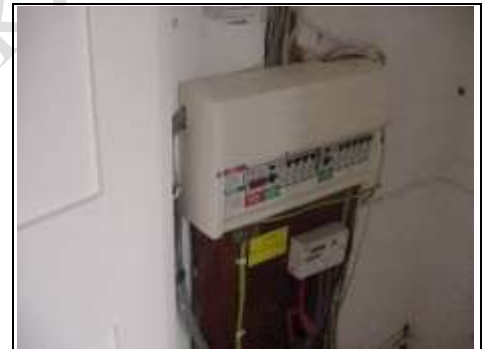
Fuse Board

The electric fuses and consumer units were located under the stairs. The fuse board looked dated 1970's, 1980's or possibly 1990's and better are now available.

ACTION REQUIRED: Upgrade the fuse board. Please see our comments within the Executive Summary.

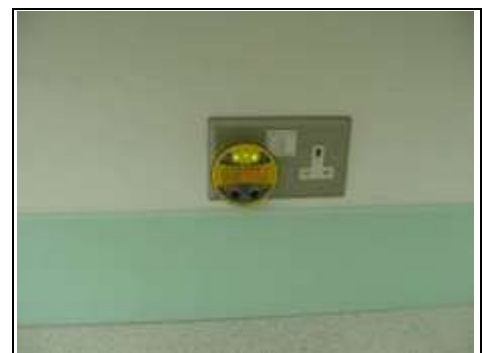
Earth Test

We carried out an earth test in the kitchen area to the socket point that is normally used for the kettle, this proved satisfactory.

ACTION REQUIRED: As the property is changing occupancy an Institute of Electrical Engineers (IEE) test and report should be carried out by a NICEIC registered and approved electrical contractor or equivalent.

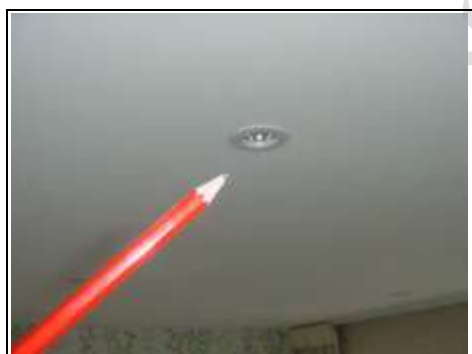
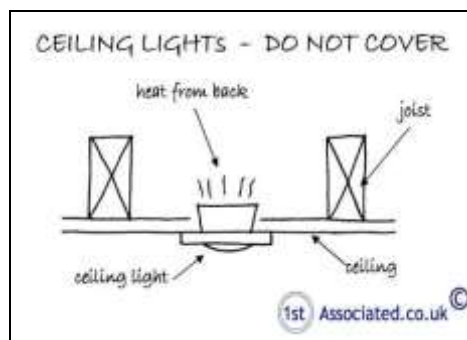
Ceiling lights

We still have concerns over this type of ceiling light where there is nowhere for the heat to escape to particularly the ceiling lights that are present in the room in the roof. There is a flat roof above them that is likely to become warm and we are unhappy with this combination. We recommended earlier that you form an access hatch in the flat roof to give access to the flat roof and it will also enable you to hopefully see the backs of these lights. We would then suggest that you get an electrician to check their condition and whether they are appropriate for here.

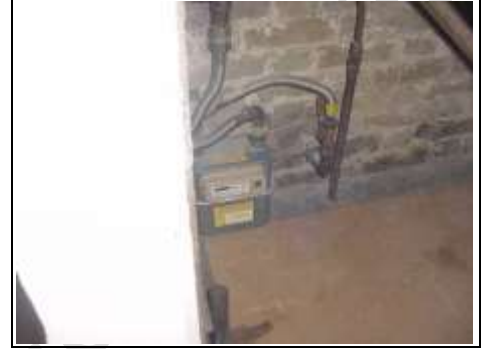
We are advised that the property has mains gas. The consumer unit is located under the stairs.

All gas appliances, pipework and flues should be the subject of an annual service by a competent engineer, i.e., a member of Gas Safe; works to gas appliances etc., by unqualified personnel is illegal. Unless evidence can be provided to confirm that there has been annual servicing we would recommend that you commission such a service prior to use to ensure safe and efficient operation.

ACTION REQUIRED: As a matter of course it is recommended that the entire gas installation is inspected and made good, as necessary, by a Gas Safe registered contractor. Thereafter the installation should be serviced annually.

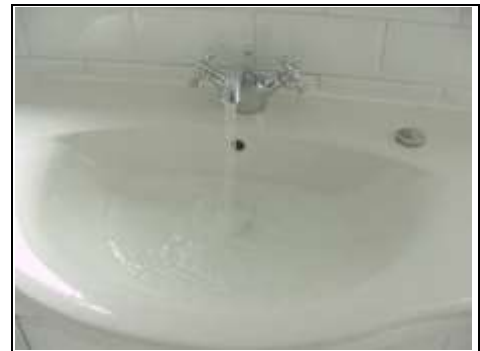
When the taps were run to carry out the drainage test we checked the pressure literally by putting a finger over the tap and this seemed average. The Water Board have to guarantee a certain pressure of water to ensure that things like boilers, particularly the instantaneous ones have a constant supply of pressured water (they would blow up if they didn't!).

Taps run in bathroom
(first floor)

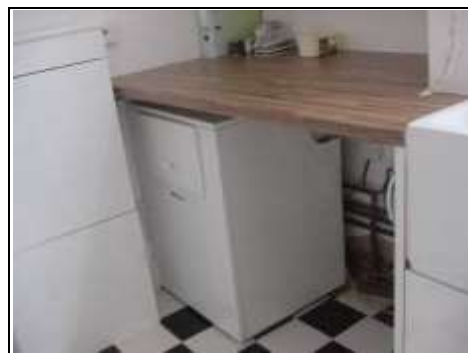
The Worcester floor mounted boiler was located in the utility room. You advised us that you were told it was new therefore a guarantee should be obtained on the boiler system. Our limited inspection of the hot water and central heating system revealed no evidence to suggest any serious defects but we would nevertheless recommend that the system be tested and overhauled before exchange of contracts and that a regular maintenance contract be placed with an approved heating engineer.

Floor mounted Worcester boiler

ACTION REQUIRED: Obtain a guarantee for the boiler system.

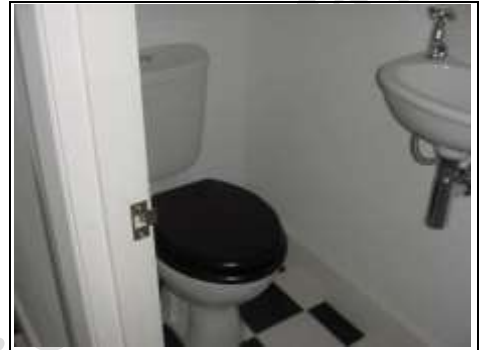
Cloakroom

There is a cloakroom on the ground floor off of the utility room. This is slightly on the small side but we always think it is better to have any ground floor W.C. than not.

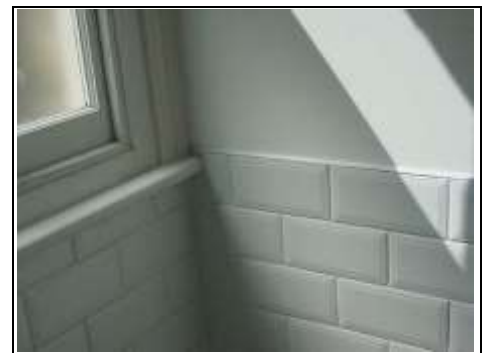
The property has a three piece bathroom suite, consisting of a bath, wash hand basin and WC, which looks in average condition.

Popular style tiles in first floor bathroom

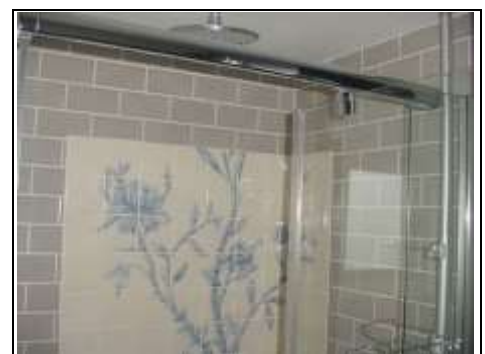
En –suite shower

We would comment that this is in as new condition.

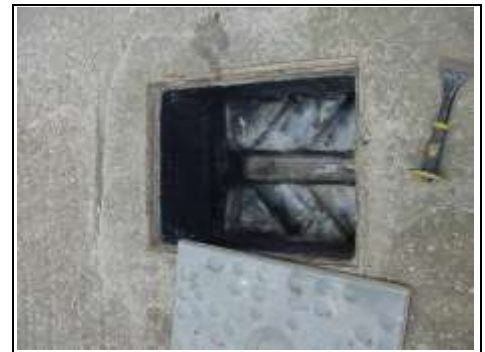
Manhole (right)

We duly lifted the cover and found it to be free flowing at the time of our inspection.

From what we could see it is plastic built.

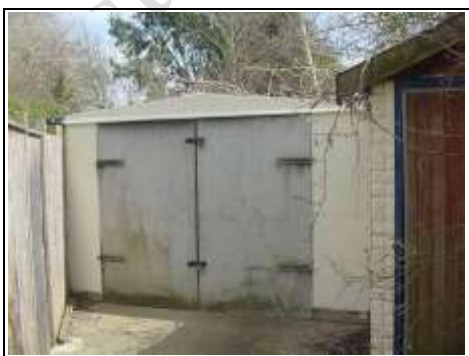
Garage

Old prefabricated garage with Asbestos roof

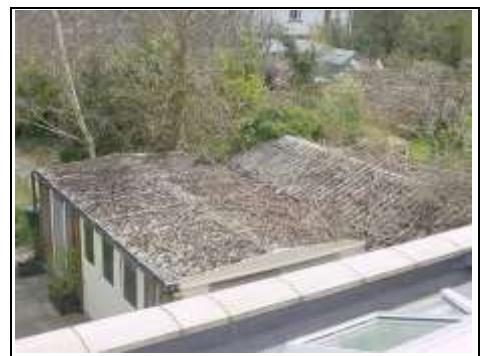
In a property of this age there may well be some asbestos. In this case we have noted Asbestos in the garage roof.

Asbestos roof on garage
