RESIDENTIAL BUILDING SURVEY

**Pinner Village
London
HA5**

**Prepared by:
INDEPENDENT CHARTERED SURVEYORS**

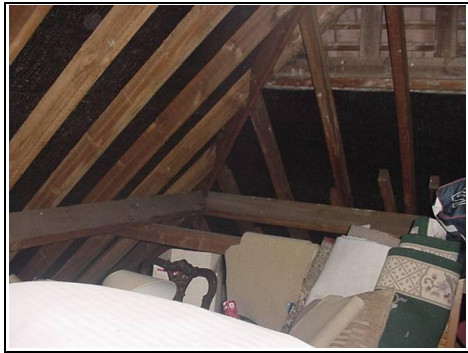
We can see there has been some movement both inside the hipped roof and externally we could see some tiles have moved.

Hipped roof movement inside

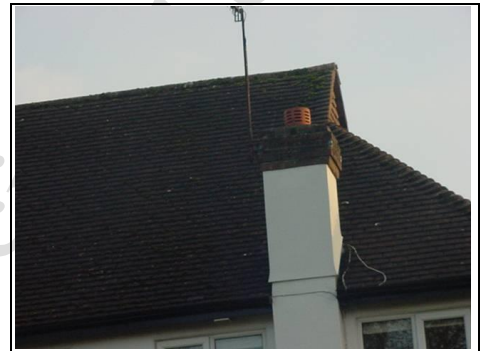
This chimney is brick built and finished in painted render with one chimney pot and an ariel. Aerials can damage chimneys, with the wiring that holds them on cutting into the chimney like cheese wire. We were unable to see the flashing. From what we could see from ground level the chimney looked in average condition considering its age, type and style. Unfortunately we were unable to see the top of the chimney, known as the flaunching, we therefore cannot comment upon them.

Chimney to rear

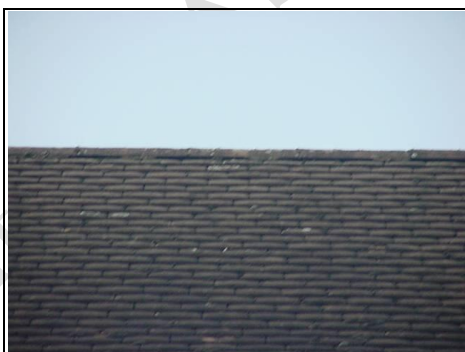
Slight opening up of tiles,
hog back ridge needs re-bedding

ACTION REQUIRED: Carry out periodic inspections and maintenance of the roof, as required.

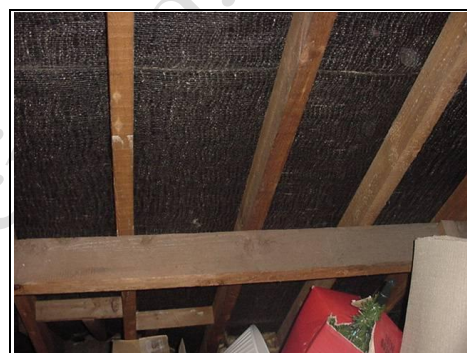
When we inspected the loft space we found a Hessian base Bitumen membrane. This type of membrane has been used since the 1960s. We generally found it to be in average condition, it is damaged in a few more places than we normally find.

This photo shows the common rafters (the ones that form the pitch of the roof) and the dark area between is the underlayer

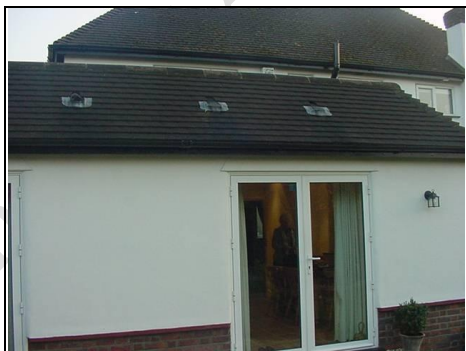
This roof has a pseudo-pitched roof to give the impression of being pitched but behind it is a felt flat roof that has been covered with shingle.

Pitched roof hiding flat roof

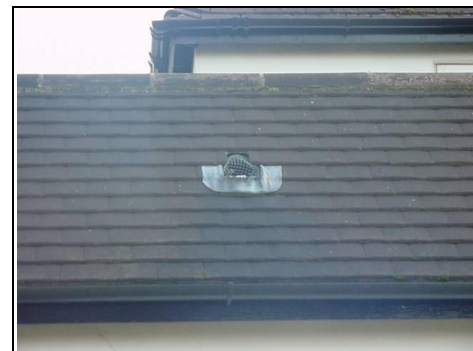
Close up showing drainage outlet

Flat roofs are renowned for problems, but this flat roof being relatively new looked in reasonable condition, with no large areas of moss growing on it from what we could see indicating that there are flat areas, but we did notice some minor blemishes internally to the kitchen area, which may indicate that there have been some problems with water getting in. In our question and answer session the owners advised us that there had not.

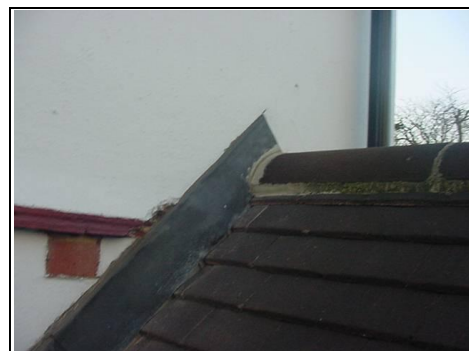
We were pleased to see that there was a flashing between the flat roof/pseudo pitched roof extension and the main building. This has been cut in the form of a lead flashing. We feel the lead flashing, providing they are put in correctly, are the Rolls Royce of flashing materials.

Lead flashing

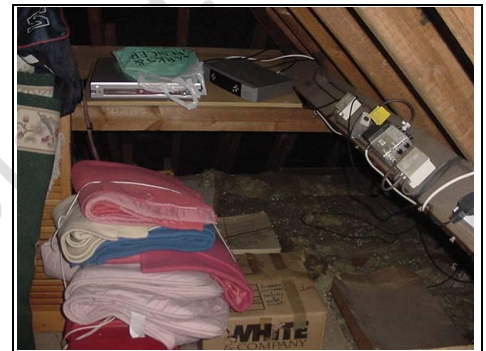
There were lots of stored items in there which limited our view.

Mass of stored items

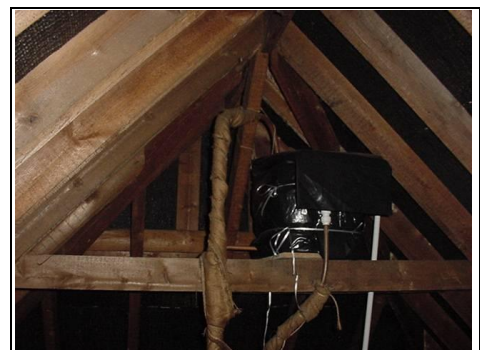
We can see a plastic water tank.

Plastic water tank

We would always recommend that water tanks be drained down and cleared of any debris etc. (we have seen dead birds and other unmentionable things in these tanks). As you are cleaning your teeth with this water it is best that it is as clean as possible!

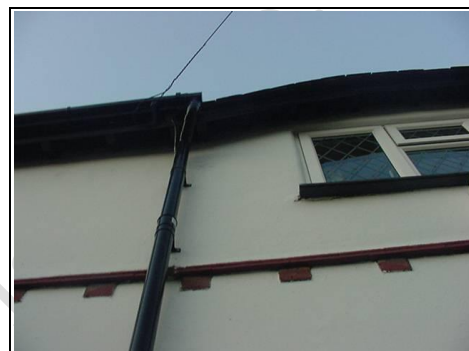
The property has plastic gutters and downpipes which appeared in average condition. There may be some minor leaks, but we feel that most people could live with these.

Plastic gutters and downpipes

We would always recommend that the gutters and downpipes are cleaned out, the joints are checked and the alignment checked to ensure that the gutters fall towards the downpipes.

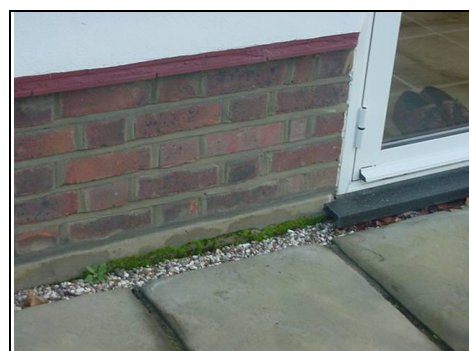
We believe the flat roof outlet overflows the gutter below and causes dampness to the rear of the kitchen/dining room area.

Dampness to the rear in the kitchen /dining area

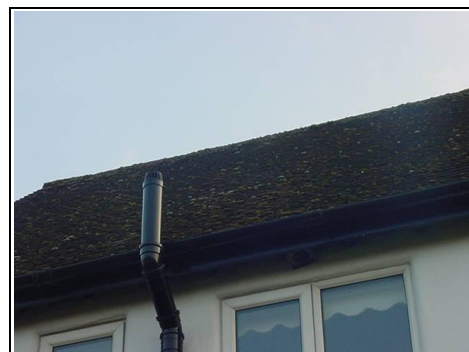
The property has plastic soil and vent pipes.

The property originally had cast iron gutters and downpipes and soil and vent pipes and there may be elements of this remaining. If there are then these need to be redecorated and maintained, though we would add that cast iron usually lasts far longer than plastic.

Plastic soil and vent pipe

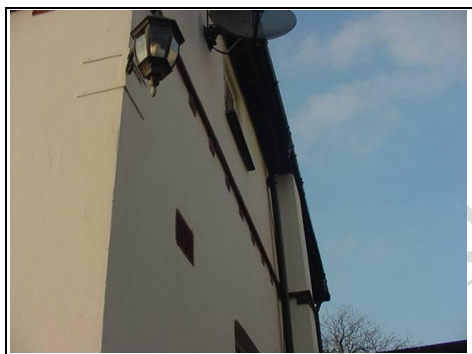
The external walls are rendered. We are always wary when we see rendered properties as it usually means they have been rendered for a particular reason.

Painted render

In this particular case we believe it is part of the original aesthetics and we would consider the render to be in average condition.

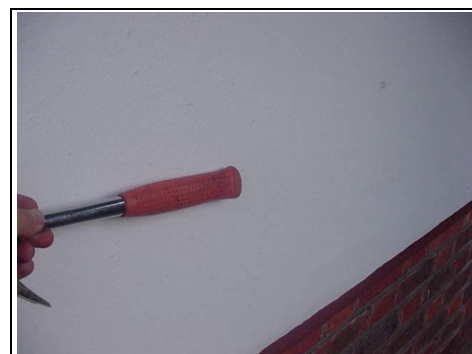
We have carried out a tap test to the render at low level (literally hitting the render with the back of a hammer to try to establish if there are any hollow areas in it) and we feel in this instance that the render is in average condition for its age, type and style.

Hammer test on walls

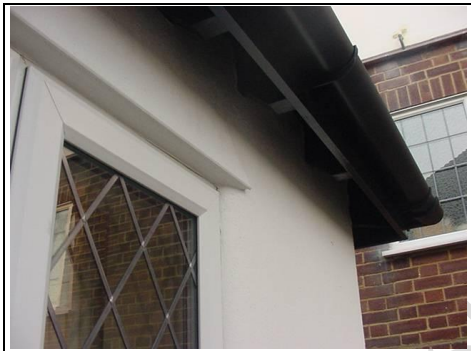
Drip detail over window

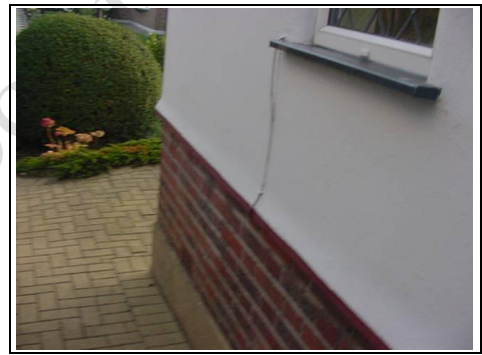
Drip detail to base of the render

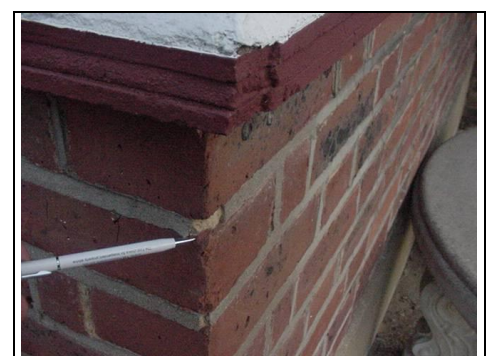
There is a small area of brickwork beneath the render which is in a Stretcher Bond brick, bed originally in a lime mortar which has been repointed in a cement mortar.

Brickwork, originally it would have been pointed in a lime mortar but has been repointed in cement mortar (see sketch below)

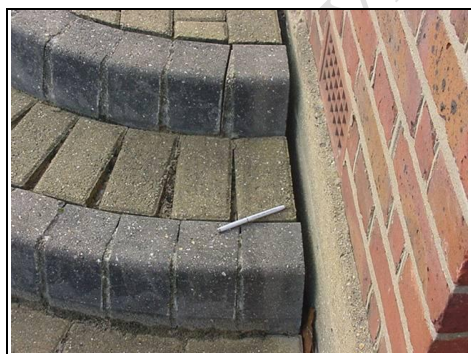
There are various signs around the property that indicate there has been some movement. We believe that some of them relate to the pavement moving away from the building, which we show in the three photos below. There has also been some movement in the property as a whole, which can be seen in the concrete around the building.

Path breaking up to front of property

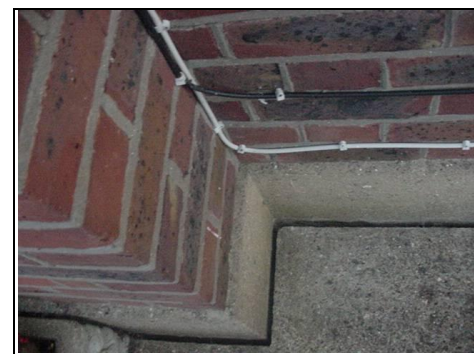
Movement between concrete and wall

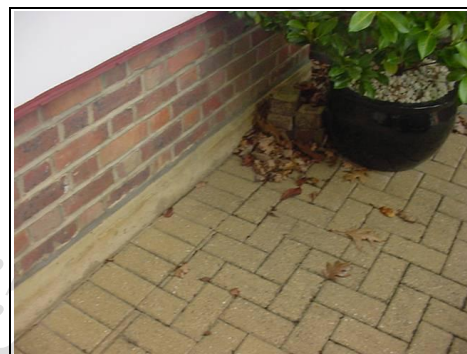
All modern properties should incorporate a damp proof course (DPC) and good building practice dictates that a differential of 150mm (6 inches) should be maintained between the damp proof course and ground levels. In this case cannot physically see a DPC as there is a plinth around the perimeter of the property. In this age of property we would expect the DPC to have been built in.

Plinth around perimeter of property

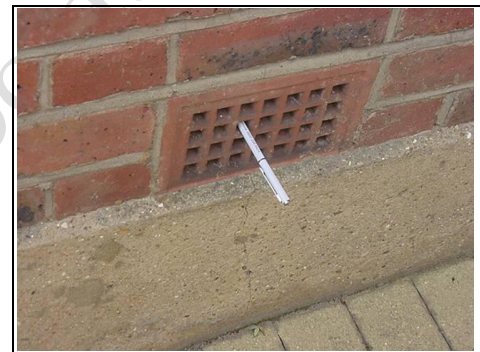
These indicate there is a suspended timber floor in parts of the property. You need to ensure that these air bricks are clear, which they were in the areas seen.

Air brick

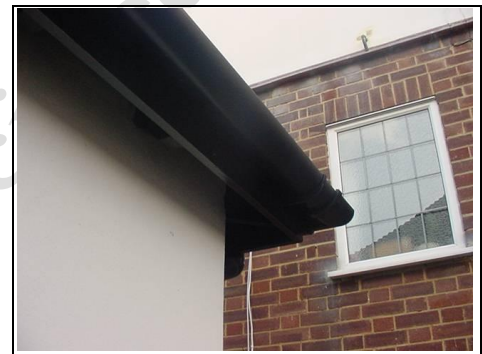
The fascias and soffits are painted timber and we would comment they are in average condition for their age, type and style.

Timber fascia and soffit

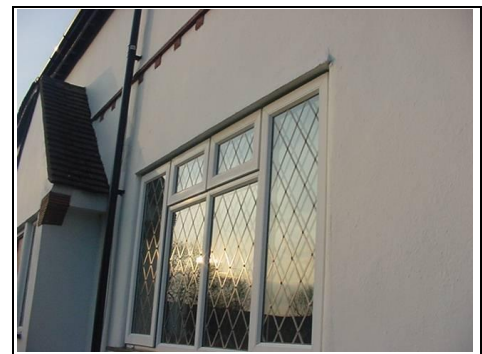
The property has plastic double glazed windows, which generally look to be of a reasonable quality. We would draw your attention to the fact that sealed double glazed units can fail, particularly as a result of poor workmanship during installation. Failure of the seal leads to condensation between the two panes of glass and simply replacing the affected units may not provide a satisfactory long-term solution. In this case there were no trickle vents.

Double glazed windows

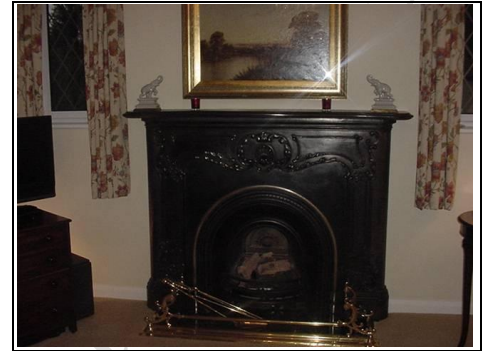
At the time of the survey no chimneys were in use. Any chimneys that you do not propose to use should be capped and ventilated to prevent dampness.

Fireplace

It is strongly recommended that flues be cleaned and checked for obstructions prior to use to minimise the risk of hazardous fumes entering the building.

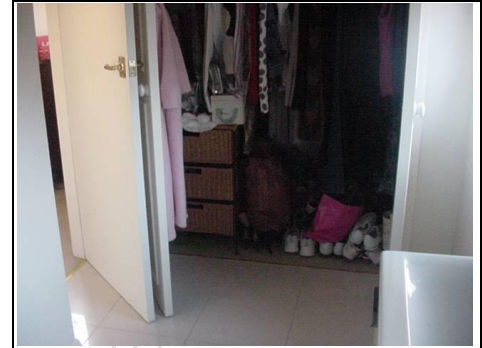
The doors are painted flush doors.

Painted flush door

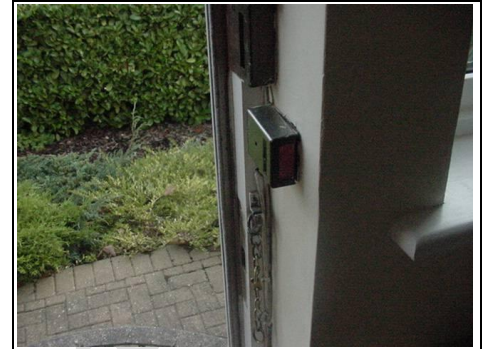
A security system has been installed and is located in the hallway cupboard. A good alarm system should not only help reduce break-ins but also your insurance. We are not experts in this field and therefore cannot comment further. Further information should be obtained from the vendor and the installer at a later date.

Panic alarm

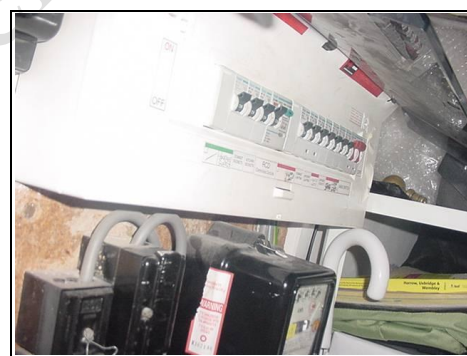
The electric fuses and consumer units were located under the stairs. The fuse board looked to be from the 1980's/1990's and better fuse boards are now available.

Fuse Board

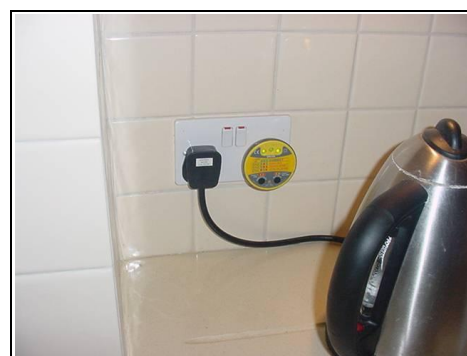
We carried out an earth test in the kitchen area to the socket point that is normally used for the kettle, this proved satisfactory.

Earth Test

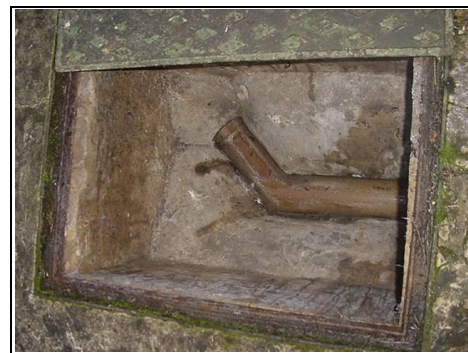
Manhole to front middle

We duly lifted the cover and found it to be free flowing at the time of our inspection.

From what we could see it is lined with concrete.

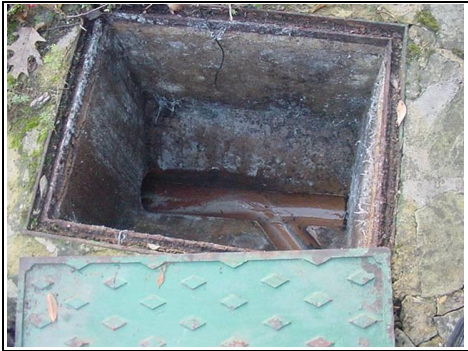
Front manhole

We duly lifted the cover and found it to be free flowing at the time of our inspection.

From what we could see it is it is lined with concrete.

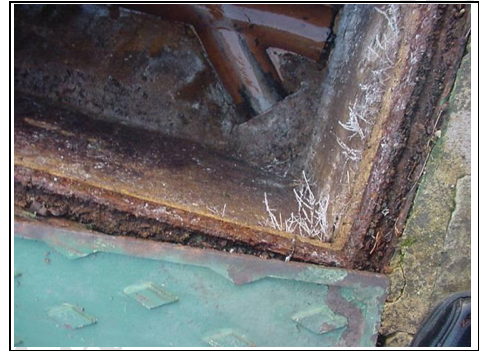
Tree roots in drain

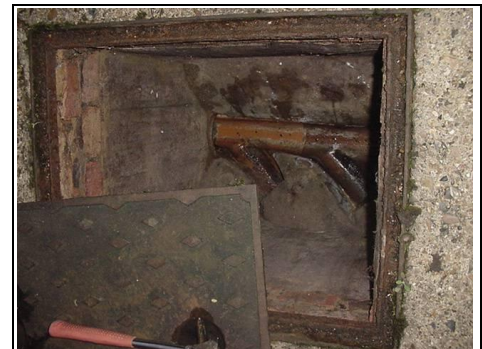
Rear left hand side manhole

We duly lifted the cover and found it to be free flowing at the time of our inspection.

From what we could see it is it is lined with concrete.

ACTION REQUIRED: You need to have a closed circuit TV camera report in this area due to the cracking that we can see above.

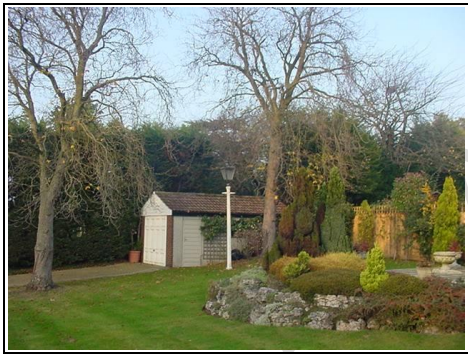
There is a pre-fabricated concrete garage. We often find with these that as they get older the reinforcement in them rusts and starts to break the garage up. There are so many tools and other equipment in the garage (including a car, which we very rarely find) that it is was difficult to view properly.

Garage

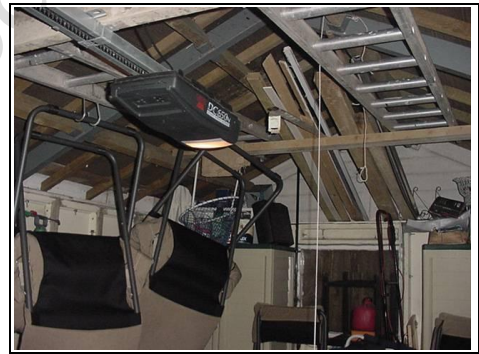
Inside of garage

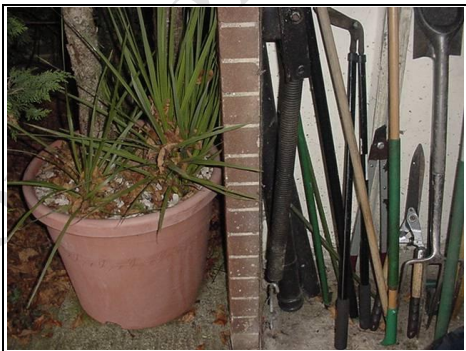
Tools inside garage

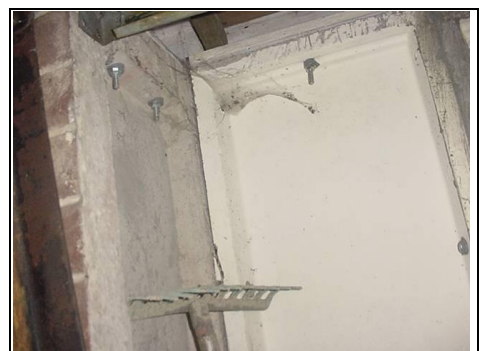
Inside of garage

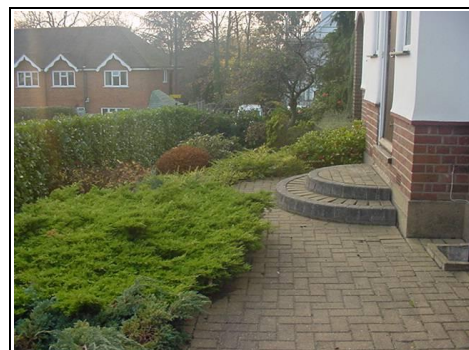
The front garden is on a sloping site.

Sloping front garden

ACTION REQUIRED: Please see our comments in the Executive Summary about the pavement, etc, dropping away.

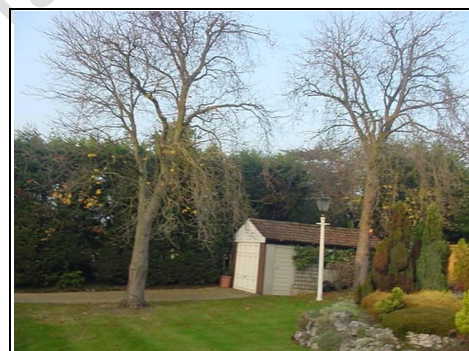
Reasonable sized garden with landscaped areas and mature trees.

Rear Garden

ACTION REQUIRED: Please see our comments about the trees requiring maintenance.

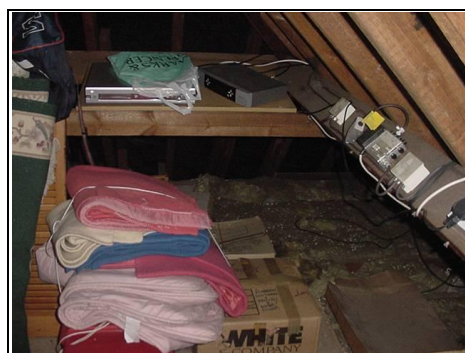
- 1.1 the mass of stored items in the roof
- 1.2 suspended timber floors on the ground floor not being opened up, and
- 1.3 not having full access to the flat roof area as there was no hatch here, as is common.

Mass of stored items in roof limited our view
