RESIDENTIAL BUILDING SURVEY

Sheffield

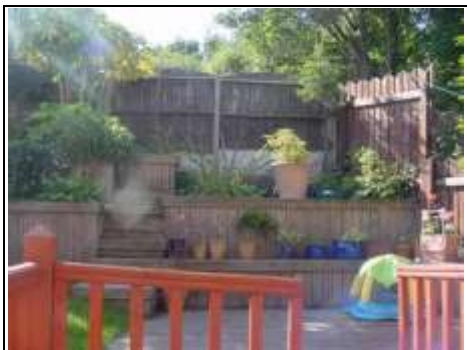
The property sits on a sloping site which means that any rainwater or ground water needs to travel from the top of the plot to the bottom.

Sloping site

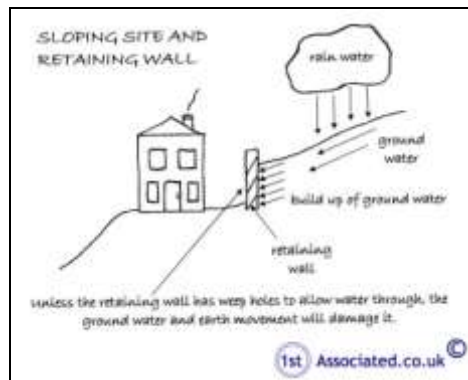
We were unable to see the rear wall of the property properly due to the dry lining.

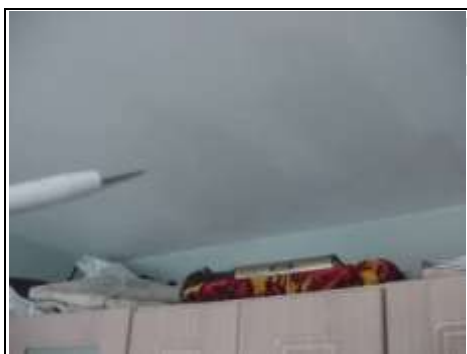
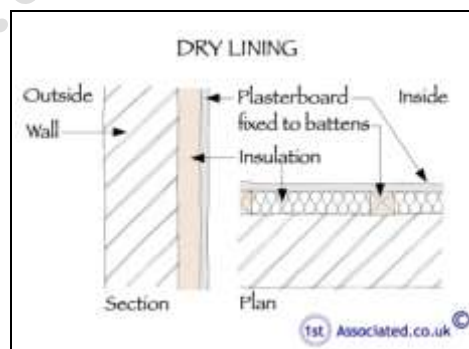
We were unable to see the rear wall of the utility room as it is dry lined. Note: also repainting of ceiling may be hiding dampness coming in identified by the pen

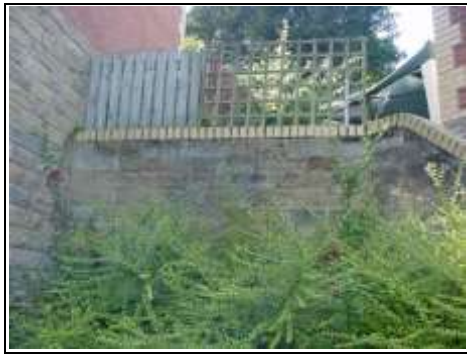
We can however see that the rear retaining wall to the right hand side (strictly speaking this may not be all in your property but it is the best we have to look at) would benefit from weep holes to allow water to pass through it rather than build up pressure behind it. We can only make assumptions as to whether the same thing is occurring to the rear wall unless we open it up. There is no obvious smell in these rooms of dampness but we are well aware there were a lot of stored items in these rooms.

Retaining wall on right hand side

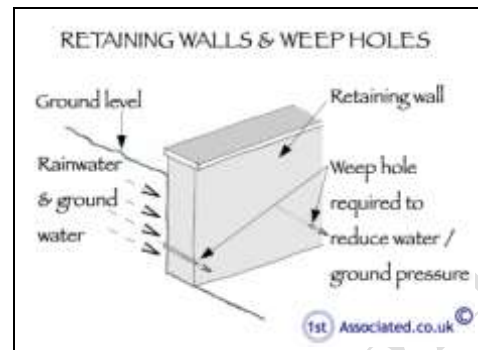
Rainwater travelling from the top of the sloping site to the bottom

ACTION REQUIRED: We would recommend a French Drain or running gully around the property to allow rainwater to pass around the building rather than through it. This, providing there haven't already been any problems caused, will reduce any dampness in the property.

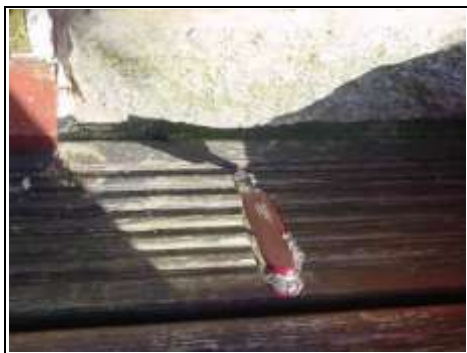
Mould on stonework

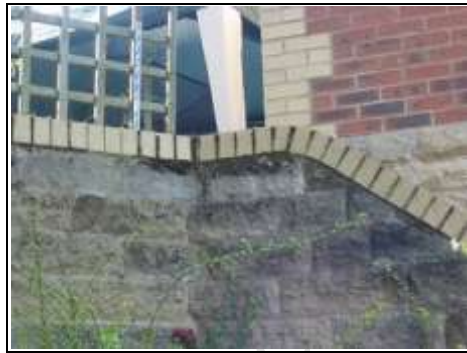
Moss appearing on brickwork and top of stone of retaining wall

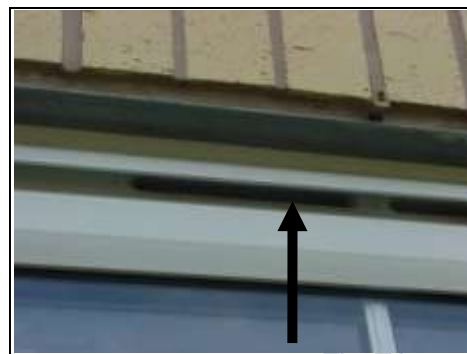
Trickle vents allow a trickle of air through, therefore stopping/reducing the likelihood of condensation occurring within the property.

Trickle vent

ACTION REQUIRED: Large extract fans with humidity controlled thermostats to be installed within the kitchens and bathrooms which are moisture generating areas.

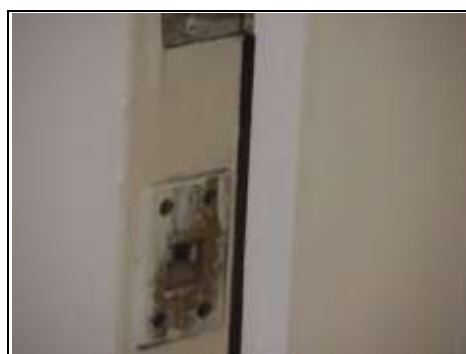
We also noted doors to the staircase had their door closers removed (known generically as Perco door closers which is their trade name) or have broken and not been replaced. We talk a bit more about the fire risk in the next section.

Perco door closer

ANTICIPATED COST: Replace the door closers which are likely to be a few hundred pounds or a few thousand pounds if you wish to put a fire alarm system in; please obtain quotations.

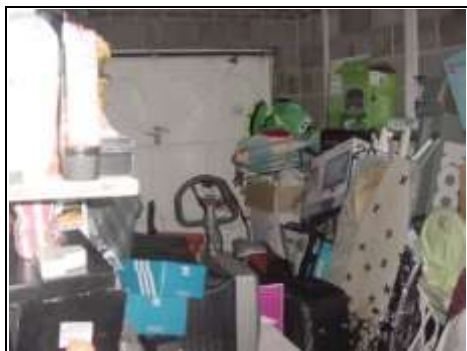
This house has far more stored items than we usually see in a property. In fact the garage has probably got our record for the fullest garage that we have seen this year but equally there were items placed against many of the walls.

Garage completely blocked

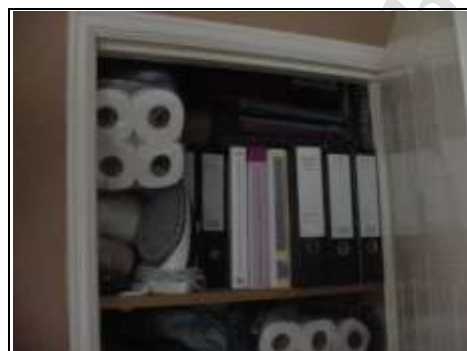
Stored items

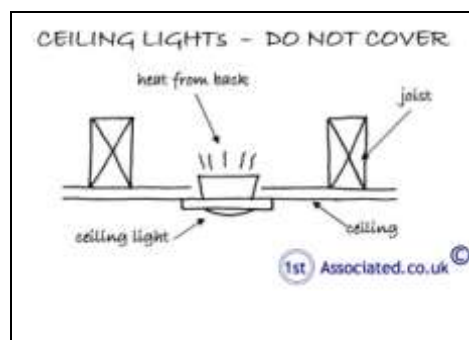
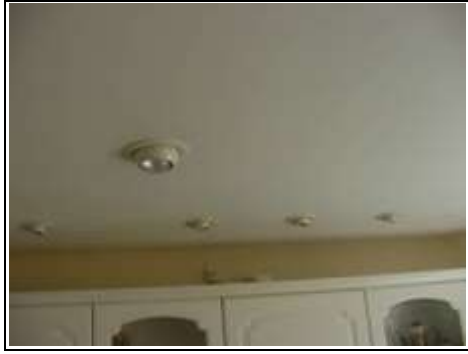
The property has electric lights to the ceiling in a variety of ages. In some instances these ceiling lights can cause problems as the heat given off has in some cases lead to outbreaks of fire; these tend to be in the older type of ceiling lights and we recommend that where ceiling lights are used that the rear of the light is not covered; this is particularly the case in rooms with a loft space above it where stored items are placed in it.

Ceiling lights in kitchen

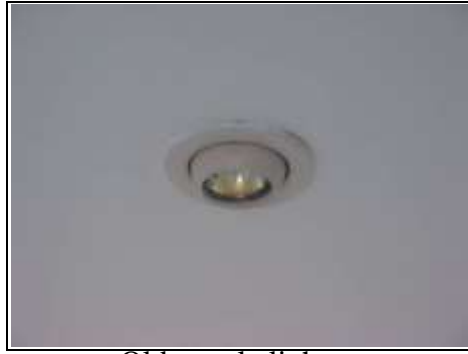
Older style lights

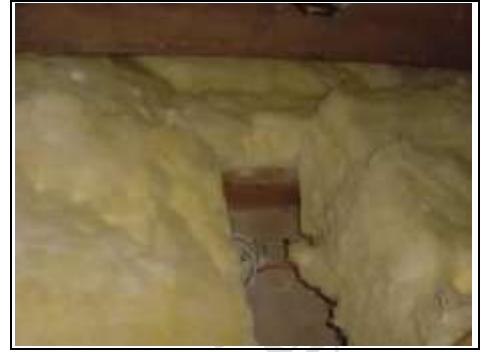
Gaps where lights are is good but shouldn't be covered further

ACTION REQUIRED: Check when putting stored items into the roof that you do not cover the lights

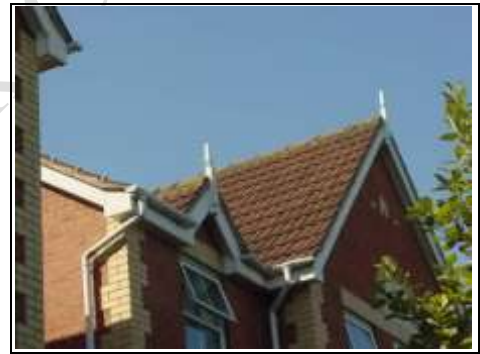
Main roof

As is the case with most three storey buildings the roof is quite difficult to see particularly to the front in this case. What we can see is a pitched and gabled roof clad with a concrete tile and, from ground level, this looks in average condition from a limited view, considering the roofs age type and style. There is some slight mossing on the ridge and also to the fascias and soffits.

ACTION REQUIRED: Carry out periodic inspections and maintenance of the roof, as required. Potential problems are blocking up of the gutters and the valley gutters. Please see below.

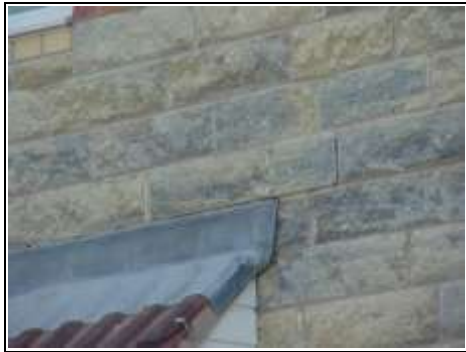
There is a single storey pitched roof over the entrance porch/garage which is clad in concrete tiles with a lead flashing. The flashing was coming away.

Flashing coming out

ACTION REQUIRED: Re-fix lead flashing using plumb mate.

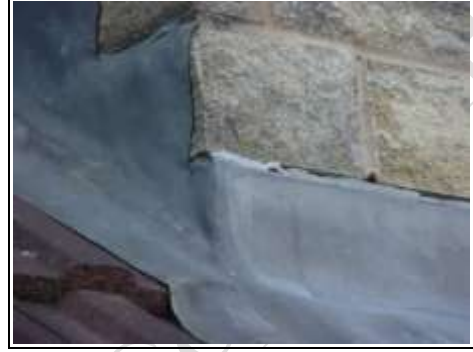
Close up of flashing

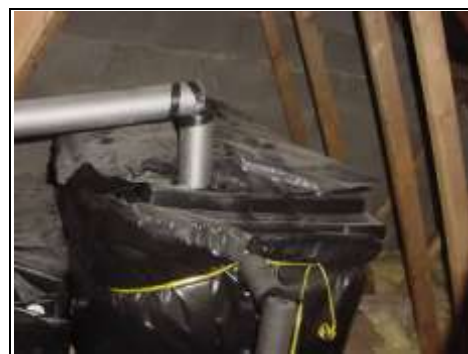
Water tank

There was a plastic insulated water tank.

We would always recommend that water tanks be drained down and cleared of any debris etc. (we have seen dead birds and other unmentionable things in these tanks). As you are often cleaning your teeth with this water it is best that it is as clean as possible!

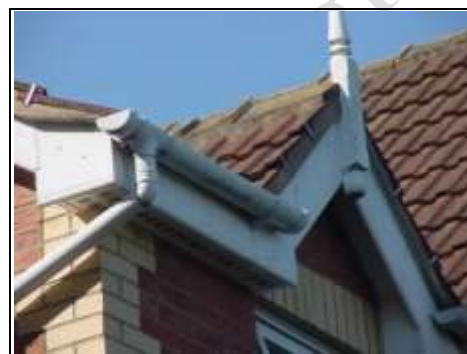
Gutter and downpipe

We noted that the rainwater goods discharge directly into the ground, a practice that we are not keen on as they are often prone to blockages. Ideally, they should be changed to a gully system.

We would also recommend that the gutters and downpipes are cleaned out, the joints are checked and the alignment checked to ensure that the gutters fall towards the downpipes.

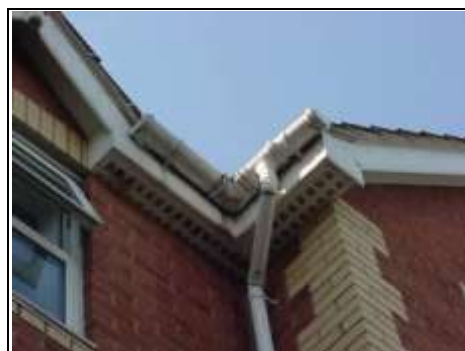
The fascias and soffits are timber and are vented. There is a possibility they are overclad which is unusual on such a new property although from what we can see from the small fixings it does look like they are possibly overcladding a timber fascia and soffit. A way of testing them is to drill through them to see if there is wood underneath. If there is wood underneath, then we would recommend they are replaced. If you do find they are timber, please contact us and we will explain further our thoughts behind this.

Unusual vent in fascia

ACTION REQUIRED: Make sure gutters and downpipes are watertight before carrying out any work on fascias and soffits.

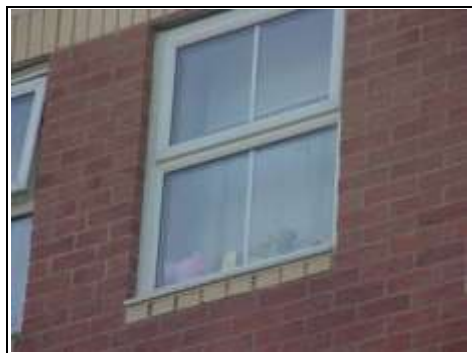
Front window

The property has plastic double glazed windows with trickle vents and small window sills, which generally look to be of a average quality. The window sills surprised us as they effectively mean that any water from the window that runs down the window to the sills then drips against the brickwork so we believe in the long term there will be pattern staining and possibly moss beneath the windows.

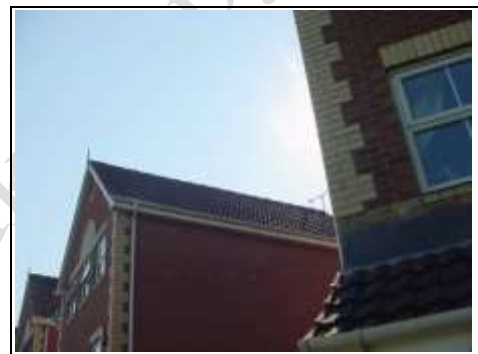
The chimney breasts are located to the right hand side (all directions given as you face the front of the property). They are a feature; if you look at the right hand side of the property you will see there is no chimney or chimney breast relating to the fireplace.

No chimney or chimney breast
on right hand side

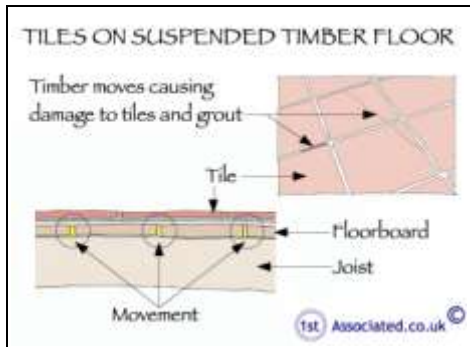
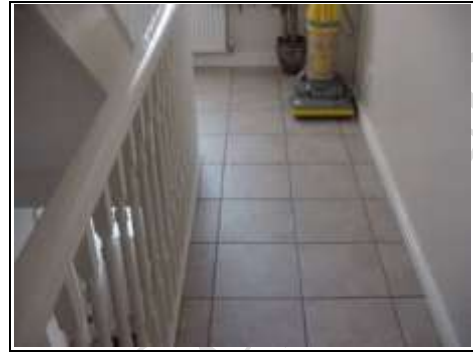
We noted tiles were laid on wood at first floor level and also in the bathrooms and the kitchen.

Tiles on landing

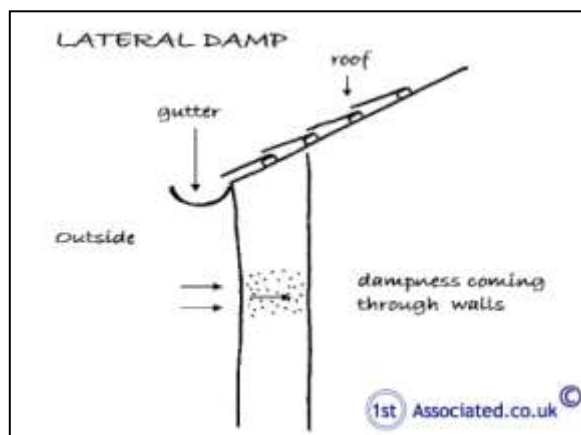
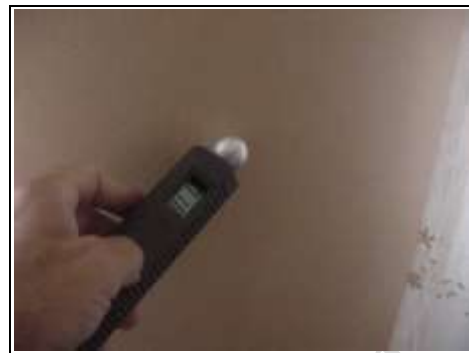
Again, we were unable to check for lateral dampness due to the dry lining. Once again, we are concerned that

dampness may be getting in to the rear of the property.

Check for lateral dampness not possible due to dry lining

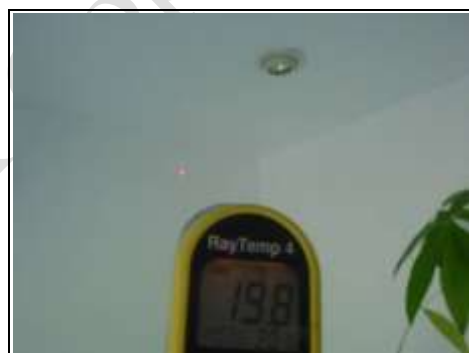
At the time of the inspection there were signs that this property would get condensation when occupied. We took surface temperature readings and these were in line with what we would expect.

Surface temperature reading

A way of helping to reduce condensation is to have good large extract fans with humidity controlled thermostats within the kitchens and bathrooms which are moisture generating areas.

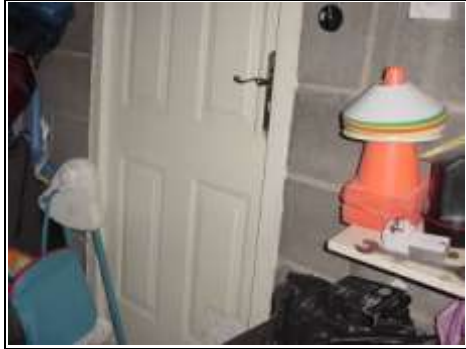
The property has modern hollow core doors known as egg box doors.

Hollow core door

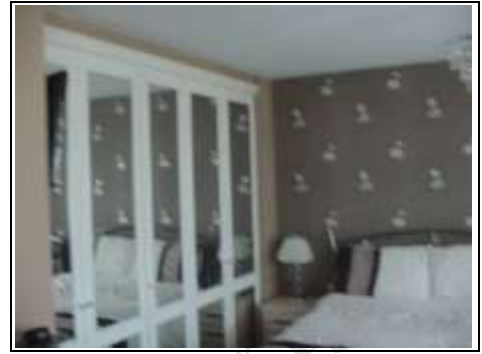
We were pleased to see built in cupboards in some of the bedrooms, something that many modern properties do not have.

Built in cupboards to master bedroom

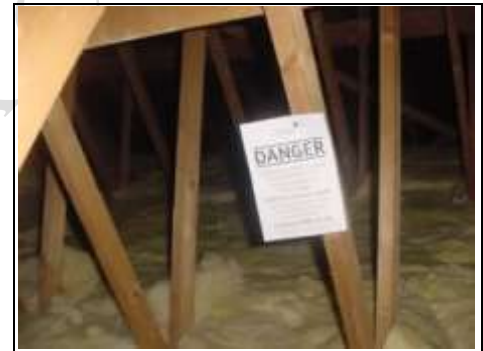
Some roof insulation was present although not to current Building Regulations requirements of 300mm.

Mass of insulation

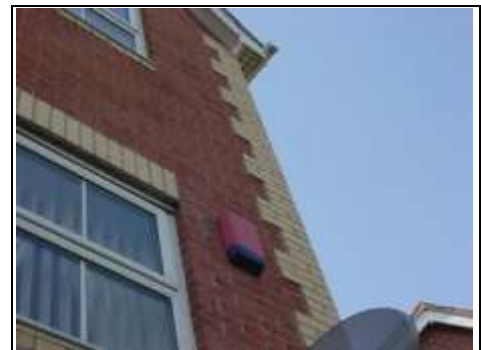
A security system has been installed. A good alarm system should not only help reduce break-ins but also reduce your insurance. We are not experts in this field and therefore cannot comment further.

Alarm

ACTION REQUIRED: Further information should be obtained from the vendor and the installer at a later date.

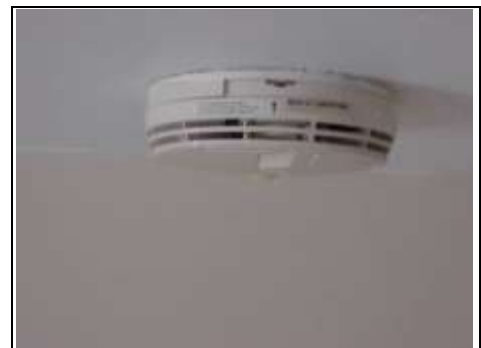
Some smoke detectors were noted. The current Building Regulations require that they be wired into the main power supply. Obviously in a property of this age this is difficult, as it would mean having surface mounted wires or cutting wiring into the plaster.

Smoke alarm

ACTION REQUIRED: We would recommend, for your own safety, that smoke detectors be installed. We would always recommend a hard wired fire alarm system and are also aware that some now work from a wireless signal which may be worth investigating. Whilst fire is relatively rare it is in a worst case scenario obviously devastating.

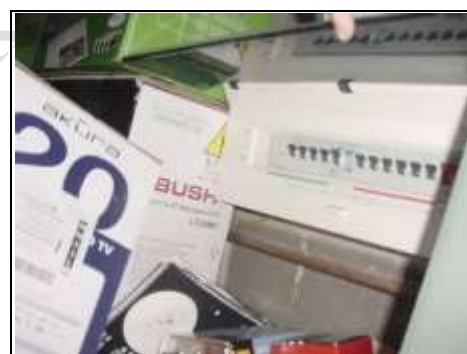
The electric fuses and consumer units were located in the garage. The fuse board looked original from when the property was built in the 1980's/1990's and better are now available.

Fuse Board

ACTION REQUIRED: As the property is changing occupancy an Institute of Electrical Engineers (IEE) test and report should be carried

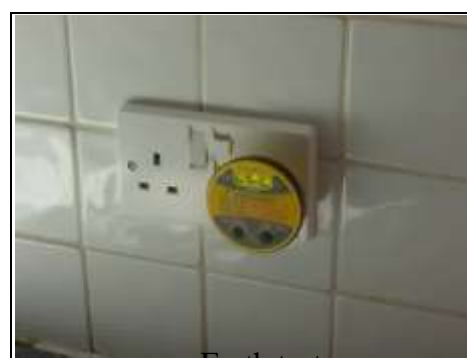
We carried out an earth test in the kitchen area to the socket point that is normally used for the kettle, this proved satisfactory.

Earth test

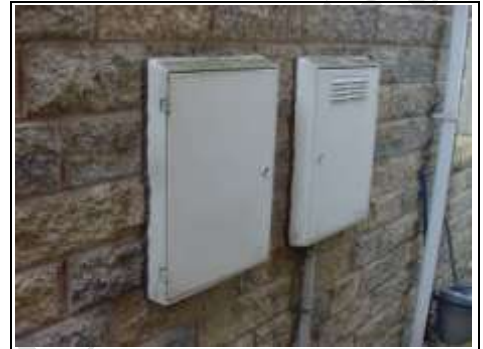
We are advised that the property has mains gas. The consumer unit is located on the left hand side of the property.

Gas meter

ACTION REQUIRED: As a matter of course it is recommended that the entire gas installation is inspected and made good, as necessary, by a Gas Safe registered contractor. Thereafter the installation should be serviced annually.

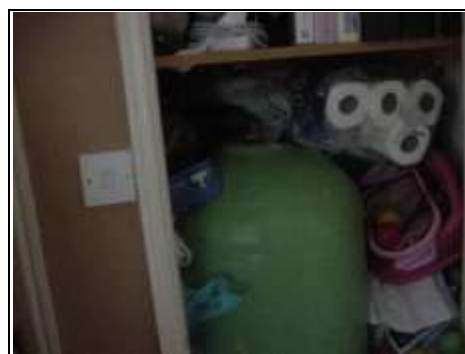
There is a factory insulated hot water cylinder. This cylinder will therefore have a good thermal efficiency, although not as good as the more modern hot water cylinders.

Factory insulated cylinder

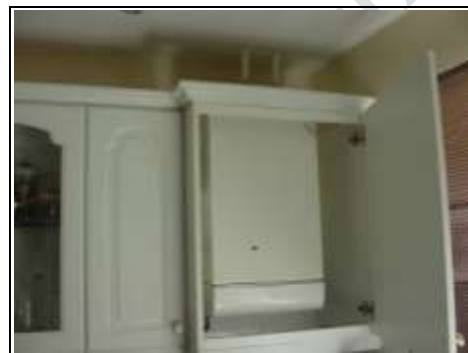
The boiler was located in the kitchen; it is an Ideal Standard wall mounted boiler.

Our limited inspection of the hot water and central heating system revealed no evidence to suggest any serious defects but we would nevertheless recommend that the system be tested and overhauled before exchange of contracts and that a regular maintenance contract be placed with an approved heating engineer.

Boiler

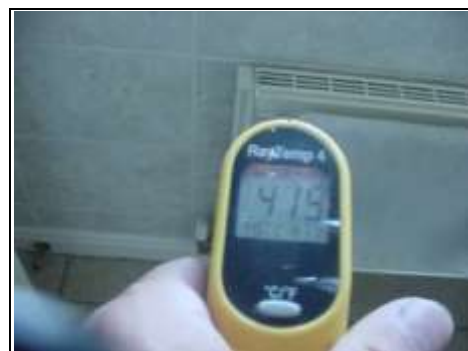
The owner / occupier at our request turned on the heating for approximately ten minutes. We checked the radiators in the en-suite bathroom to the master bedroom and these were warm.

Heating working

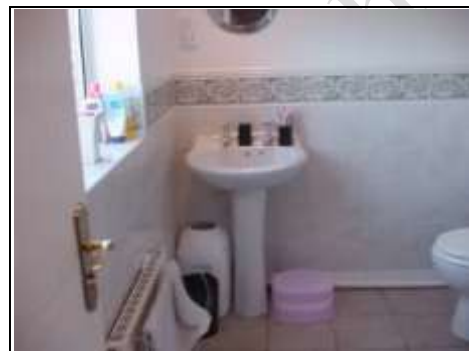
En-suite to master bedroom

The en-suite to the master bedroom comprises a shower, wash hand basin and WC. We believe the shower is leaking.

ACTION REQUIRED: Please see our comments in the Executive Summary.

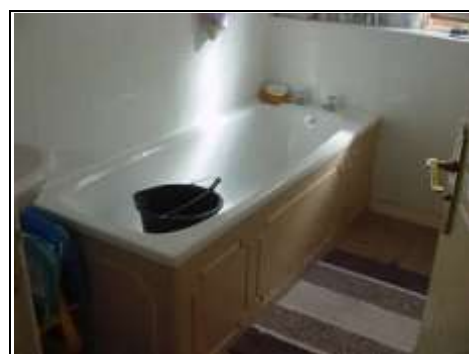
Bathroom

The property has a three piece bathroom suite, consisting of a bath, wash hand basin and WC, which looks in average condition, subject to some day-to-day wear and tear, as one would expect.

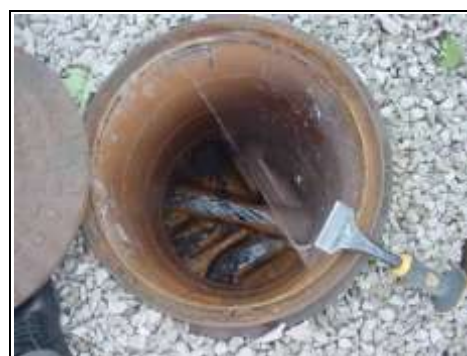
Manhole one

We duly lifted the cover and found it to be free flowing at the time of our inspection. From what we could see it is plastic.

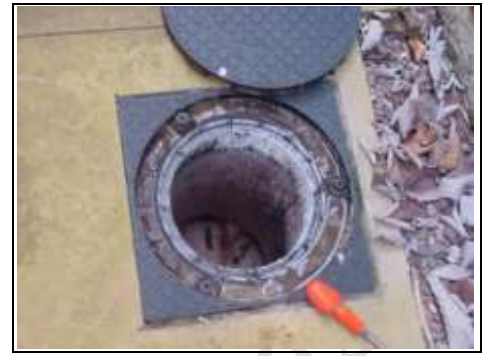
Rodding eye

We duly lifted the cover and found it to be free flowing at the time of our inspection. From what we could see it is plastic.

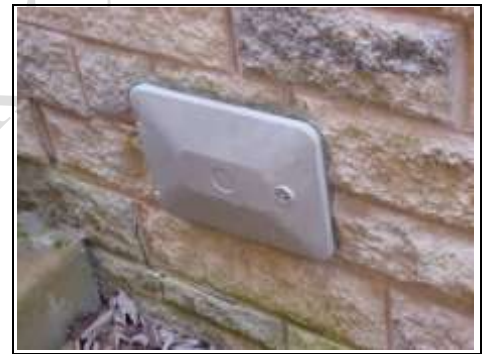
Water meter

We were unable to open this as the owner couldn't find a key but we believe it is a water meter.

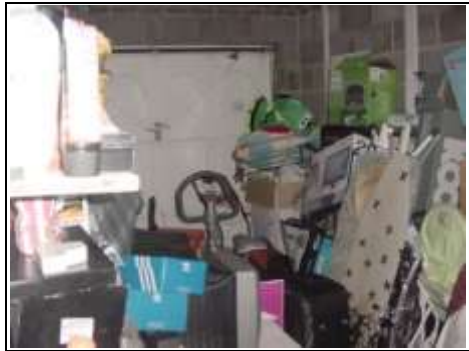
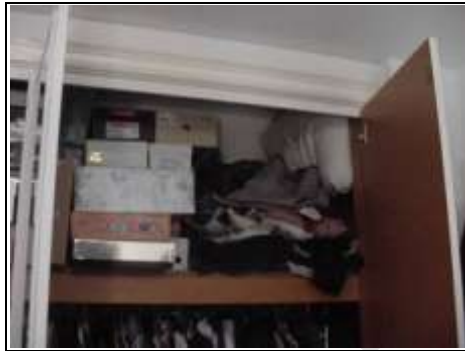
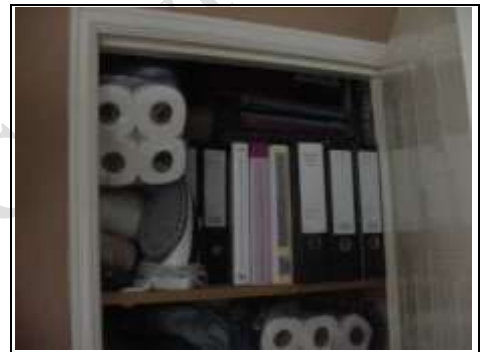
Unfortunately in this instance our inspection has been very limited due to lots of stored items throughout the property and a mass of insulation within the roof. We didn't open up the ground floor, first floor or second floor. We didn't have the benefit of meeting you at the property to talk about your specific requirements which always helps us. We would add to this that we were accompanied by the occupier during the entirety of the survey.

Garage completely blocked

Stored items
