RESIDENTIAL BUILDING SURVEY

CAMBRIDGESHIRE

**Non-traditional
Modern
Semi-detached**

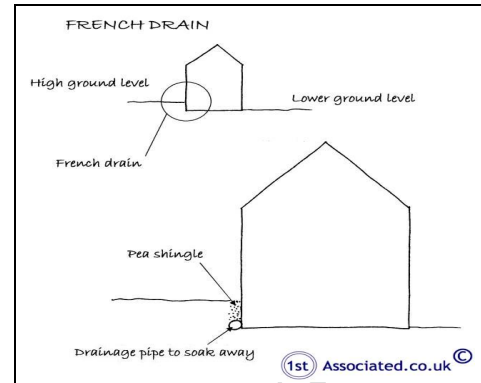
There are French drains around part of the property, that from our investigations have not been constructed correctly.

Digging up French drain to front left hand side

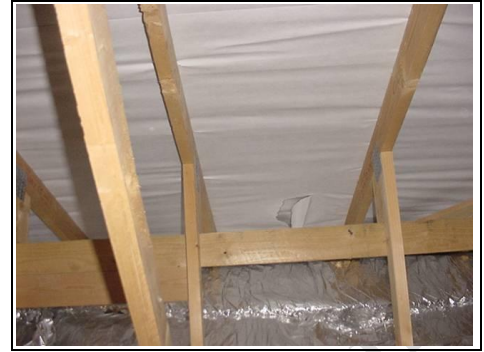
When we inspected the loft space we found a modern breathable underlayer. This type of sarking felt, as far as we are aware, has been used since 2002. It allows air flow in the loft to help prevent condensation.

This photo shows the common rafters (the ones that form the pitch of the roof) and the dark area between is the underlayer.

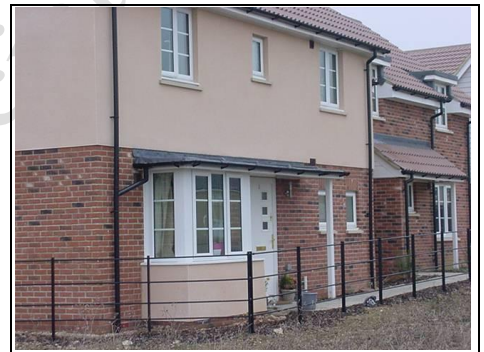
Front bay window roof

There is a small bay window roof to the front that looks to be lead which we feel is one of the better materials for a flat roof although it is rarely used on modern constructions so we were surprised to see it. We were pleased to see it has guttering around it.

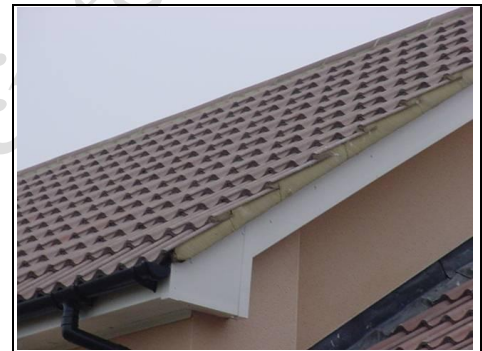
Fascias and soffits

The fascias and soffits are plastic and are in reasonable condition.

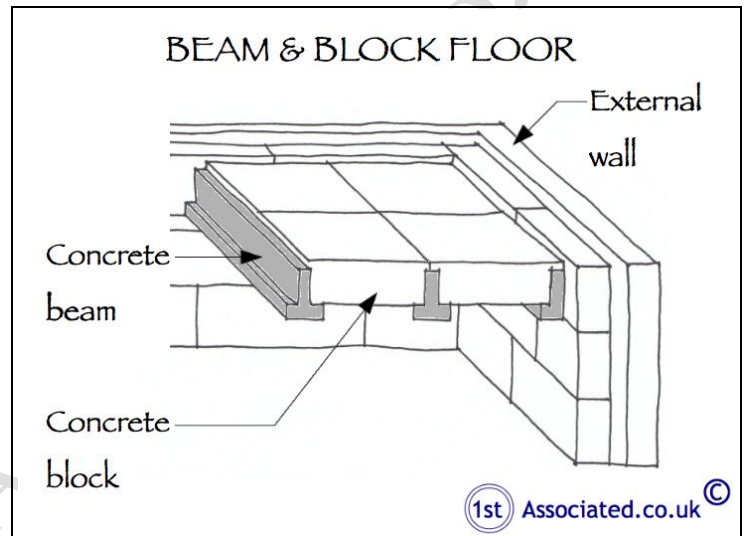
Please refer to our comments in the Executive Summary where we show the dampness in the ground floor kitchen area. Equally this could be occurring in other areas.

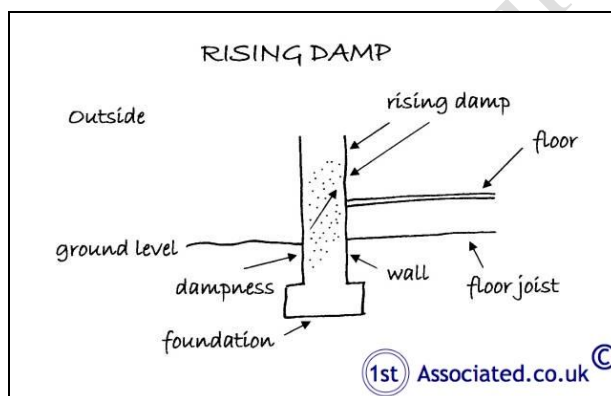
The property has a damp proof course but this is lower than we would expect.

ACTION REQUIRED: We would like to see Building Regulation approval certificates in relation to the way this building has been constructed.

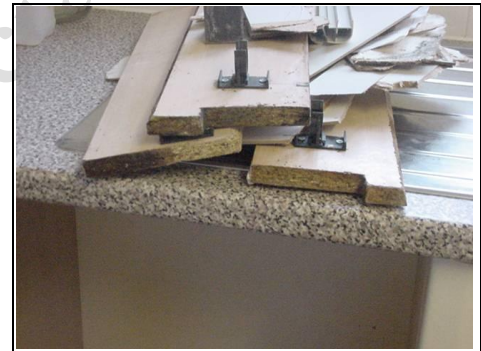
From our cursory visual inspection, generally the kitchen looked in generally average condition although obviously there are problems with the dampness to the base of the kitchen which you can see in the photo.

Kitchen unit affected by dampness

ACTION REQUIRED: Take a sample of the moisture to the floor and chlorine test to check whether it is a leak from the pipes.
