RESIDENTIAL BUILDING SURVEY

Milton Keynes. MK17

INDEPENDENT CHARTERED SURVEYORS

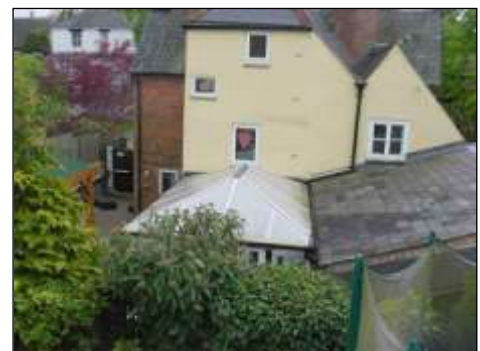
Over view of rear roofs

As with many properties that have been extended and altered over the years there are some awkward roof details particularly awkward valley gutters details in this case.

There is an awkward roof detail created by the conservatory extension and it is very difficult to now carry out anything that we would term as good building practice. It is disappointing that a modern extension has been so badly thought through. Whilst we could not see any visual signs of dampness getting in we tend to find that these type of valley gutters let in rainwater sooner rather than later. We suspect that there have been problems to the front valley gutter because of the way that it has been pointed with mastic.

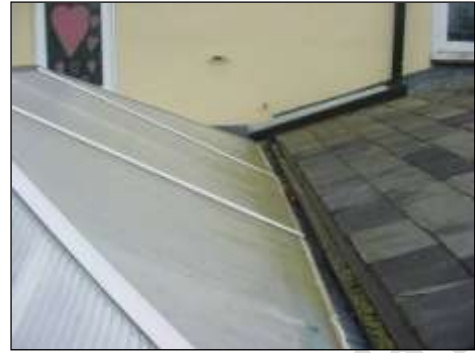
Valley gutter between conservatory and kitchen area

We suspect the valley gutter between two roofs is to be the area likely to leak.

ACTION REQUIRED: There are two ways of dealing with this;

Ideally we would recommend that the conservatory is completely redesigned (if indeed it was designed originally!) We would suggest a higher double pitched roof would be more appropriate for this age of property and allow the forming of a box gutter that you could walk on to clean, this would be very expensive and needs further thought.

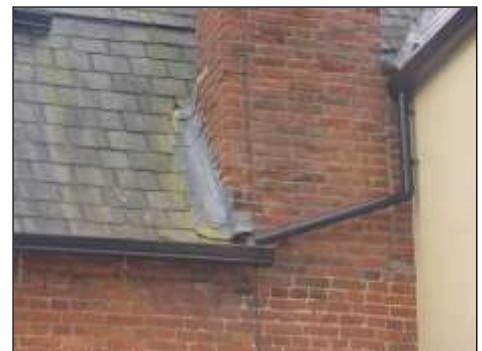
The main building has a mansard style main roof which is clad in natural slates with the exception of the repairs that have been carried out to the rear which have been carried out in a modern manmade slate. There still looks to be problems in this area where the main roof meets the new roof as the lead looks to have been tarred (indicating dampness is getting in) and also has been returned at the end at the base to help prevent the rainwater surcharging running down the building.

Natural slate to the left hand side and manmade slate to the right hand side and a lead valley gutter that has been tarred indicating that it has leaked

ACTION REQUIRED: We recommend to the main roof that you stand outside next time it is

raining heavily and see where the rainwater is surcharging over the gutters. We suspect a box gutter will be needed and a swan neck downpipe is not working, you may for example be able to use a downpipe to a water butt in this area.

ANTICIPATED COST: You also need to budget for repairing the remaining slate roof (we would never recommend that a slate roof is replaced with a manmade slate roof as in this case) and set aside the sum of £1000-£3000 for these various items; quotations required.

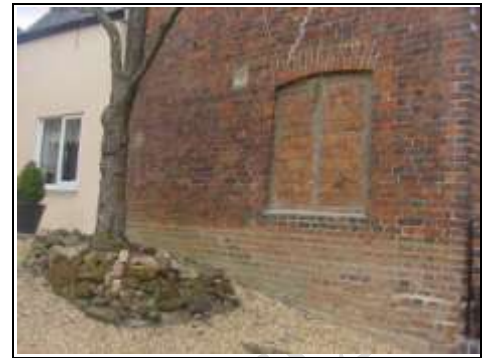
Incorrect cement mortar used to the base of the left hand side of the property for example

ACTION REQUIRED: Repointing can be carried out over a number of years with some ad hoc re-pointing in lime mortar ideally carried out in the summer of 2011. This will help the property start to breathe again and reduce the dampness.

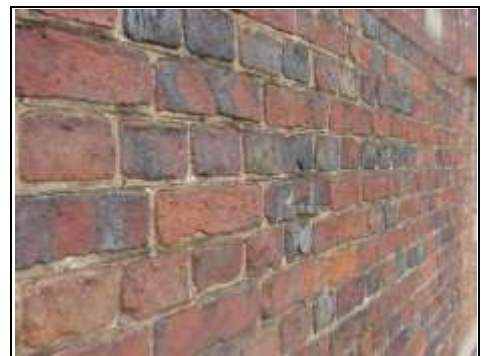
We would also add that the original brickwork was to a high standard and is what is known as pinch pointed.

An example of brickwork where the mortar is pinch pointed. If you look closely you can see a line through the mortar.

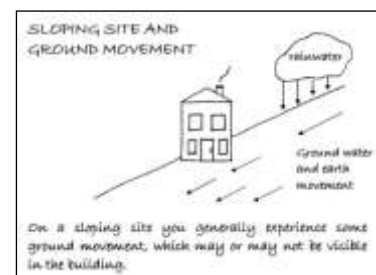
3.0.1) The property sits on a sloping site and as such the ground levels are above the floor levels. In most instances we have found dampness at the property both to the perimeter walls and internal walls.

3.0.2) We would comment that rising damp can be blown out of all proportion by companies that profit from this condition. Remember there should be an element of dampness in older properties. Having said this you do need to reinstate the breathability of the structure to enable this to happen which we have already mentioned.

3.0.3) We recommend a French drain is run along the property to all sides to lower the ground levels. On the left hand side of the property you would of course need the permission of your neighbours.

ACTION REQUIRED: Add French drain to reduce dampness in the property.

ANTICIPATED COST: In the region of £10,000 - £15,000. The difficulty will be accessing some areas to dig the area out; quotations required.

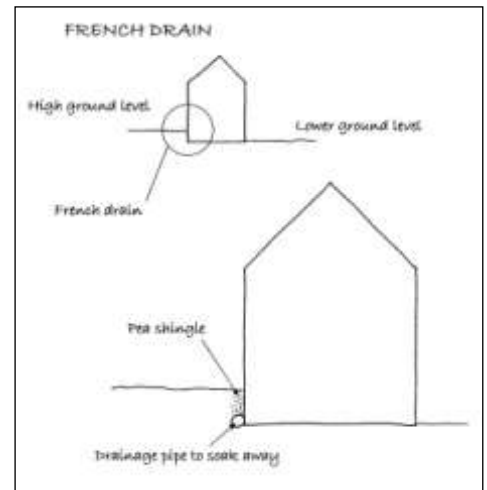
Please see the dampness section of the report

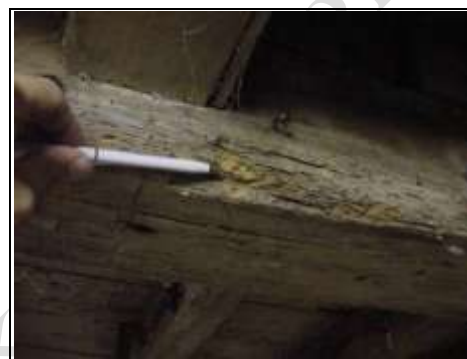
6.0.1) We would advise that the property has active woodworm. We could see areas of frass (chewed up saw dust) that woodworm leaves behind. Many properties of this age have woodworm, the question is whether it is active or not. We can never be 100% certain without going into concealed undisturbed areas (usually the roof space which we do not have the opportunity of doing in this case). We very rarely come across woodworm that we would term as structurally damaging woodworm which is what we would conclude in this instance. However woodworm can affect the structure over a long term and also affect you obtaining a mortgage on a property. We would add that we have had a limited view of the floors and the roof space as they have not been opened up.

Signs of woodworm in basement

ACTION REQUIRED: We would recommend opening up sections of the property at roof level and at floor level to check for woodworm and also check for wet rot and dry rot at the same time. The ideal locations to open up are:-

We are in two minds as to whether to recommend woodworm treatment as there is only a limited amount of exposed timber in the property and the unexposed timber would affectively remain still being attacked by the woodworm. This is why we recommend investigation work first. We suggest setting aside a sum of £1000-£3000 for investigation work and minor repair work. We would be more than happy to return when the property is opened up to make further comments; quotations required.

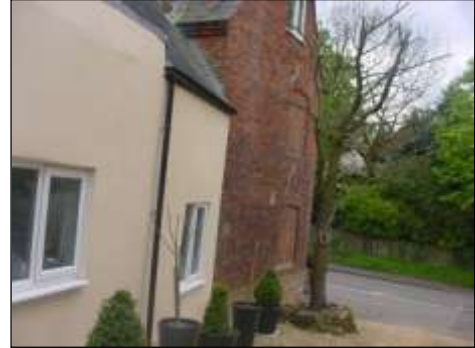
Left hand gable

- 7.0.3) Critical areas of the timber frame carcass are what are known as the wall plates which are at the base of the floor which as you have dampness this needs to be checked, which is why we recommend opening up the floors. They can of course in this age of property have been replaced completely.

ACTION REQUIRED: As mentioned we would recommend some opening up to be carried out to investigate the hidden areas of the property to ensure that you carry out work long term for the correct repair of this building.

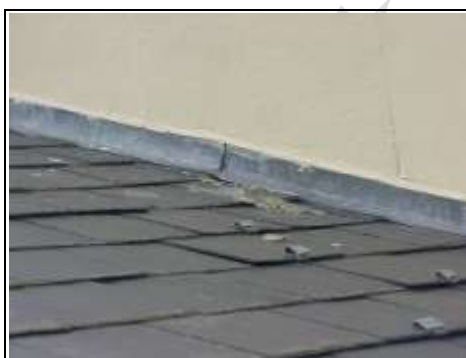
Dampness

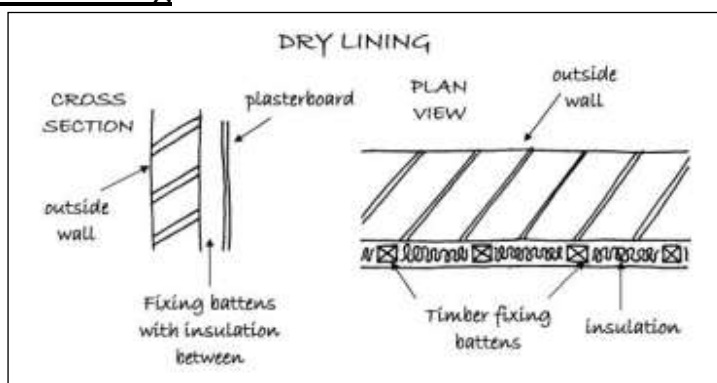
12.0.1) We suspect there is dampness to the rear walls due to the high level of the ground outside on this general sloping site. We are unable to check the walls due to the dry lining. We also noted there is sandstone to the base of the walls which could be contributing to the dampness.

ACTION REQUIRED: We have recommended earlier a French drain is added and would also recommend that the gutters are checked on your neighbours side to ensure that they are collecting the water correctly when it rains and we would also recommend ad hoc re-pointing in this area.

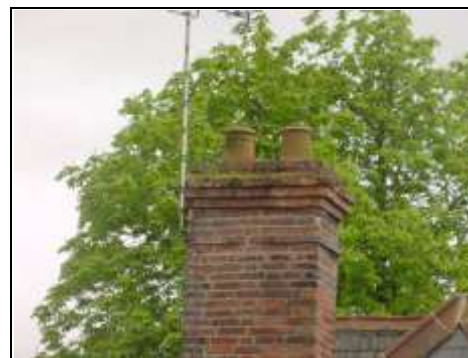
Chimney Two

This chimney is built as per chimney one with similar comments to chimney one.

We can see moss growing at the very top of the chimney, the whole chimney needs a close examination. Our other concern is the aerial that is fitted at the very top with wire that can cut into the chimney like wire cutting into cheese.

ACTION REQUIRED: Again you need to have a close inspection of this chimney and suspect it will have similar problems to chimney one and be allowing dampness into the structure. Please see our comments in the Executive Summary

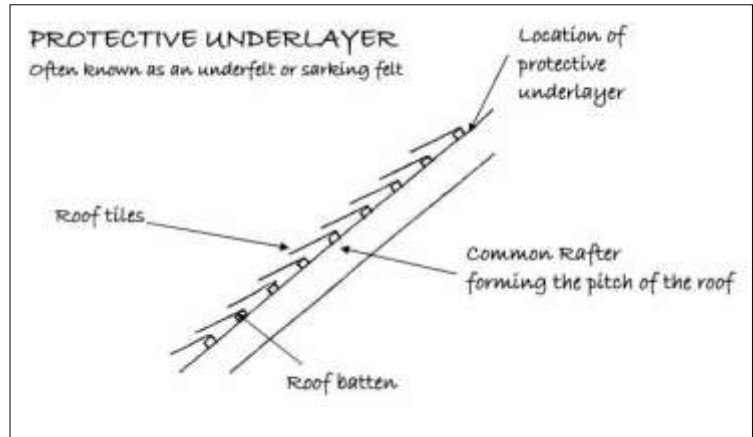
We could only see a very small area of the protective underlayer this was from within the main building accessed via a panel adjacent to the chimney. We could see approximately 5% of the whole roof and what we could see is a hessian based felt which was typically used from the 1960s to approx the 1990s.

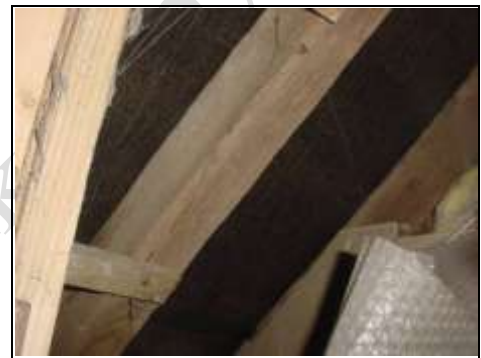
This photo shows the common rafters (the ones that form the pitch of the roof) and the dark area between is the underlayer.

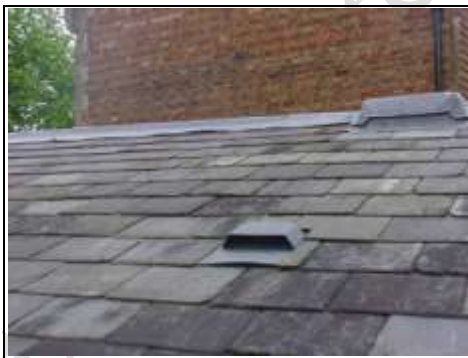
Rear slate roof in average condition

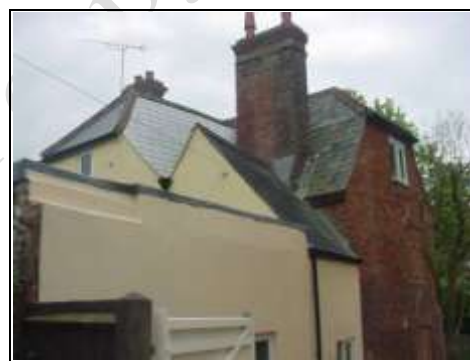
Single pitched roof at the rear - there are also some ledges on this wall

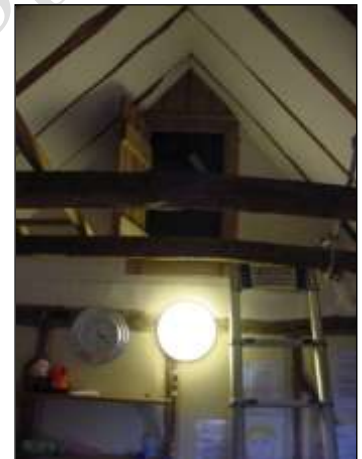
Roof access

We had next to no limited access to the roof structure.

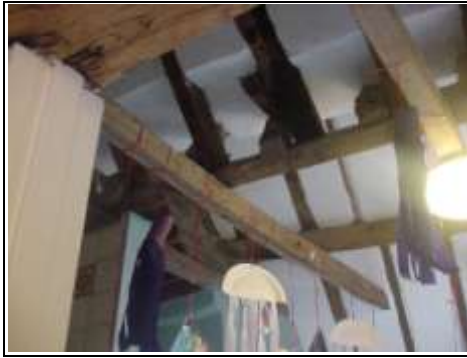
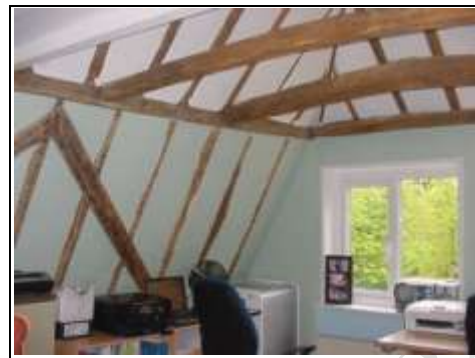
Roof structure

We had a very limited view and could see approximately 5% at most of the roof structure this sort of detail we typically wish to see in this case being able to view the front and back. We therefore cannot really comment on the roof structure itself other than to say we found woodworm throughout the property so this could well be affecting the roof structure. In addition the main roof sits fairly true therefore indicating to us that there is little movement in this area. We have mentioned previously sections of the roof that allow dampness in such as the rear valley gutter and those adjacent to the chimneys.

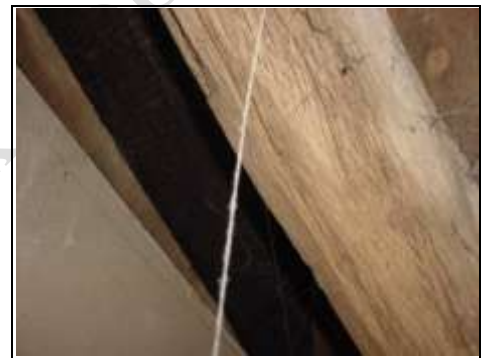
Roof timbers

The timber that we could see has been affected over the years with woodworm, to comment further with regard to woodworm we would advise that the woodworm we could see that was active was particularly in the cellar however it could spread quite easily throughout the entirety of this building. You therefore do need to open up and examine a section of the roof.

ACTION REQUIRED: Open up and examine a section of the roof by removing panelling.

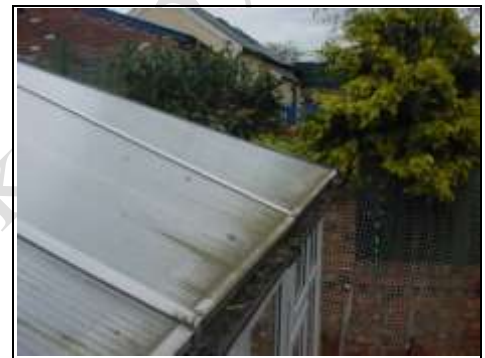
We were surprised to see the deeper metal gutters have been used at high level nevertheless we feel that some of them will overflow and there is also a need for repairs in some areas and there are some awkward gutter detailing. Please see our comments in the Executive Summary.

ACTION REQUIRED: We would always recommend that the gutters and downpipes are cleaned out, the joints are checked and the alignment checked to ensure that the gutters fall towards the downpipes.

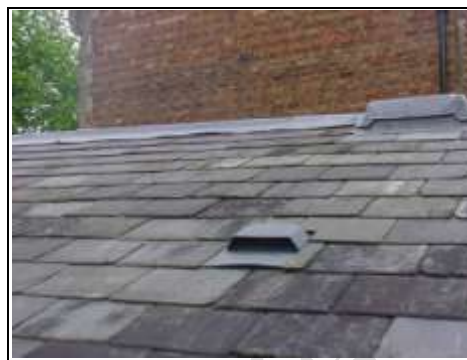
We think to the single storey extension the vent may be this one that you can see formed in the slate roof. This is not a normal style vent.

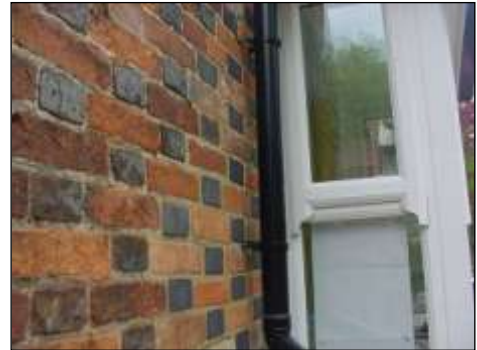
Replacement repaired brickwork at front of main building

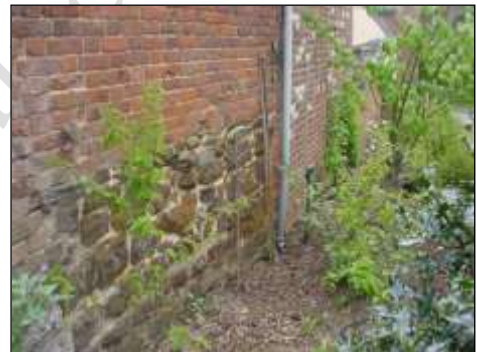
Rear of main building left hand side original sandstone

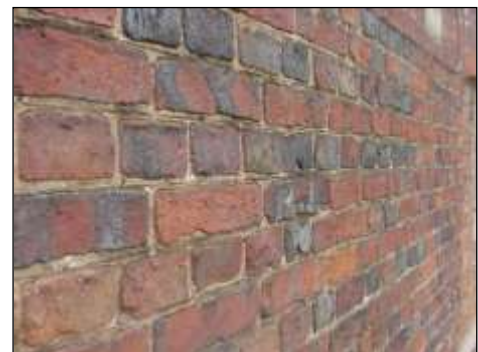
Pinch pointing

The mortar has been finished using a method known as pinch pointing, this method requires a high level of skill, and was used predominately on poorer quality bricks to take the eye away from them and focus on the pointing

ACTION REQUIRED: Ideally re-point in a like for like style but very few brick layers have the skill to carryout this work.

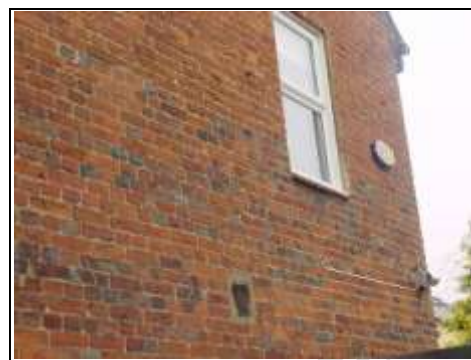
Building/Bonding timbers

We spoke in the Executive Summary about the importance of keeping the timber frame or the carcass in good condition and there are signs that there is a timber carcass within the main property as you can see timber ends.

Before the 19th Century, the practice of building timbers into external walls was almost universal. These were known as bonding timbers. They are of course prone to rot as solid walls allow dampness through. Unfortunately, without opening up the structure, we are unable to confirm if this is the case.

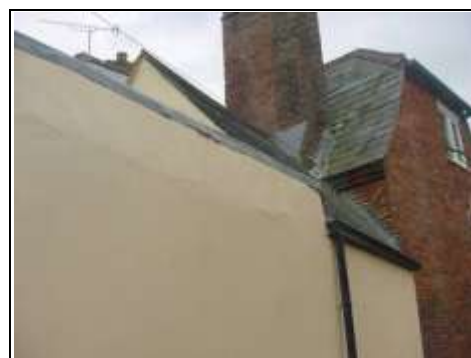
Render to main building

The walls to this property are finished in a "smoothish" faced painted render. We have carried out a tap test to the render where we could access it, lots of it is present at high level so it was hard to access (the tap test is literally hitting the render with the back of a hammer) to try to establish if there are any hollow areas. We have found was in average condition and typical for this age of property.

We have used the term smoothish as some areas have undulations in them and look to have seen better days, and/or have been repaired, for example the render to the left hand side top of the building looks to have had a repair.

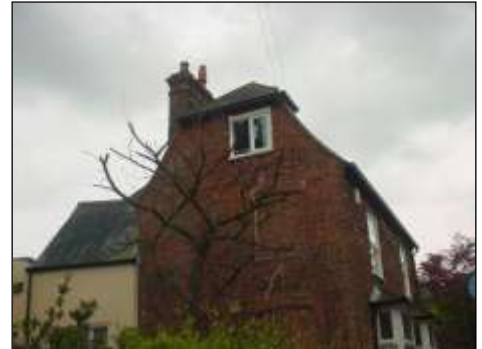
Tree to side of the main building

Next door has a tree very close to the building although there does not look to be much life to it.

ACTION REQUIRED: You need to speak to next door to ask them what they intend to do with the tree, if they do intend to keep it alive it is important that they maintain it due to its close proximity to your building; the tree roots will certainly be close to this property. If it has died then unfortunately this will mean there will be further problems with dampness in the property as the tree will have been taking away dampness from the property.

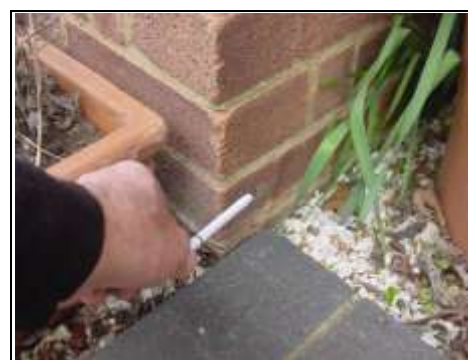
All modern properties should incorporate a damp proof course (DPC) and good building practice dictates that a differential of 150mm (6 inches) should be maintained between the damp proof course and ground levels. In this case, holes have been noted on the outside of the building, which have been drilled into the wall. This is a typical sign that a chemical injection damp proof course has been inserted. This is not appropriate for this age of property.

Old inserted damp proof course to front main building

ACTION REQUIRED: Please see our comments with regard to making the property more breathable in the Executive Summary.

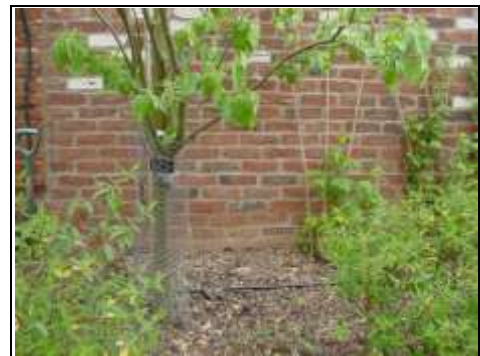
We noted an airbrick to the rear side of the property in modern stretcher bond brickwork which to us indicates there may be a suspended timber floor in this area. We were however surprised to see no airbricks to the main part of the property where we would expect to see a timber floor. The air bricks allow ventilation to under the floor which is essential in discouraging rot and should not be blocked or obstructed.

Airbrick to the rear side of the property in modern stretcher bond brickwork

ACTION REQUIRED: We have mentioned elsewhere within this report that you need to open up the floors to check the condition and you also need to check the construction as if they are a suspended timber floor then they will need airbricks to be added.

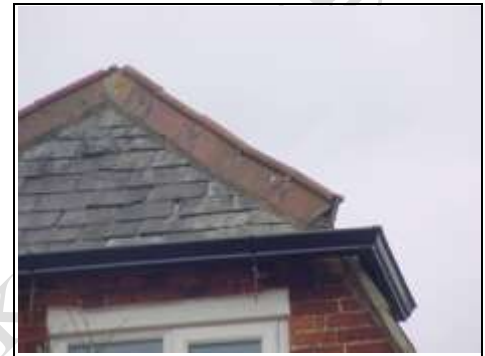
The property we assume has painted timber fascias and soffits although much of them are hidden by the large metal gutters. Due to the shape and the pitch of the roof we expect some deterioration to have occurred due to overflowing gutters, this will only be able to be seen with high level access.

Guttering hiding fascias and soffits

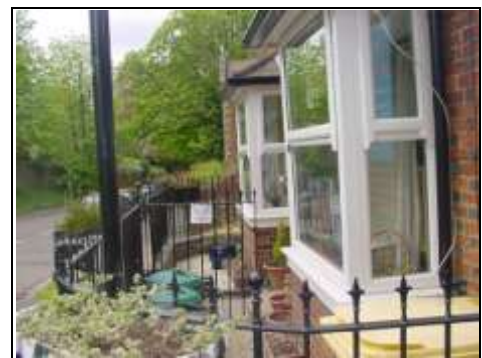
The majority of the windows have been replaced with plastic windows which probably could be argued are inappropriate for this age of property. We would also comment from what we could see they are from the cheaper end of the market.

Plastic windows to front of main building

ACTION REQUIRED: Enquiries should be made as to the existence of any transferable guarantees. Generally it is considered that double glazed units have a life of about ten years.

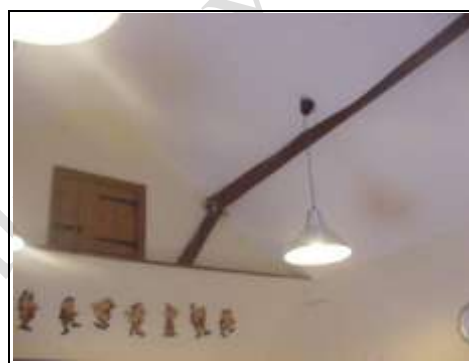
Lath and plaster ceiling

As should be expect with a building of this age, the ceilings have been finished in a variety of ways, from the original lath and plaster to more modern plasterboard. We could see that some of the ceilings are degrading and popping is occurring which is where the plaster on the head of the plaster nail has come away, you can particularly see this in the rear building. It can also occur where there is high humidity such as in these buildings.

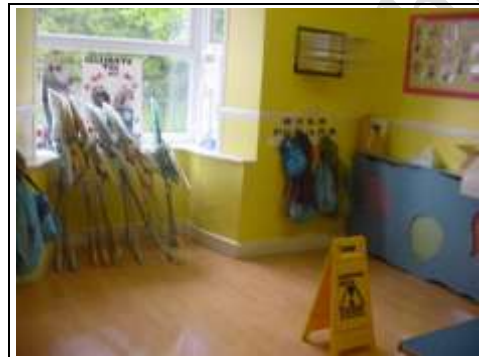
Laminated floor

The floor covering hides the floor in many instances, we believe there is a timber floor to the ground floor and in turn it is a suspended timber floor. We can only be certain of this in the cellar area which is where we can see the timbers when we go into the basement.

ACTION REQUIRED: We feel that you have to open up a section of the floor to check its construction and condition and if it is a suspended timber floor you will need to add airbricks around the property.

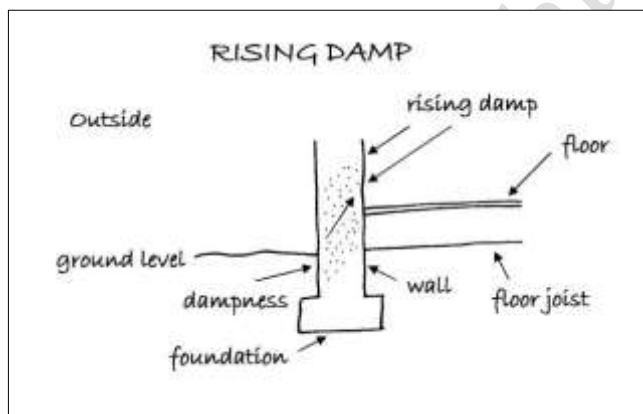
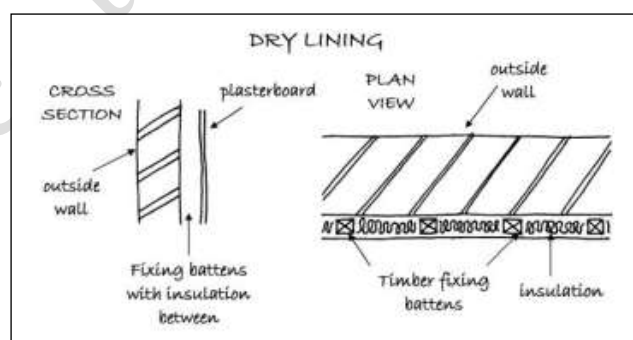
Generally throughout the entire property we found dampness in the areas however we did not find dampness in the rear building where it was dry lined but we suspect that behind the false walls there will be dampness.

ACTION REQUIRED: Please see our comments in the Executive Summary.

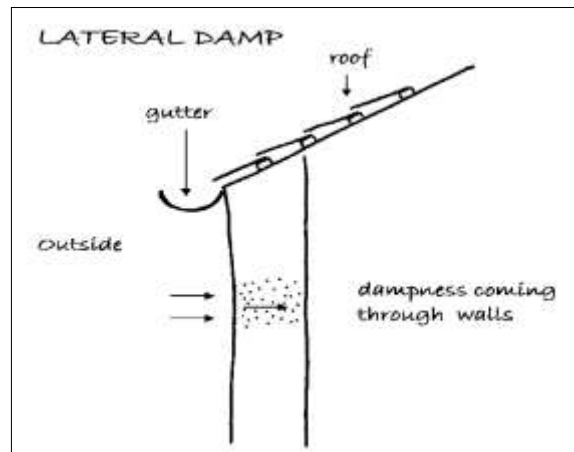
Some lateral dampness was found around the chimney areas and also there areas of hollow plaster on the walls indicating that there is dampness coming in through the brickwork. We would refer you to our comments about carrying out some ad hoc re-pointing externally and also refer you to our comments about the general high humidity in the property both of which may be contributing towards this.

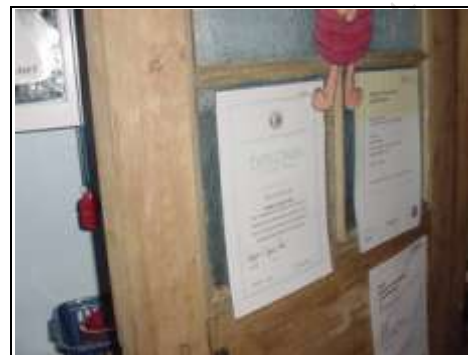
Timber and glass door

There is a mixture of doors in the property that require some work to bring them up to standard normally found within this type of property, although it does depend on the look you intend to have in the property.

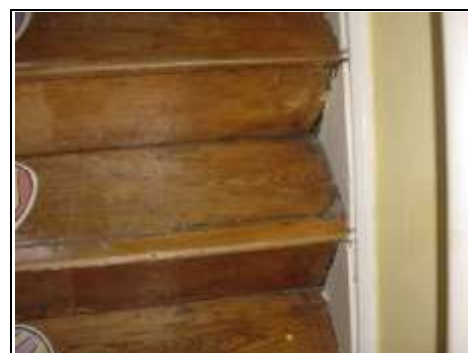
Staircase

We noted that some nosings were deteriorating and would benefit from repair. There is relatively high usage as the property is being used as a nursery.

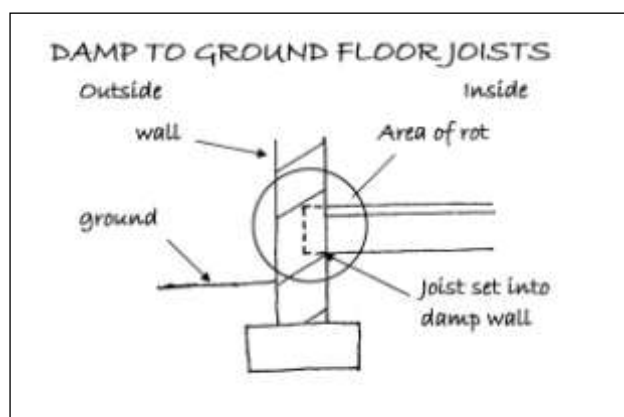
There is some deterioration to the windows that may have wet rot, what we could see did not seem excessive. The most likely place in opinion for wet rot to be occurring is to the roof and floor timbers, particularly where they are embedded into the main walls which are damp. To some extent this dampness and wet rot should

be expected in a property of this age but we do feel it has been accelerated to some extent by the lack of understanding of an older property that seems to have occurred throughout with maintenance work carried out.

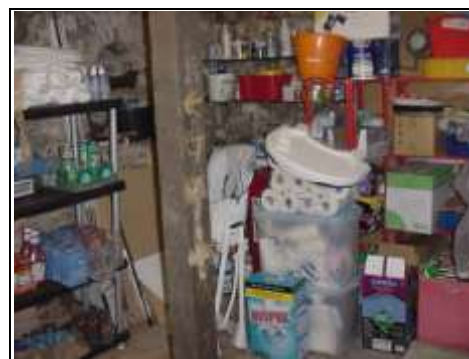
Cellars should be considered as areas that are damp and you should not store anything of any importance or that is perishable. When we inspected the basement/cellar area it was very crowded with stored items which limited our view. What we were looking for was a sump pump which we were unfortunately unable to find. A sump pump is, in our opinion, essential as when it rains when there is high water table levels for whatever reason any water that gets into the cellar can then be pumped out of the area.

Stored items in the cellar

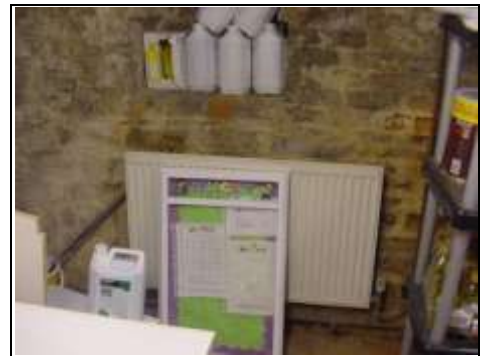
Quite unusually, although a sensible idea, we noticed there is a radiator in the cellar as well.

Radiator in the cellar

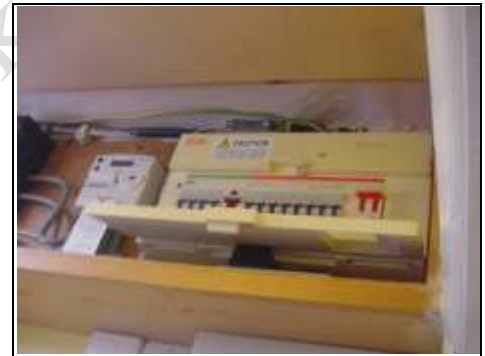
Fuse board

The electric fuses and consumer units were located in the staircase to the basement. We would date the fuse board as being from the 1990s and, whilst not the best now available, it is reasonable.

ACTION REQUIRED: If there is no record of an electrical test having been undertaken within the last five years, it is recommended that the installation be tested by a competent electrician (NICEIC registered) and all recommendations implemented. Thereafter, the installation should be re-tested every five years.

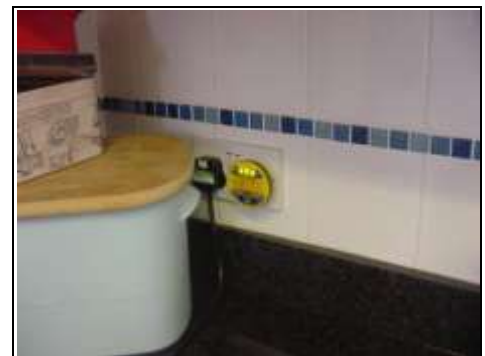
Earth Test

We carried out an earth test in the kitchen area to the socket point that is normally used for the kettle and this proved satisfactory.

Neither of these indicators can give certainty as to the condition of the rest of the wiring.

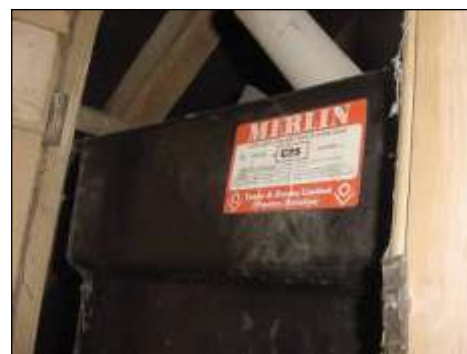
There is an empty water tank in the small roof space we assume everything has been changed over so that the water is directly fed to the taps. The original idea behind a water tank was to help water pressure and to give an emergency supply of water.

Disused water tank

ACTION REQUIRED: Your legal advisor needs to specifically ask the existing owners to advise on this.

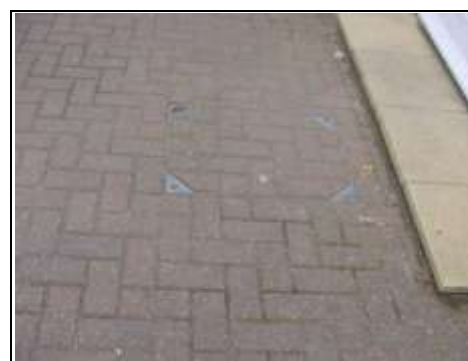
Manhole one

We were unable to lift the manhole, this is an insert manhole with brick paver set within it, we usually find that we cannot lift these and the generally need a special machine. We did note there was no moss around them indicating that they have not overflowed.

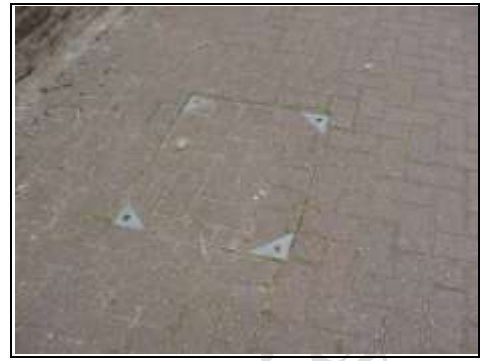
Manhole two

We would make similar comments to manhole one.

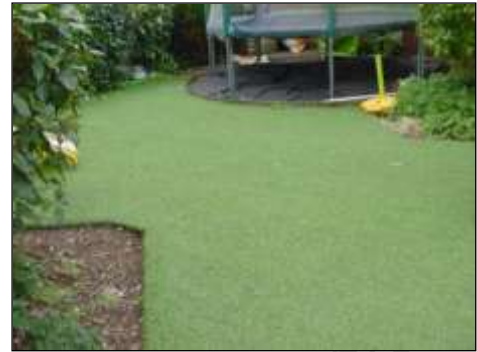
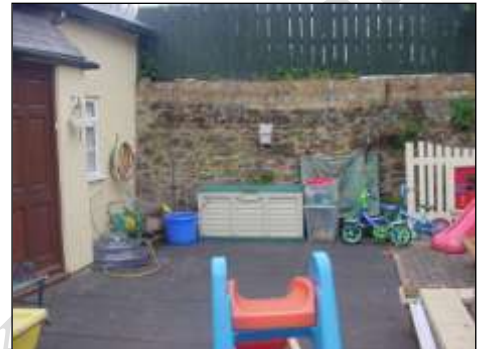
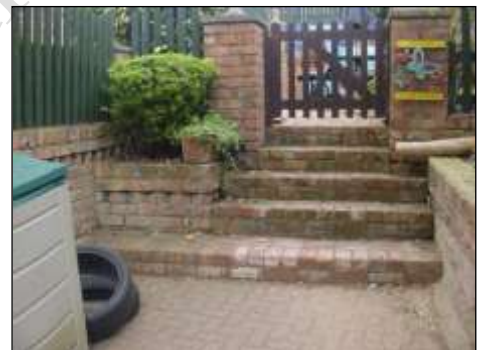
This has been taken over and redesigned for the nursery and is on a sloping site so it does have steps within the area. We recommend that weep holes are added to the retaining walls.

We noted the right hand boundary wall is bulging, this needs work carried out on it and you need to check the condition on the rear of the wall. We believe that there is a higher ground level on your neighbours' side of the wall which is causing it to be pushed over.

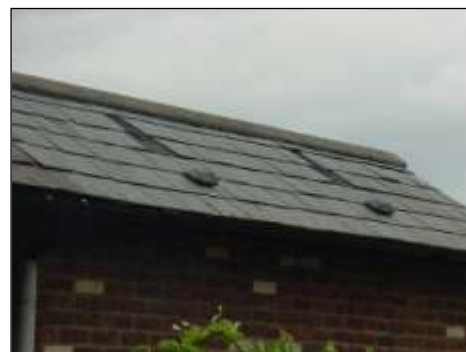
There is an unusual venting system to the rear of the property.

Vents to the roof
