RESIDENTIAL BUILDING SURVEY

Ealing

**Victorian Detached
Property with loft
conversion**

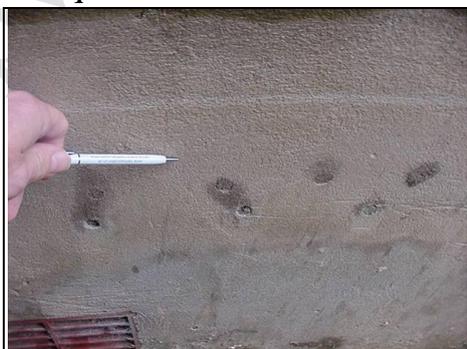
We can see to the left hand side and also to some of the right hand side, that there have been numerous previous attempts at inserting a damp proof course. We believe the problem to be on the right hand side and rear due to the high ground level and on the left hand side we believe is due to the render bridging the damp proof course, this requires a bell mouth to the render.

Damp proof course has been inserted on the left hand side

ACTION REQUIRED: It is important that both these works are done correctly as unless this happens, the dampness will remain.

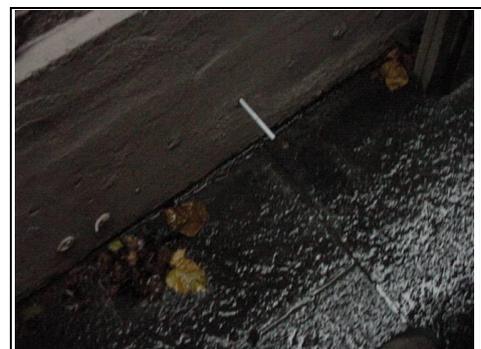
Damp proofing on right hand side

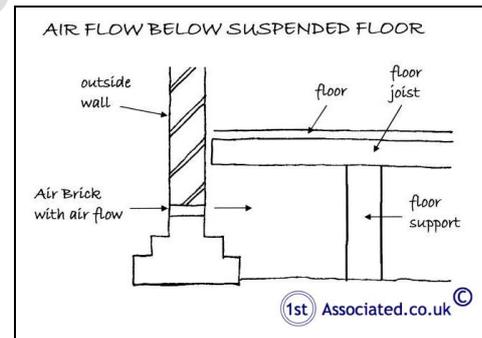
There is a suspended timber floor that you can't see because it has been clad with a ceramic tile throughout the interior of the property. However we do know this type of construction and suspect that there could be a timber floor beneath it that is deteriorating due to the lack of airflow. There would normally be vents however we haven't managed to find them in this instance with the exception of those in the photos below. The airflow underneath the building is needed to ensure the chances of wet rot, dry rot and woodworm are reduced.

ACTION REQUIRED: You need to ensure that all the current air vents are clear and allow a flow of air. You need to open up a section of the floor to check the condition of the timber underneath. If there is any dampness or deterioration then we would recommend additional airbricks are added to the rear.

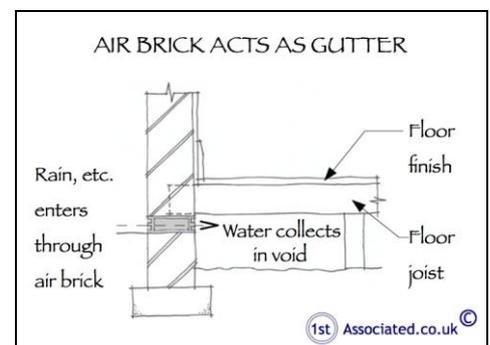
We suspect that additional airbricks were originally to the rear but these have been covered up by the decorative paving slabs that have been added.

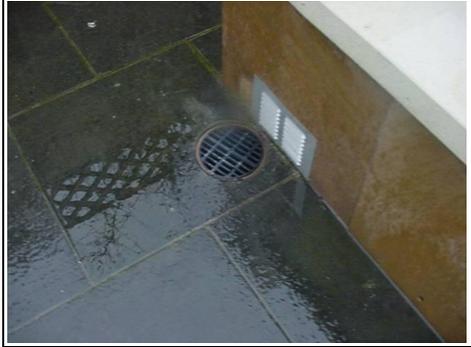
Airbricks acting as a gutter to the rear

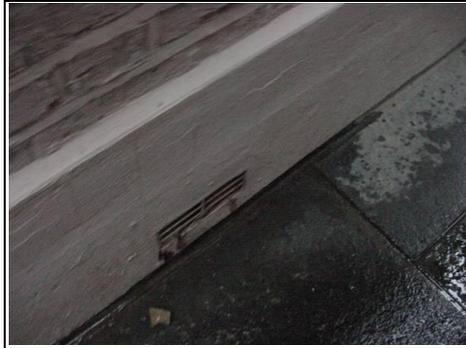
Airbrick acting as a gutter on the right hand side

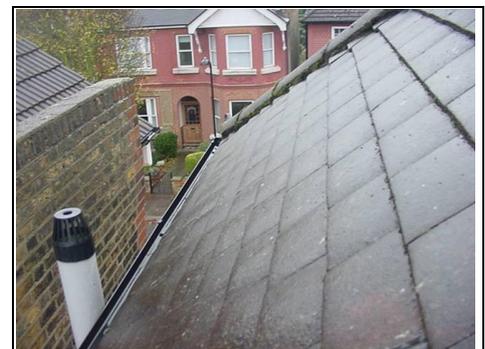
Close up of roof tiles

ACTION REQUIRED: A roofer to replace displaced tiles. Carry out periodic inspections and maintenance of the roof, as required.

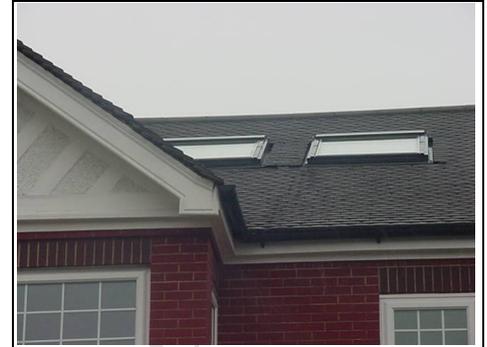
Three roof windows have been added to the front and one to the side as part of the loft conversion. These are a modern manufactured roof light and looked in reasonable condition. The important factor with roof lights is the flashing around them, in this instance we could see it looked in average condition although there was some moss sitting around it.

Roof windows

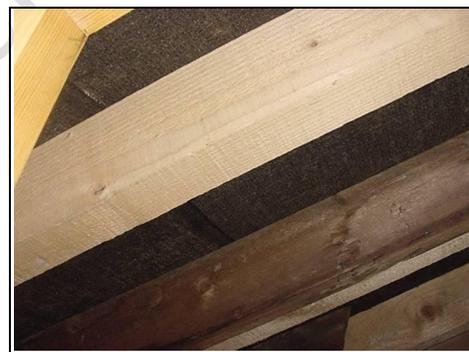
We were only able to see a very small area of the protective underlayer. This we found to be a Hessian base Bitumen membrane. We could only see approximately five percent of the underside of the roof. The Hessian based membrane has been used since the 1960s. We generally found the little we could see to be in average condition.

This photo shows the common rafters (the ones that form the pitch of the roof) and the dark area between is the protective underlayer

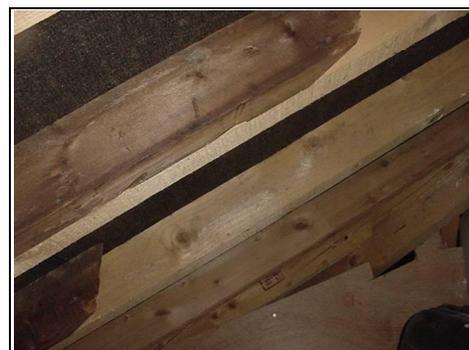
Roof viewed in rear right hand cupboard space on the top floor

Our examination was very limited due to the loft conversion. The timbers we could see were newer timbers and were thinner and smaller in profile than we expected but without seeing the whole roof we cannot be certain of how it is constructed. It may, for example, have a metal frame within it which would allow the size of the timbers to be reduced.

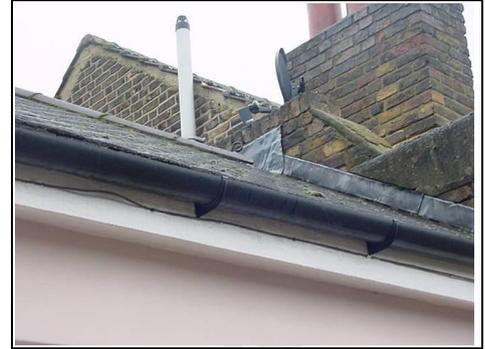
Cast iron of this age can crack and rust and needs regular maintenance.

Soil and vent pipe – cast iron to plastic

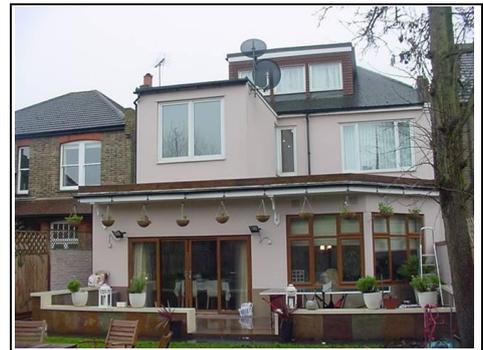
Render to the rear

The external walls to the rear are finished in a smooth faced painted render. We are always wary when we see rendered properties as it usually means they have been rendered for a particular reason.

In this particular case we believe it has been added at a later date as we cannot see it on adjoining properties. It looks a new style cement render.

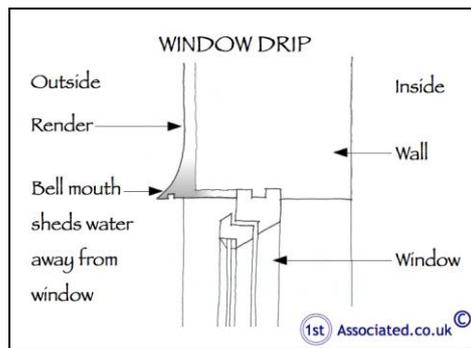
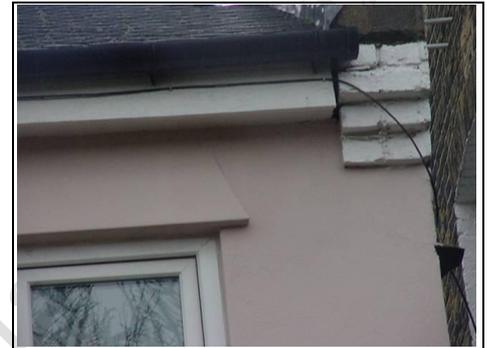
Drip details over the window on the render to the rear

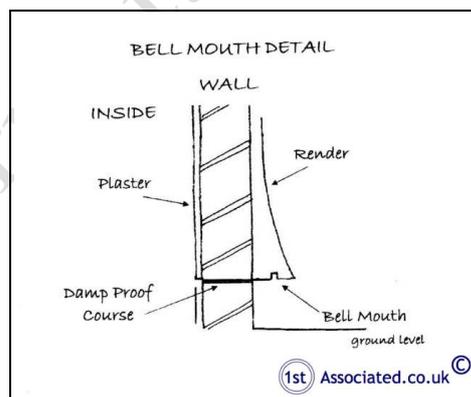
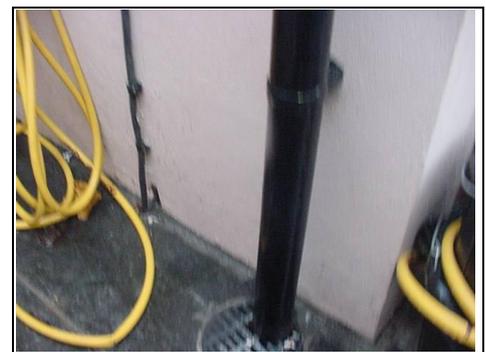
However to the base where we would expect to find a drip detail, there is no detail.

No bell mouth

ACTION REQUIRED: Please see our comments within the Executive Summary with regards to adding a bell mouth.

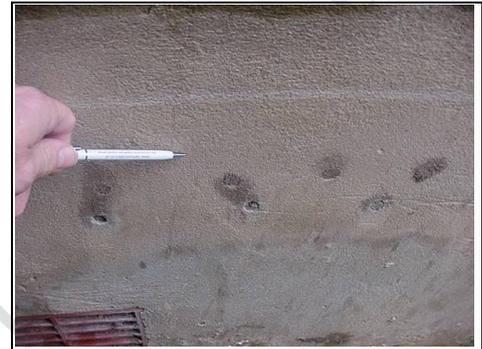
Damp proof course has been inserted on the left hand side

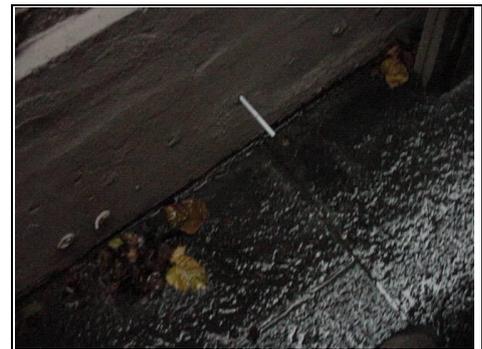
Damp proofing on right hand side

A random visual inspection and tests with a moisture meter have been taken to the perimeter walls. In this particular case we have found rising damp to the right hand side of the property.

ACTION REQUIRED: Please see the Executive Summary.

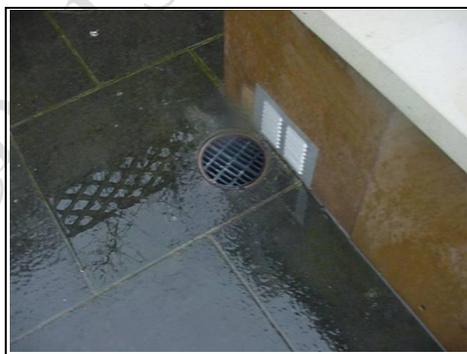
Airbrick acting as a gutter

ACTION REQUIRED: Please see our comments within the Executive Summary.

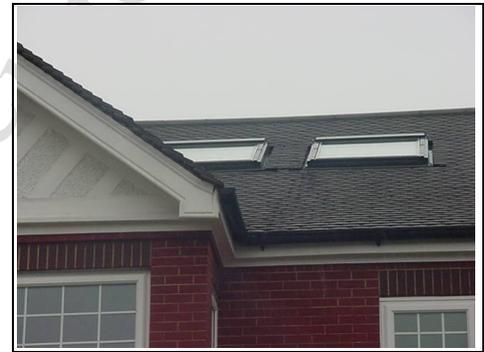
Fascias and soffits

The fascias and soffits are timber. They are painted and we would comment they are in average condition for their age, type and style.

ACTION REQUIRED: Make sure gutters and downpipes are watertight before carrying out any work on fascias and soffits.

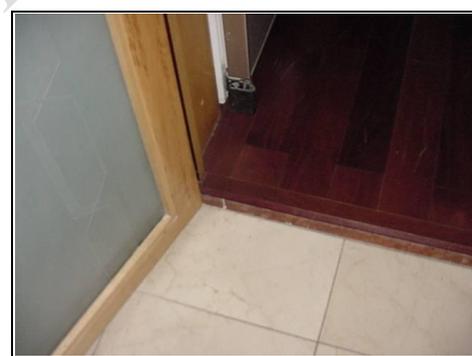
The floors to the property are suspended timber floors which are covered with ceramic tiles and wood flooring which has limited our inspection.

Tiles to wooden floor with a step on the ground floor

ACTION REQUIRED: Please see our comments within the Executive Summary with regards to the problems that can occur where ceramic tiles are laid over timber floors.

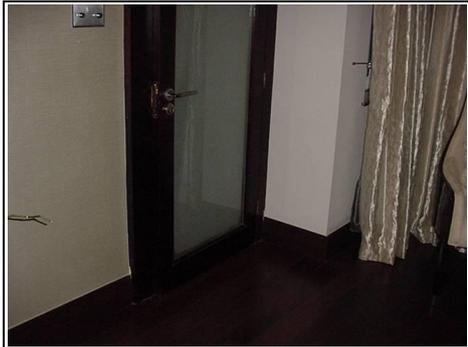
There is a variety of modern doors. Some of them are glazed, these should have a British Standards kite mark to ensure that they are safety glass; we couldn't see it in this instance.

Glass doors

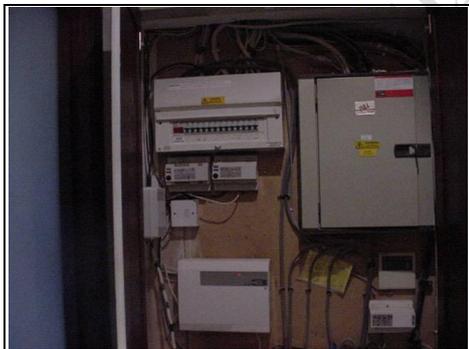
Quite unusually this property has two electric fuse boards. One is located in a cupboard on the ground floor next to the entrance door, the other one is at first floor level. This may have been added due to the under floor heating being electric.

Circuit board on ground floor

ACTION REQUIRED: You need to specifically ask the owner why two fuse boards are present. We would add that we were pleased to see that the fuse boards were relatively modern.

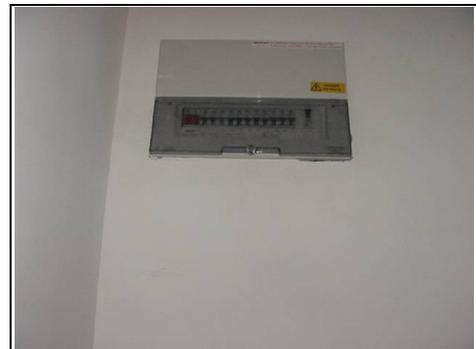
Fuse Board on first floor

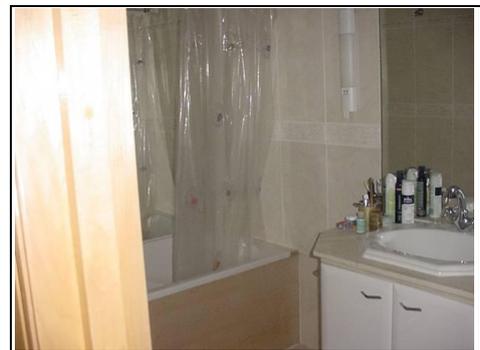
This comprises a three piece bathroom suite, consisting of a bath, shower, wash hand basin and WC, which looks in average condition. The shower mastic needs checking.

En-suite bathroom to front left hand bedroom

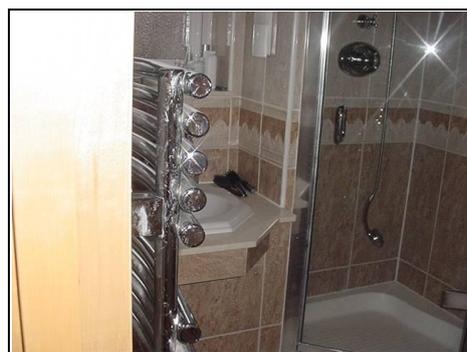
This comprises a three piece bathroom suite, consisting of a shower, wash hand basin and WC, which looks in average condition. We would recommend you check the seals around the shower.

En-suite shower room to front right hand bedroom

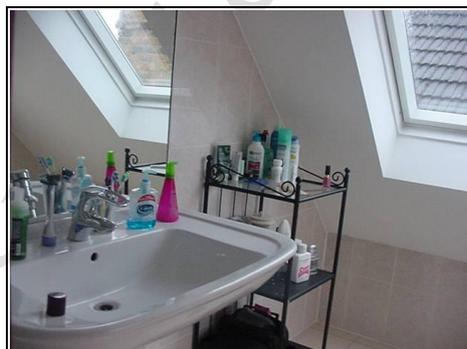
This comprises a three piece bathroom suite, consisting of a shower, wash hand basin and WC, which looks in average condition. Again, we would recommend you check the seals around the shower.

Bathroom to top floor

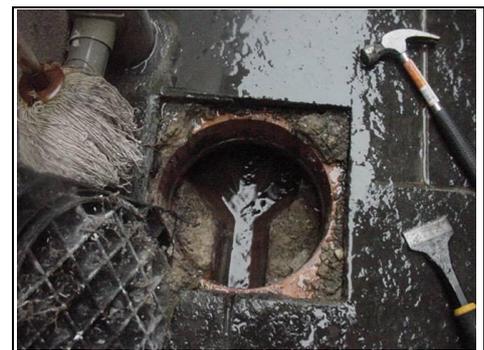
Manhole one

We duly lifted the cover and found it to be free flowing at the time of our inspection.

From what we could see it is plastic.

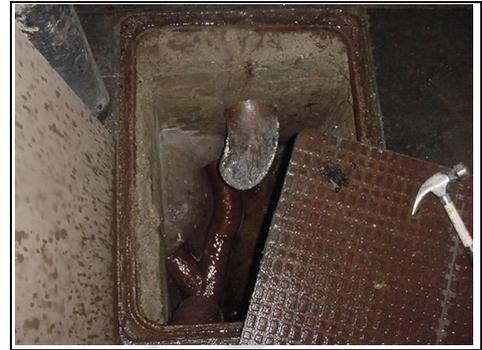
Manhole two

We duly lifted the cover and found it to be free flowing at the time of our inspection.

From what we could see it is concrete built.

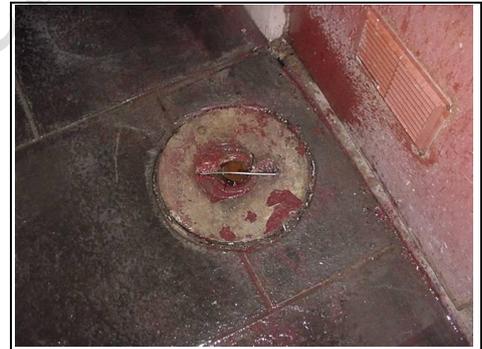
Manhole three

Inspection Chamber / Manhole Three –located in the middle

We were unable to lift this manhole. It is known as a modern inspection chamber.

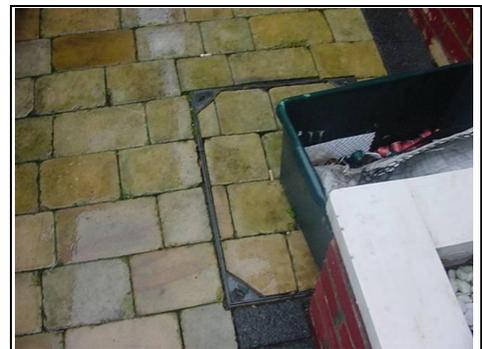
Manhole four

Inspection Chamber / Manhole Four – located to the front right hand corner

We were unable to lift this manhole.

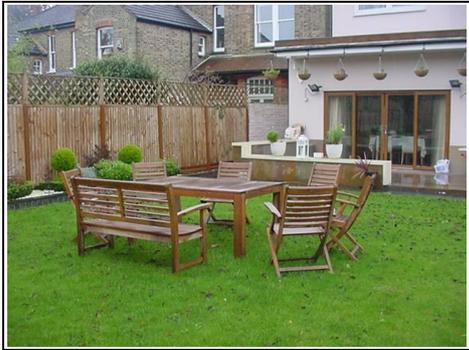
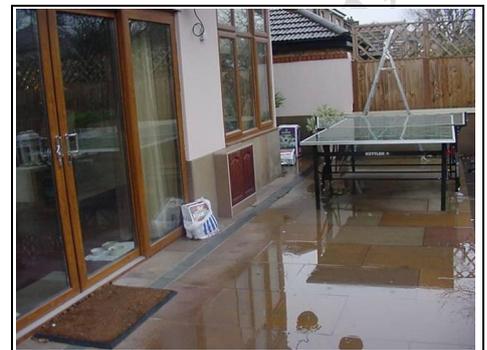
Rear Garden

The rear garden has a patio area and a grassed area. Please note our comments on the tree in the Trees Section, which could affect your insurance and could be affecting the rear of the property.

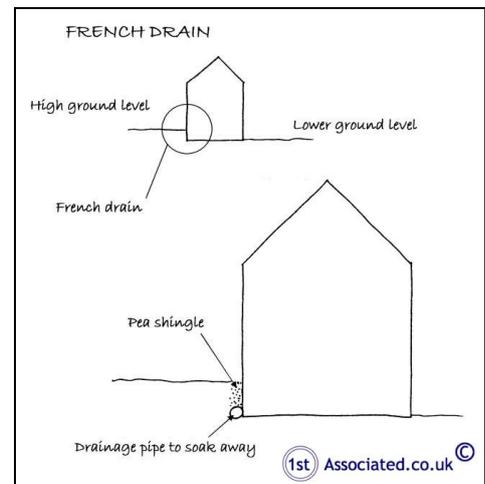
French drains must be on a slope

The piping that goes at the base of a French drain should be perforated or, as we did years ago for land drains, there should be gaps between each pipe. It should be set onto a bed of firm ground and the pipes should on a fall to the drain. Whilst you should be able to ensure there is enough fall by sight, we also like the idea of rolling a marble from one end to the other.
