RESIDENTIAL BUILDING SURVEY

XXXXXXXXXXXXX,
Luton,
Bedfordshire,
LU3

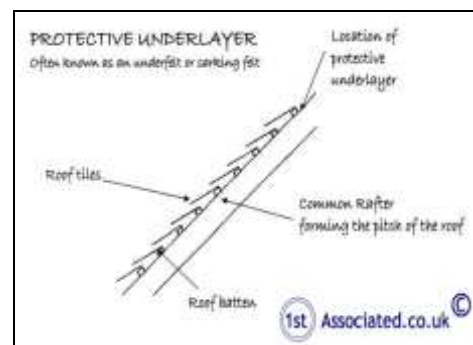
The original roof has nibbed tiles without a protective underlayer. This type of roof has been superseded by a modern roof with a protective underlayer. We would recommend that a protective underlayer is added to the roof.

Protective underlayer

ACTION REQUIRED: Within the next five to ten years we would remove the existing roof and add a protective underlayer, re-batten and add the tiles. You will probably have in the region of thirty per cent waste so you will need to replace some of the tiles.

ANTICIPATED COST: In the region of £5,000 - £7,500 (five thousand to seven thousand, five hundred pounds) assuming that some tiles can be re-used. A substantial part of the cost for this type of work is for the scaffolding. Many insurers/companies now require the properties to have scaffolds not only to the sides but also to be roofed over to protect against weather damage; please obtain quotations.

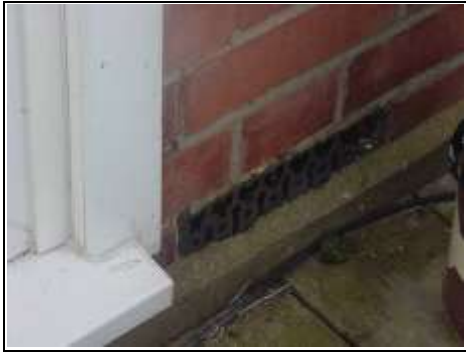
Air brick to the rear

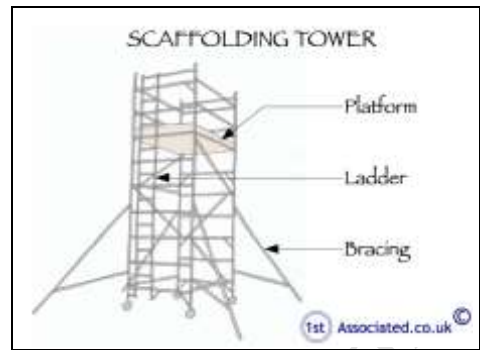
Scaffolding

ACTION REQUIRED: Dampness is coming in via the fascias and soffits or the flat roof. Both need to be looked at. This is likely to need a tower scaffold to the front of the property.

ANTICIPATED COST: In the region of £750 - £1,500 (seven hundred and fifty to one thousand, five hundred pounds)
