JOB REFERENCE: RBSM2

RESIDENTIAL BUILDING SURVEY

**Dunstable
Bedfordshire**

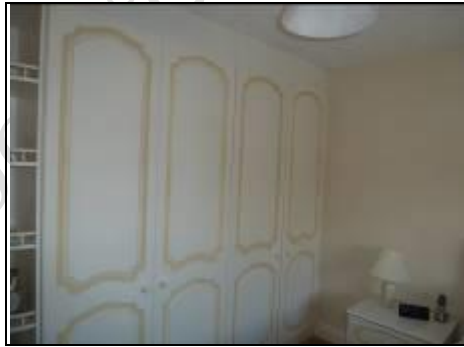
Within the property we cannot really see any major cracks; these could of course literally have been papered over, other than the door does not shut properly to the front left bedroom and there are some other minor hairline cracking. The cupboards limited our view of the right gable.

Cupboards in front right bedroom

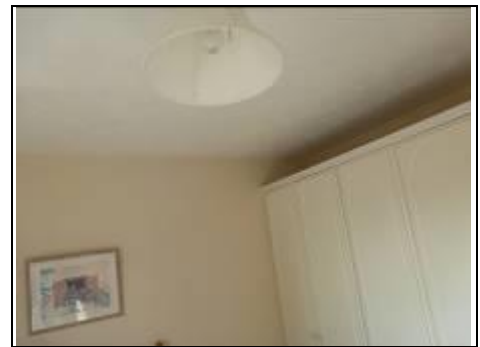
Cupboards in rear right bedroom

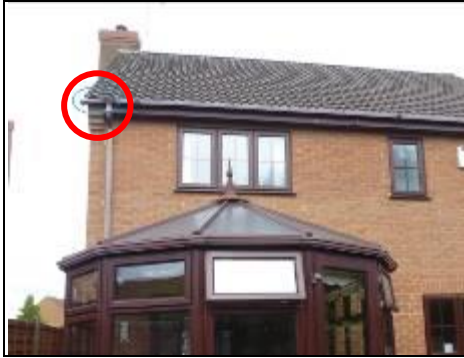
The property has older style plastic PVC gutters and downpipes which are affected by the sunlight and are discoloured.

Rear right gutter dropping

ACTION REQUIRED: We would recommend you stand outside the property next time it rains heavily and see how well the drains cope with the rainwater particularly looking at the guttering and the joints. We would suggest an extra bracket is added to the unsupported gutters.

We also recommend that the gutters and downpipes are cleaned out, the joints are checked and the alignment checked to ensure that the gutters fall towards the downpipes.

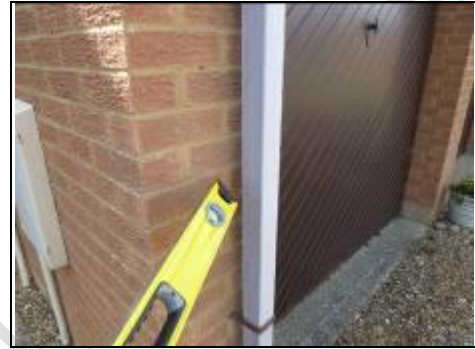
Faded plastic downpipe

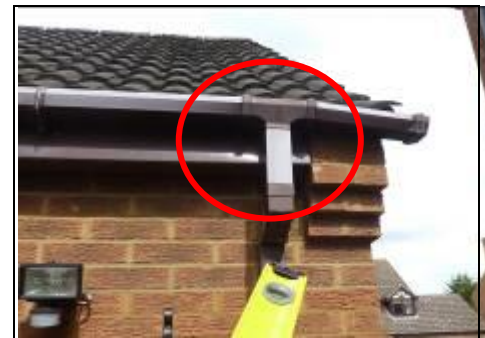
Unsupported gutter to rear left

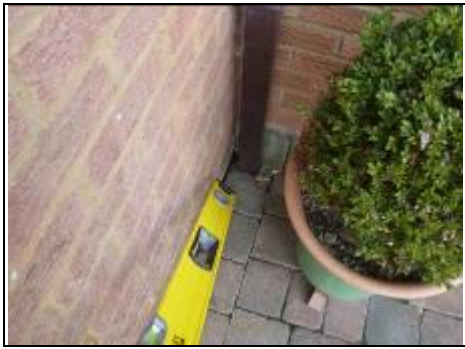
Downpipes feed directly into ground

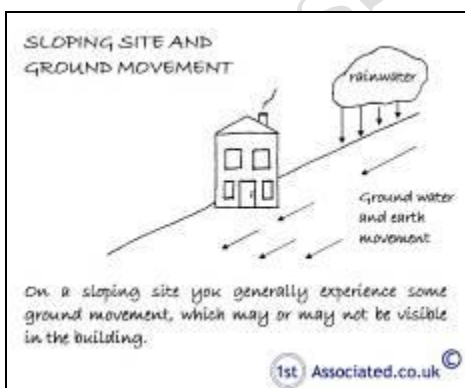
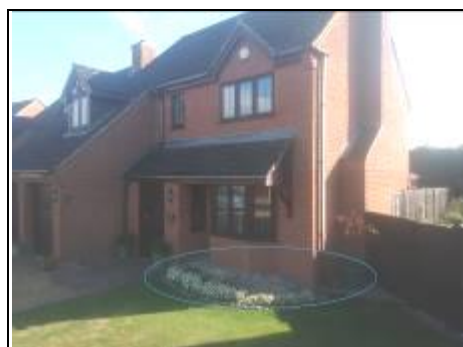
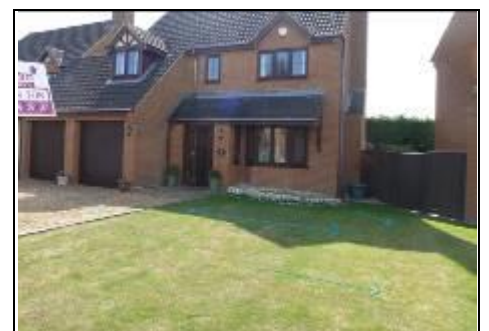
The property sits on a slightly sloping site and because of this rainwater and ground water need to travel from the top of the site to the bottom with the building in the way. Sloping sites are not as good as level sites and buildings on them are integrally unstable. You need to understand this is a characteristic of any building sitting on a sloping site.

Sloping site

The bricks at the base of the property are starting to deteriorate from water, etc due to the sloping site.

ACTION REQUIRED: You need to accept this as a characteristic of the property or add a French drain.

ANTICIPATED COST: In the region of £3,000 - £5,000 to add a proper French drain. Please obtain quotations.

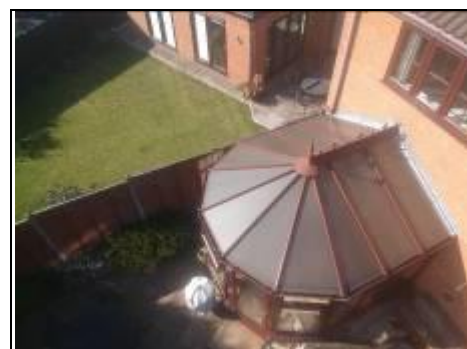
The rear conservatory is south facing and has a basic polycarbonate roof. It was very warm during the course of the survey and we believe the conservatory was adding heat to the rest of the building even though the doors were shut and numerous windows in the conservatory were open.

Conservatory with polycarbonate roof

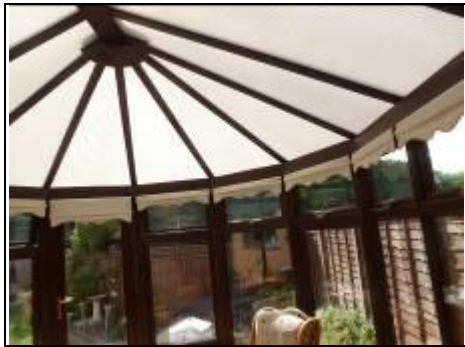
No blinds to conservatory roof

ACTION REQUIRED: A way to help this is to either have vents added in the roof and/or add ceiling blinds.

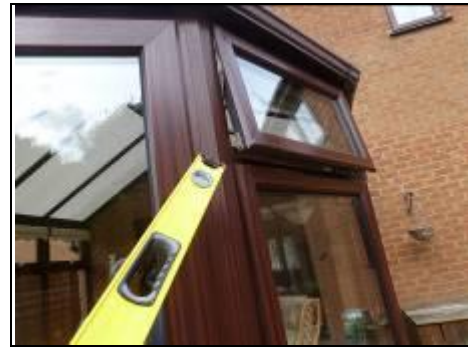
Windows open

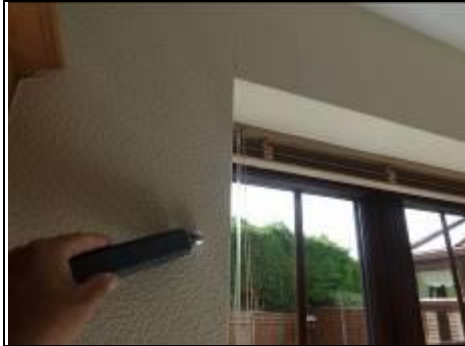
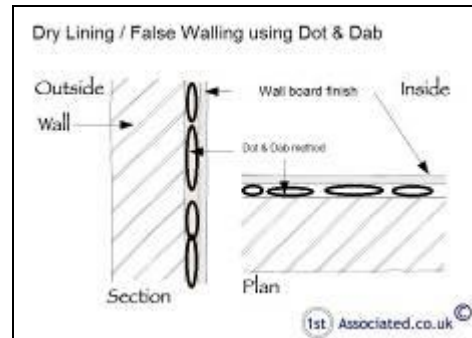
There is dry lining to the perimeter of the property which effectively highlights the construction. The dry lining limited our inspection internally.

Dry lining to perimeter walls

Dry lining

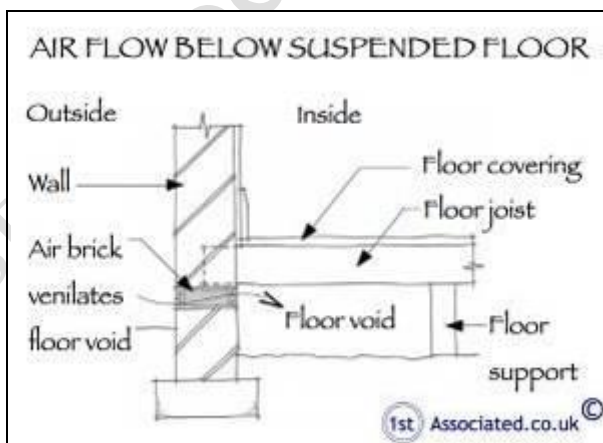
Suspended timber floor

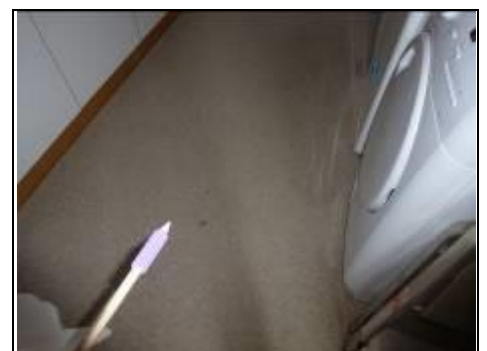
Suspended timber floor raised in garage area

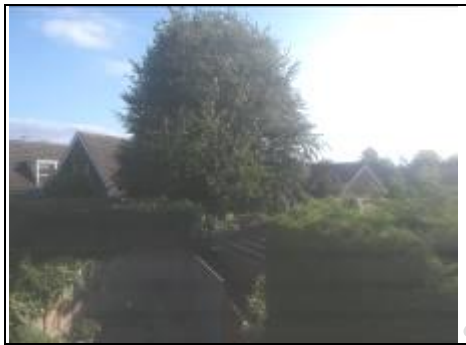
There are conifers to the rear right which you will need to keep trimmed. There is a large tree to the rear which could cause shading to the garden (which could be good or bad).

Large tree to rear

ACTION REQUIRED: Regularly cut back and maintain. It is possibly worth having a chat with the neighbour with regard to maintenance and management of the conifers (we knocked at the time of the inspection but there was no response).

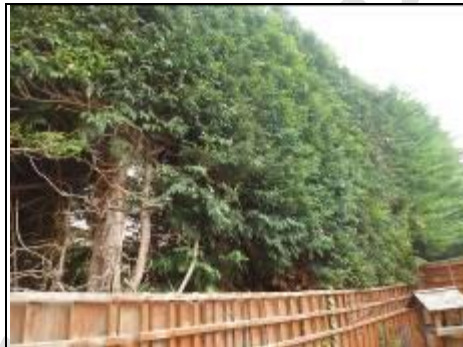
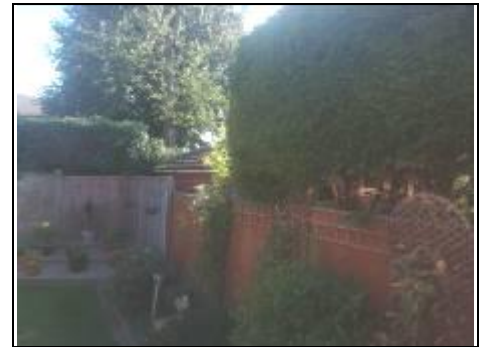
Conifers to rear right

Conifers to rear right
~ Aerial View - 360 Photo ~

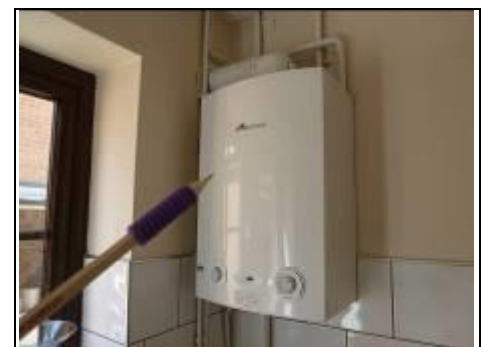
The looks to be the original 1980's Worcester boiler located in the kitchen which if it is original will be coming to the end of its life.

Boiler

ACTION REQUIRED: Check with the owners whether the boiler is original. If so, budget for a new boiler. The system is also likely to need upgrading of the single panel radiators.

ANTICIPATED COST: Budget £5,000 - £7,000 for new boiler and upgrading single panel radiators to double panel convection radiators; please obtain quotations.

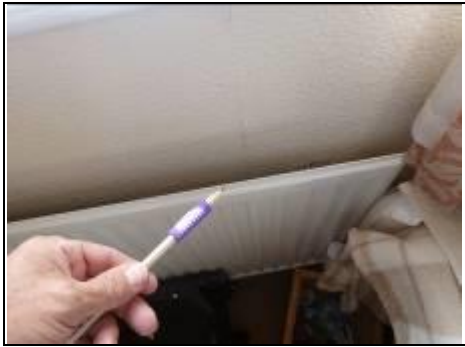
Single panel radiator

Replace single panel radiators with double panel convection radiators

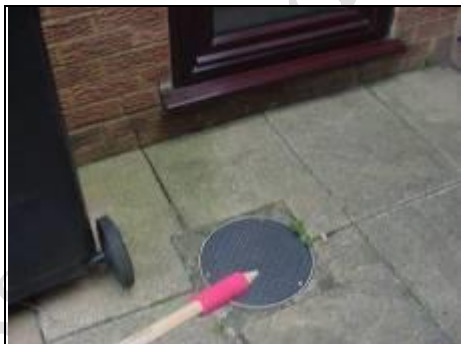
Slightly unusually, we did not find a manhole. It may be hidden underneath something in the garden (the property was empty therefore there was no-one we could ask). The sketch shows a typical layout of drainage. In this case we could only find a rodding eye close to number 1 on our sketch.

Rodding eye

ACTION REQUIRED: We would recommend a closed circuit TV camera report of the drains.

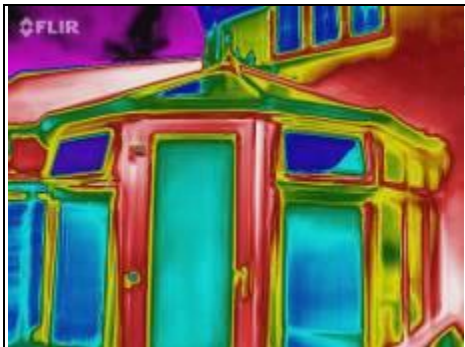
Heat from open windows

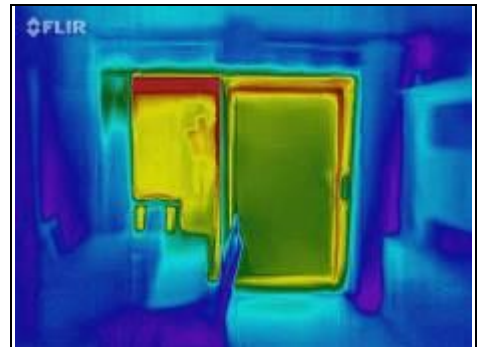
Heat coming through into building from conservatory even though doors closed

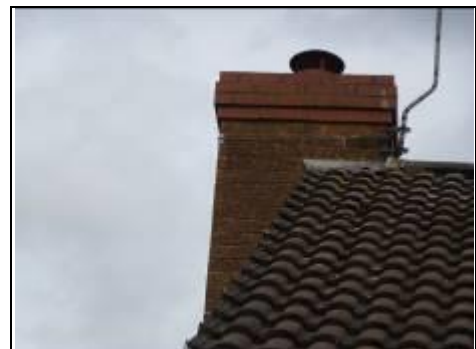
Chimney viewed from rear

We noted an aerial attached to the chimney which we are not keen on as it cuts into the brickwork rather like a cheese wire cutting into cheese.

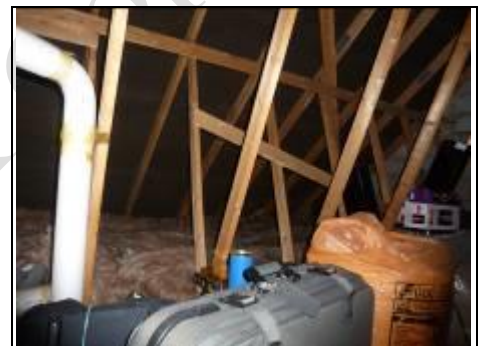
When we inspected the loft space we found a Hessian base Bitumen membrane. This type of membrane has been used since the 1960's. We generally found it to be in average condition, with damage in some areas which is what we typically find.

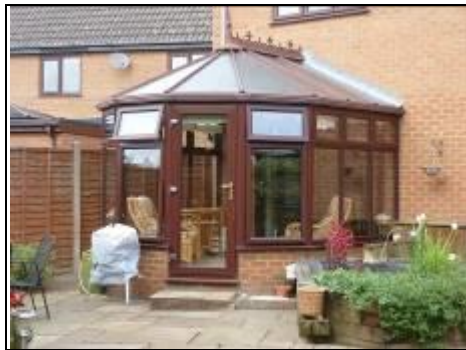
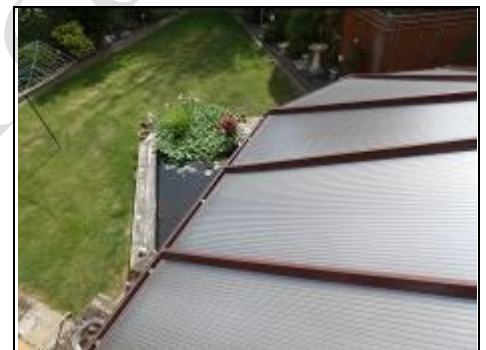
The conservatory has a polycarbonate roof which looked in average condition for polycarbonate however polycarbonate can get brittle over time.

Conservatory with polycarbonate roof

Conservatory polycarbonate roof

ACTION REQUIRED: Please see our comments in the Executive Summary.

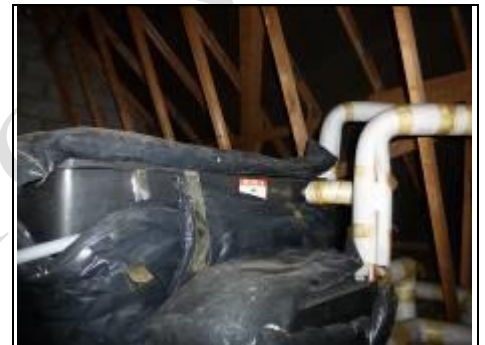
We would always recommend that water tanks be drained down and cleared of any debris etc. (we have seen dead birds and other unmentionable things in these tanks). As you are often cleaning your teeth with this water it is best that it is as clean as possible!

Water tank

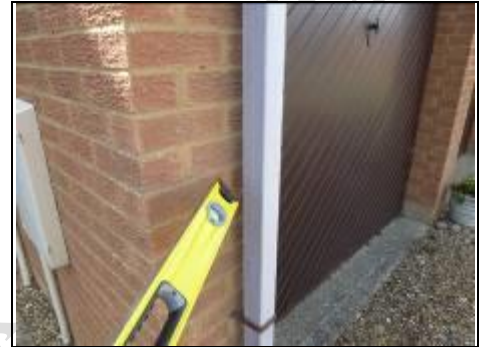
The property has older style plastic PVC gutters and downpipes which are affected by the sunlight and are discoloured.

Faded plastic downpipe

We also recommend that the gutters and downpipes are cleaned out, the joints are checked and the alignment checked to ensure that the gutters fall towards the downpipes.

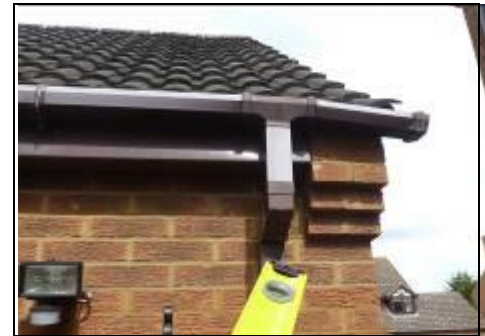
Unsupported gutter to rear left

ACTION REQUIRED: Please see our comments in the Executive Summary.

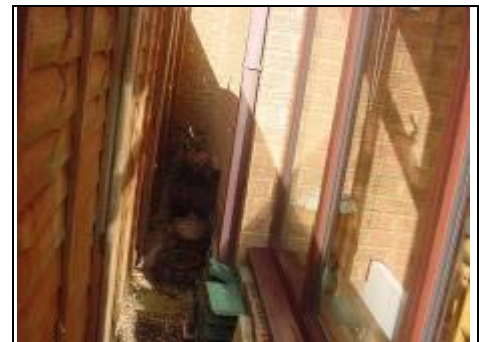
There is an unusual detail to the rear of the conservatory. We are not sure whether it is an additional course of brickwork or brickwork has been piled up against the conservatory to the rear right. Unfortunately, we only noticed it on the photographs.

Bricks near conservatory

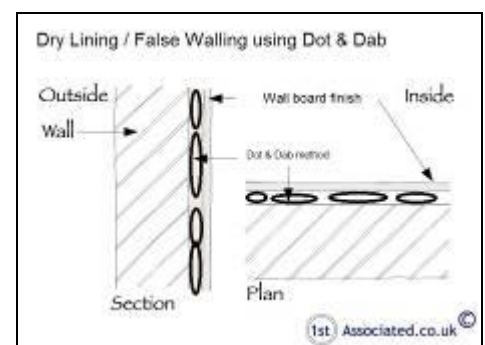
We noted internal cracks and some cracks may be hidden by the dry lining. Please remember to talk about any cracks identified within the property. Often insurers will refer to progressive and non-progressive cracking. Unfortunately, this is something we are unable to comment upon from a one-off inspection; the Building Research Establishment recommend a year of monitoring of any cracking.

Dry lining

ACTION REQUIRED: Please see our comments in the Executive Summary.

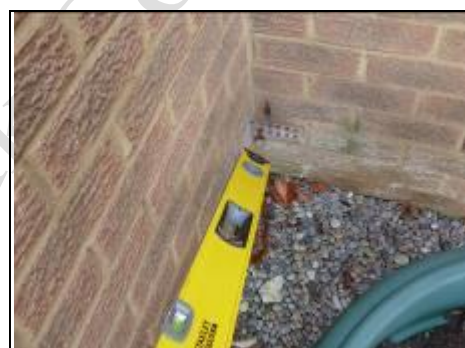
Air bricks are essential to have a through flow of air as this helps to reduce the chances of wet rot, dry rot and woodworm. In this case we found one airbrick to the chimney.

Air brick

ACTION REQUIRED: Please see our comments in the Executive Summary.

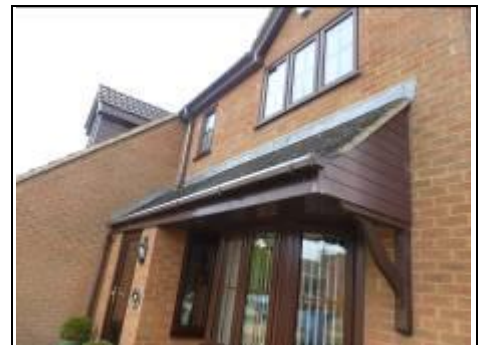
The property has plastic double glazed windows without trickle vents, which generally look to be of an average quality.

Plastic double glazed windows

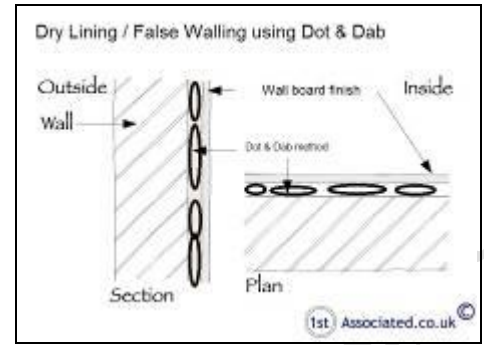
The perimeter walls are dry lined.

Dry lining

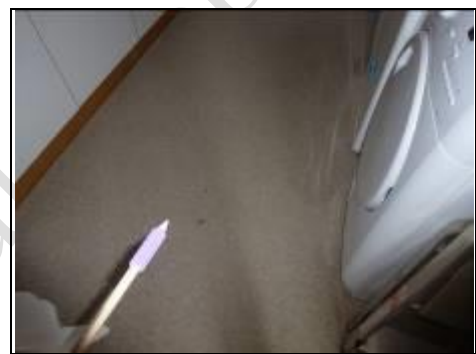
There is a suspended floor in the garage, this may be a DIY construction.

Suspended timber floor raised in garage area

ACTION REQUIRED: Please see our comments in the Executive Summary.

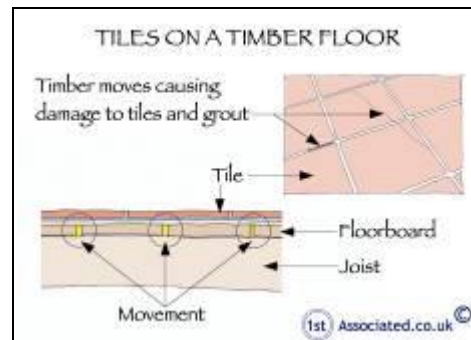
A hard material such as a tile onto a soft floor that deflects means that ultimately the joints will start to crack and deteriorate and you will need to repoint.

Tiles on timber

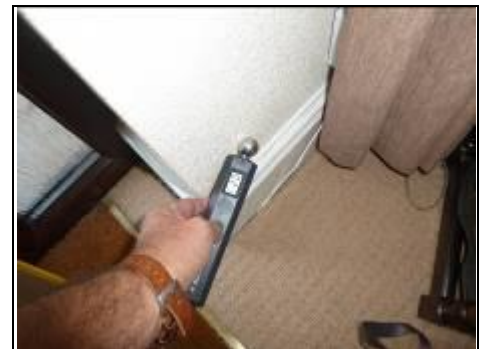
A random visual inspection and tests with a moisture meter have been taken to the perimeter walls. In this particular case we were unable to obtain readings due to the dry lining.

Dry lining

ACTION REQUIRED: Please see the Executive Summary.

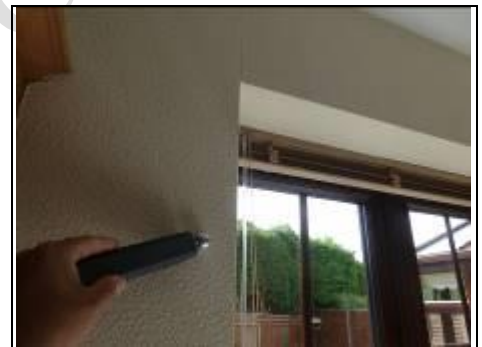
A random visual inspection and tests with a moisture meter have been taken to the perimeter walls. In this particular case we were unable to obtain readings due to the dry lining.

Testing for lateral dampness

ACTION REQUIRED: Please see our comments in the Executive Summary.

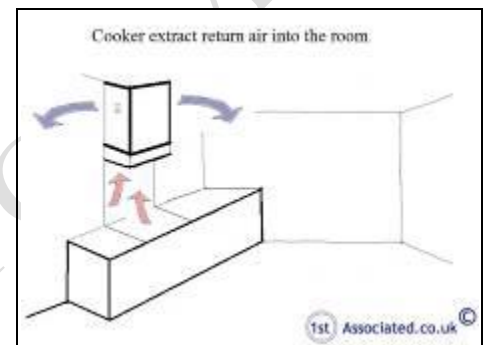
Cooker air filter in kitchen

We found the kitchen in average condition and would benefit from an extract.

ACTION REQUIRED: We would recommend good quality large humidity controlled extract fans be added to kitchens, bathrooms and any rooms where you intend to dry clothes.

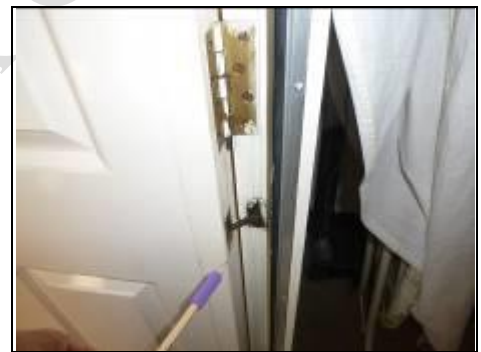
We noted the front left bedroom door is sticking and that the garage door has a door closer as garages are considered a high risk area from a fire point of view.

Internal door closer to garage

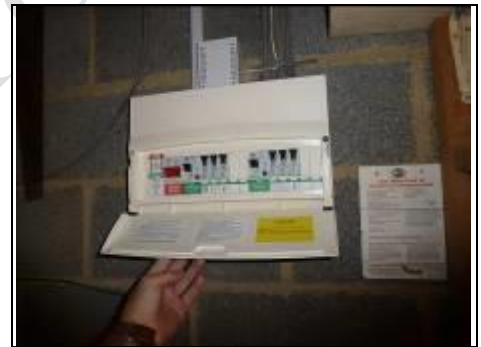
The electric fuses and consumer units were located in the garage. The fuse board looked 1980's – 2000's and better are now available.

Fuse Board

ACTION REQUIRED: As the property is changing ownership an Institution of Engineering and Technology (IET) test and report and any recommendations should be carried out by a NICEIC registered, or equivalent, approved electrical contractor or similarly approved.

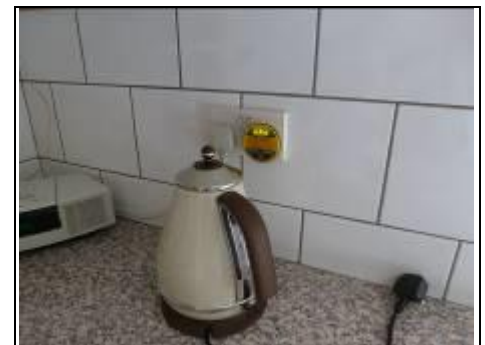
We carried out an earth test in the kitchen area to the socket point that is normally used for the kettle, this proved satisfactory.

Earth test

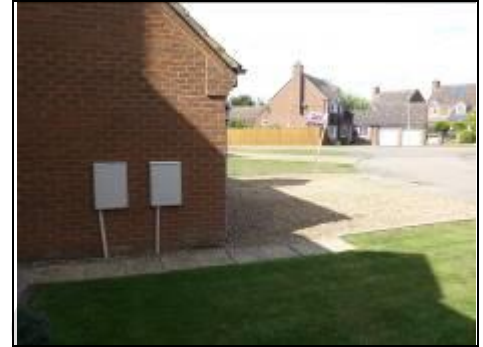
We are advised that the property has mains gas.
The consumer unit is located to the front left.

ACTION REQUIRED: As a matter of course it is recommended that the entire gas installation is inspected and made good, as necessary, by a Gas Safe registered contractor. Thereafter the installation should be serviced annually.

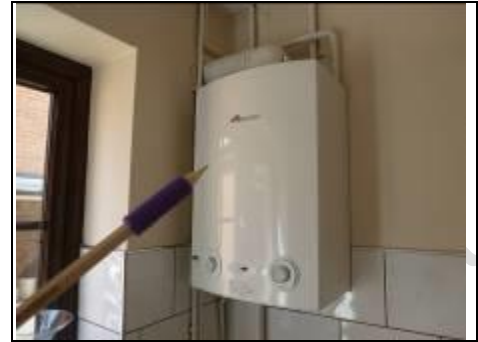
Boiler

There is the original Worcester boiler located in the kitchen.

Our limited inspection of the hot water and central heating system revealed no evidence to suggest any serious defects but we would nevertheless recommend that the system be tested and overhauled before exchange of contracts and that a regular maintenance contract be placed with an approved heating engineer.

ACTION REQUIRED: We recommend you return to the property with the estate agent to turn the heating on to ensure it is working.

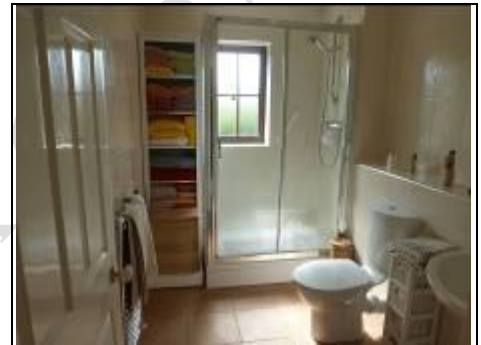
Bathroom rear middle

The property has a three-piece bathroom suite, consisting of a shower, wash hand basin and WC, which looks in average condition.

ACTION REQUIRED: The bathrooms would benefit from humidity controlled extract fans.

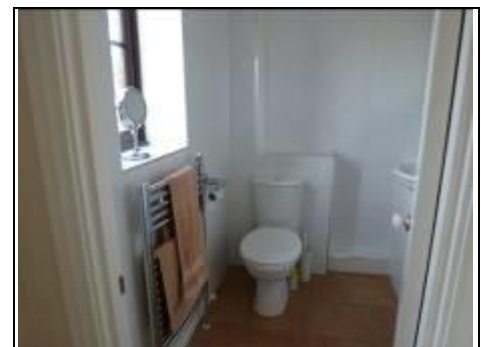
Bedroom front right en-suite

The en-suite has a three-piece bathroom suite, consisting of a shower, wash hand basin and WC, which looks in average condition.

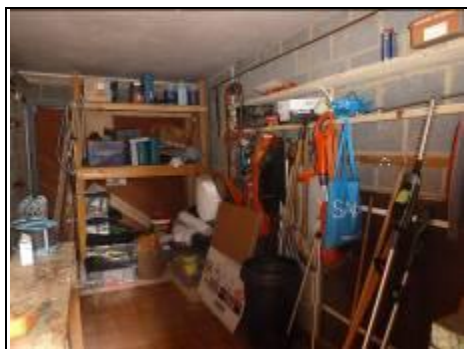
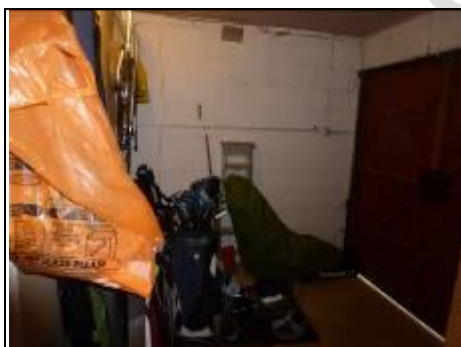
Garage

The garage has been part converted to incorporate a utility room, this should have building regulation approval. We noted cracking within the garage.

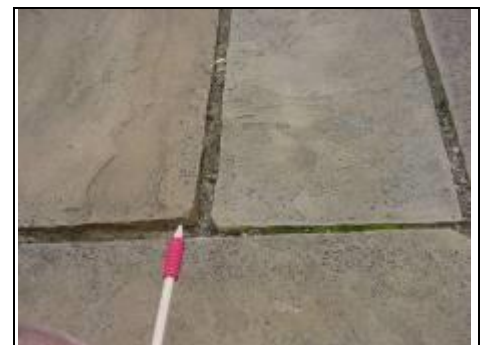
Rear triangular garden

Paving slabs need levelling up

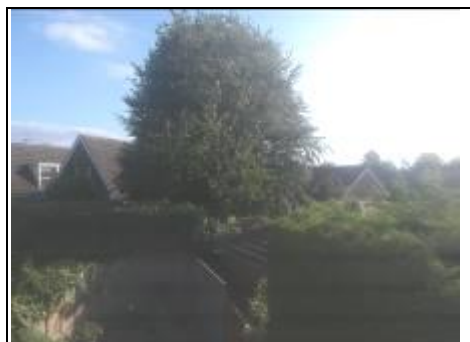
Please see our comments in the Executive Summary with regards to the large tree and conifers.

Large tree to rear

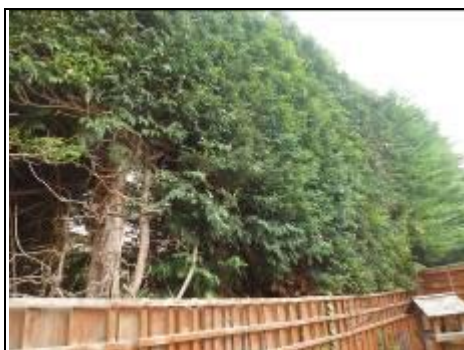
Conifers to rear right

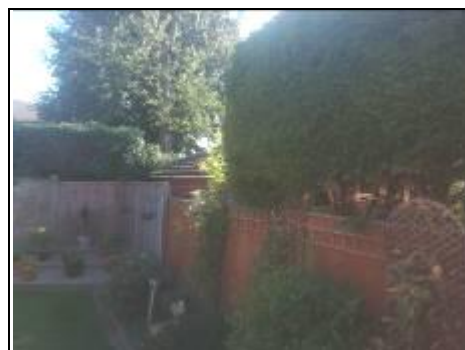
Conifers to rear right
~ Aerial View - 360 Photo ~
