RESIDENTIAL BUILDING SURVEY

Ealing

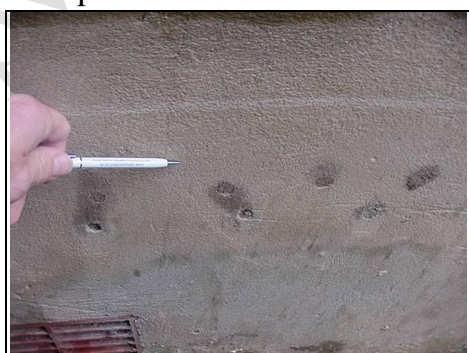
We can see to the left hand side and also to some of the right hand side, that there have been numerous previous attempts at inserting a damp proof course. We believe the problem to be on the right hand side and rear due to the high ground level and on the left hand side we believe is due to the render bridging the damp proof course, this requires a bell mouth to the render.

Damp proof course has been inserted on the left hand side

ACTION REQUIRED: It is important that both these works are done correctly as unless this happens, the dampness will remain.

ANTICIPATED COST: In the region of £10,000 - £20,000; quotations required.

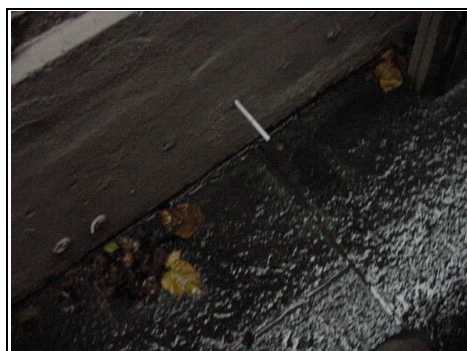
Damp proofing on right hand side

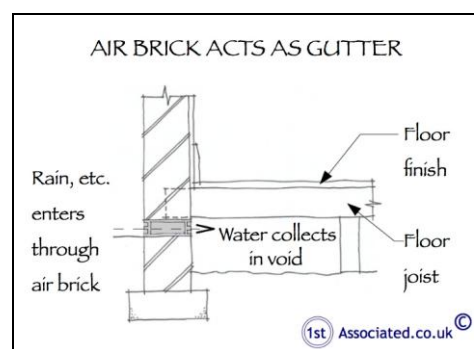
We suspect that additional airbricks were originally to the rear but these have been covered up by the decorative paving slabs that have been added.

ACTION REQUIRED: You need to ensure that all the current air vents are clear and allow a flow of air. You need to open up a section of the floor to check the condition of the timber underneath. If there is any dampness or deterioration then we would recommend additional airbricks are added to the rear.

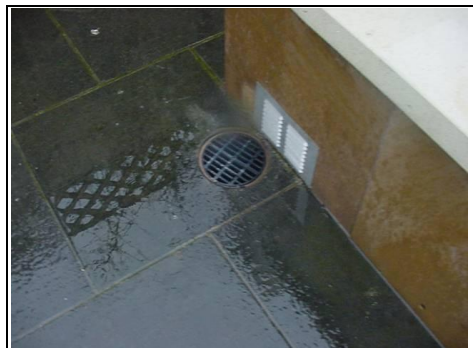
Airbricks acting as a gutter to the rear

ANTICIPATED COST: A worst case scenario would be £10,000 plus, a best case scenario would be in the region of £1,000 - £5,000; please obtain quotations.

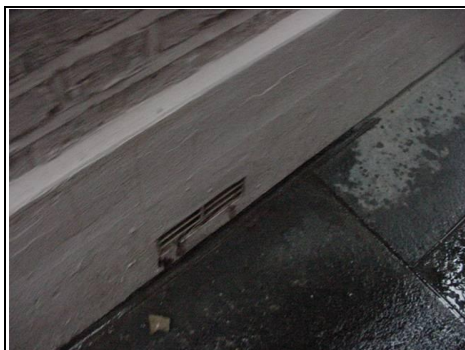
Airbrick acting as a gutter on the right hand side

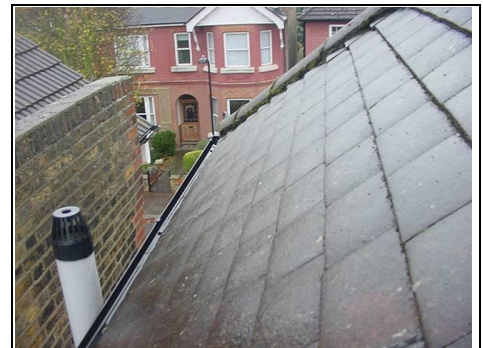
Close up of roof tiles

ACTION REQUIRED: A roofer to replace displaced tiles. Carry out periodic inspections and maintenance of the roof, as required.

ANTICIPATED COST: A few hundred pounds; quotations required.

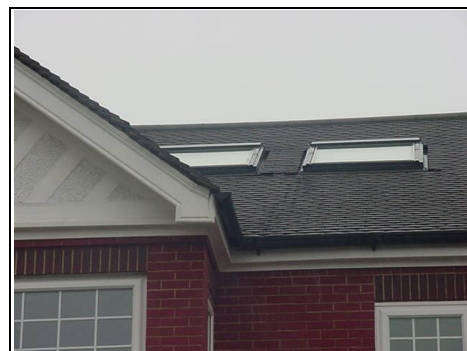
Three roof windows have been added to the front and one to the side as part of the loft conversion. These are a modern manufactured roof light and looked in reasonable condition. The important factor with roof lights is the flashing around them, in this instance we could see it looked in average condition although there was some moss sitting around it.

Roof windows

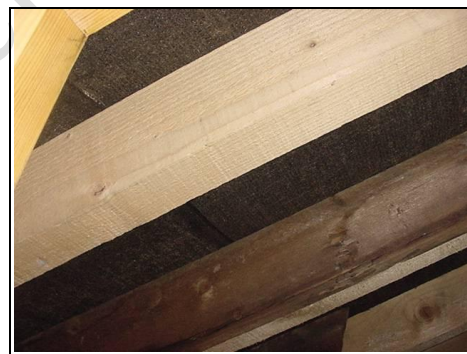
We were only able to see a very small area of the protective underlayer. This we found to be a Hessian base Bitumen membrane. We could only see approximately five percent of the underside of the roof. The Hessian based membrane has been used since the 1960s. We generally found the little we could see to be in average condition.

This photo shows the common rafters (the ones that form the pitch of the roof) and the dark area between is the protective underlayer

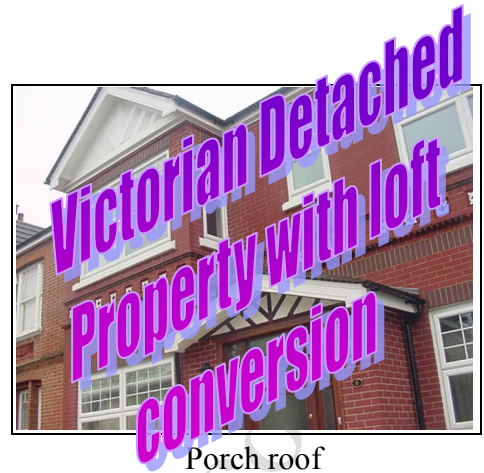
Porch roof

There is a shallow pitched roof over the porch that we assume has been put at that pitch to miss the decorative band of brickwork running across the property. We can see that the flashing has been added poorly. Rather than stepping the brickwork which is traditional with this age of property, it has been cut into the brickwork.

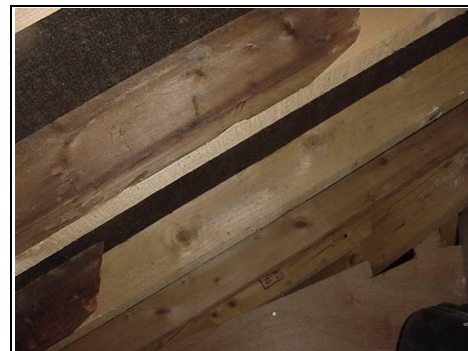
Roof viewed in rear right hand cupboard space on the top floor

Our examination was very limited due to the loft conversion. The timbers we could see were newer timbers and were thinner and smaller in profile than we expected but without seeing the whole roof we cannot be certain of how it is constructed. It may, for example, have a metal frame within it which would allow the size of the timbers to be reduced.

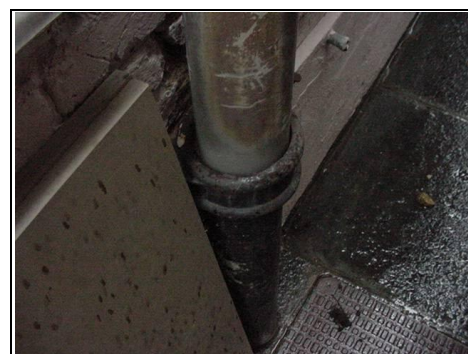
Soil and vent pipe – cast iron to plastic

The property originally had cast iron soil and vent pipes, part of the cast iron can be seen in the adjoining photo to the base of the property. The remainder is in plastic.

Cast iron of this age can crack and rust and needs regular maintenance.

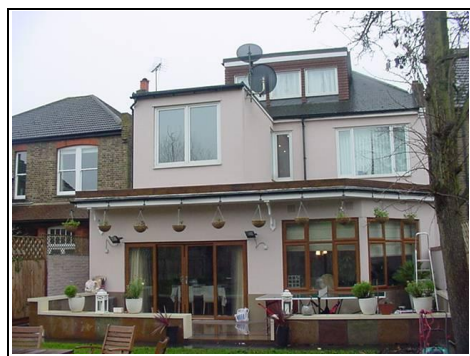
Render to the rear

The external walls to the rear are finished in a smooth faced painted render. We are always wary when we see rendered properties as it usually means they have been rendered for a particular reason.

In this particular case we believe it has been added at a later date as we cannot see it on adjoining properties. It looks a new style cement render.

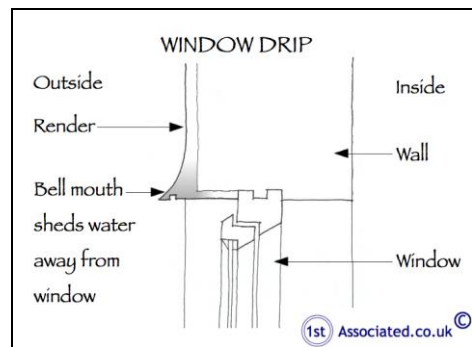
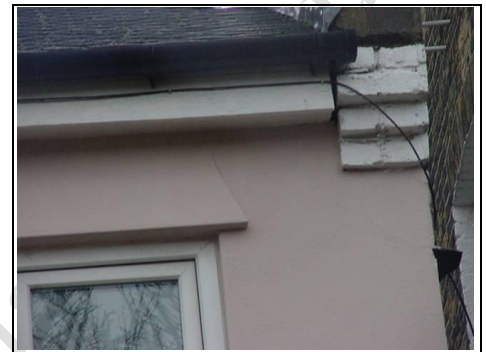
Drip details over the window on the render to the rear

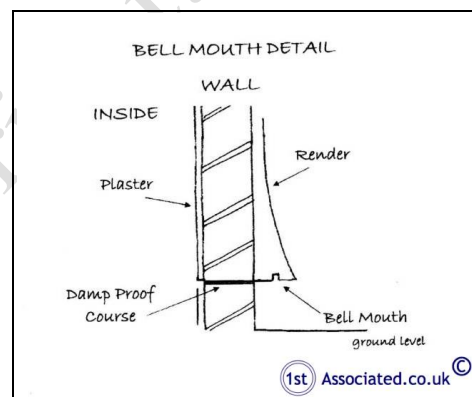
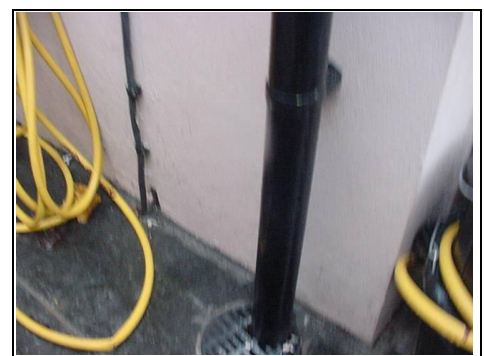
However to the base where we would expect to find a drip detail, there is no detail.

No bell mouth

ACTION REQUIRED: Please see our comments within the Executive Summary with regards to adding a bell mouth.

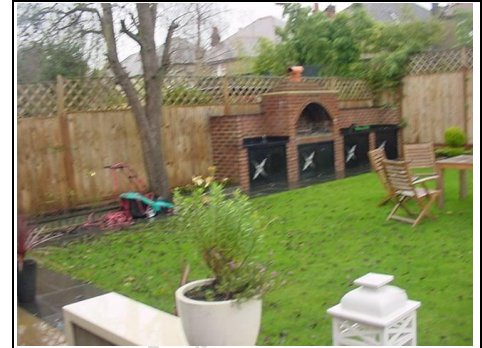
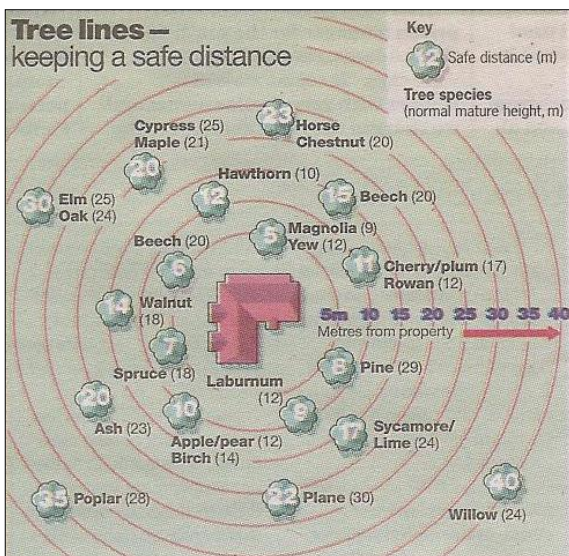
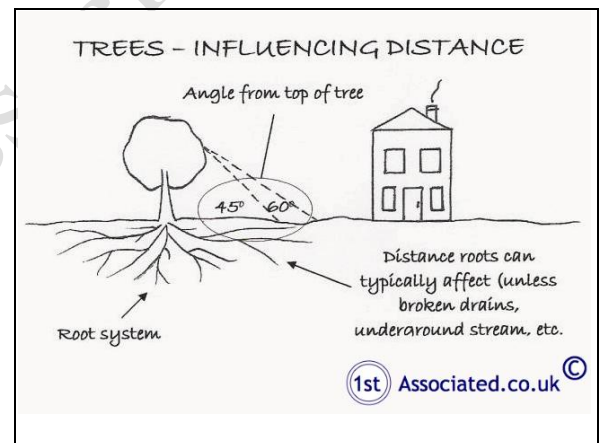
There is a tree within what we would term as influencing distance of the property. You need to keep it well maintained; it is likely to add to your insurance premium as it is so close to the house. It could be argued that this is causing the problem with regard to the cracking to the rear of the property which is why it is important to ensure that you have an insurance claim in place and agreed before you commit to purchasing the property.

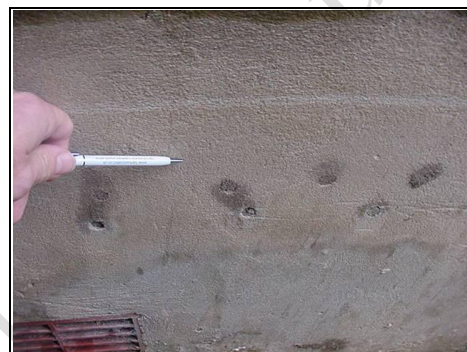
Damp proof course has been inserted on the left hand side

ACTION REQUIRED: Please see our comments in the Executive Summary.

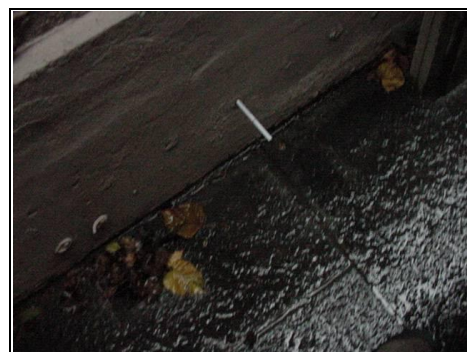
Damp proofing on right hand side

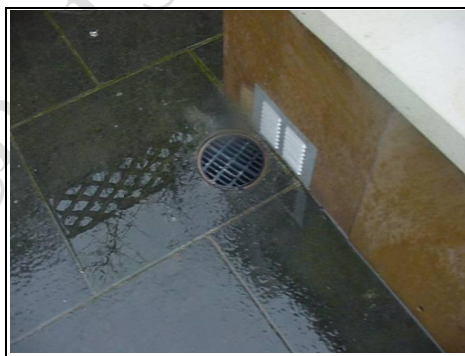
Airbrick acting as a gutter

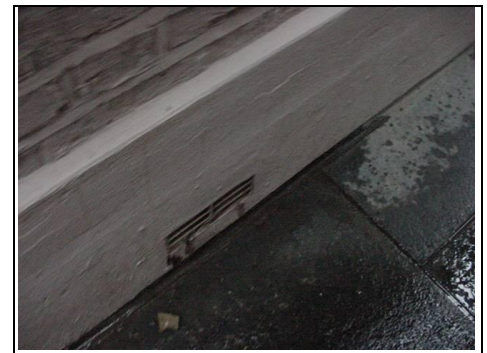
Airbrick acting as a gutter on the right hand side

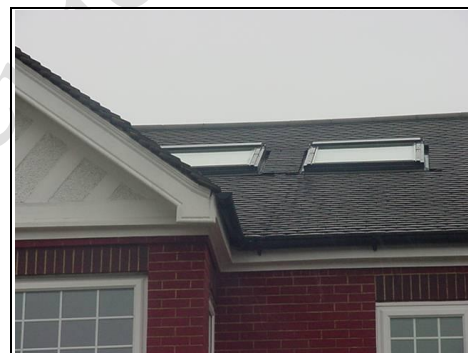
Fascias and soffits

The fascias and soffits are timber. They are painted and we would comment they are in average condition for their age, type and style.

ACTION REQUIRED: Make sure gutters and downpipes are watertight before carrying out any work on fascias and soffits.

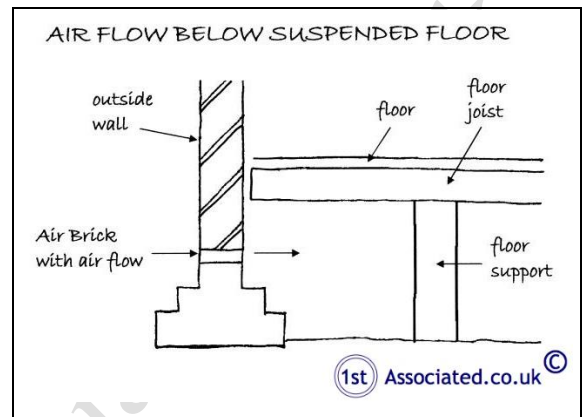
The floors to the property are suspended timber floors which are covered with ceramic tiles and wood flooring which has limited our inspection.

Tiles to wooden floor with a step on the ground floor

ACTION REQUIRED: Please see our comments within the Executive Summary with regards to the problems that can occur where ceramic tiles are laid over timber floors.

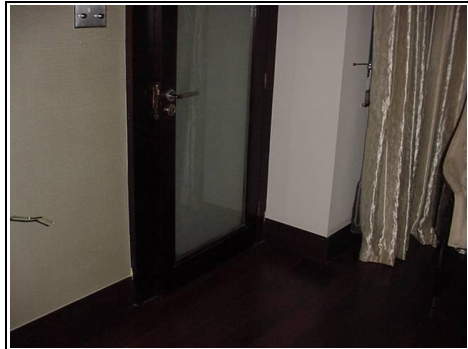
Glass doors

There is a variety of modern doors. Some of them are glazed, these should have a British Standards kite mark to ensure that they are safety glass; we couldn't see it in this instance.

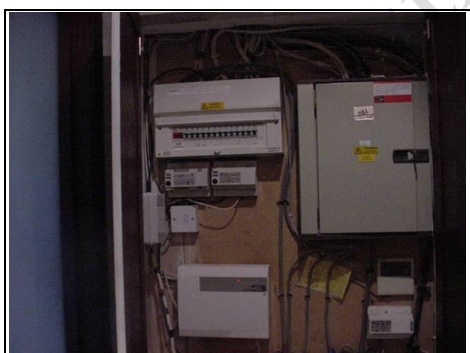
Circuit board on ground floor

Quite unusually this property has two electric fuse boards. One is located in a cupboard on the ground floor next to the entrance door, the other one is at first floor level. This may have been added due to the under floor heating being electric.

ACTION REQUIRED: You need to specifically ask the owner why two fuse boards are present. We would add that we were pleased to see that the fuse boards were relatively modern.

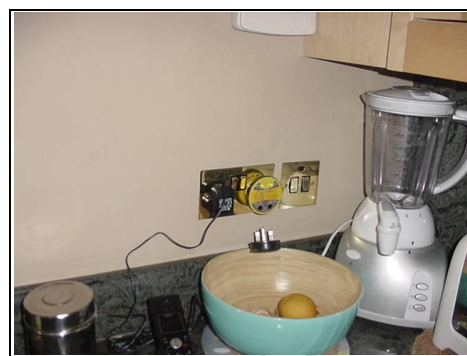
Earth Test

We carried out an earth test in the kitchen area to the socket point that is normally used for the kettle, this proved satisfactory.

ACTION REQUIRED: As the property is changing occupancy an Institute of Electrical Engineers (IEE) test and report should be carried out by a NICEIC registered and approved electrical contractor.

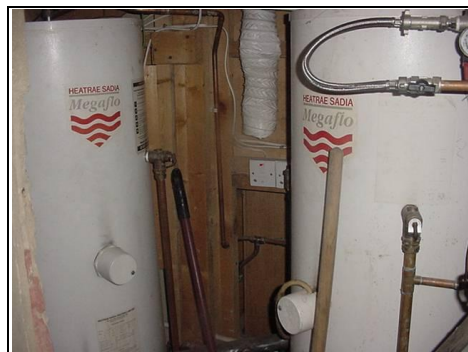
Megaflow Cylinders

There are two modern Megaflow hot water cylinders. In our experience we have found these to be very good. This type of cylinder hasn't been in existence for that long.

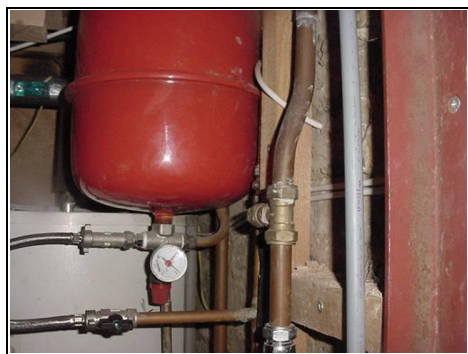
Pressurised cylinder

We noted that the system is pressurised which means that pressure is added to enable the water supply to reach all the parts of the building. These need regular maintenance.

Our limited inspection of the hot water and central heating system revealed no evidence to suggest any serious defects but we would nevertheless recommend that the system be tested and overhauled before exchange of contracts and that a regular maintenance contract be placed with an approved heating engineer.

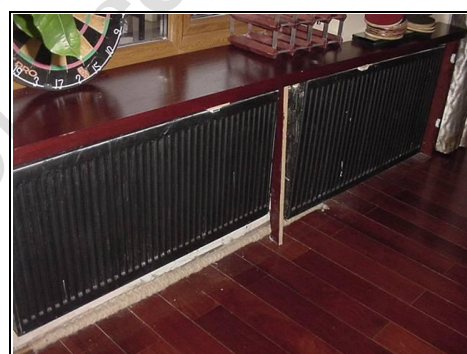
These are located on the right hand side of the property. We have not had the benefit of testing these, so we cannot comment on them.

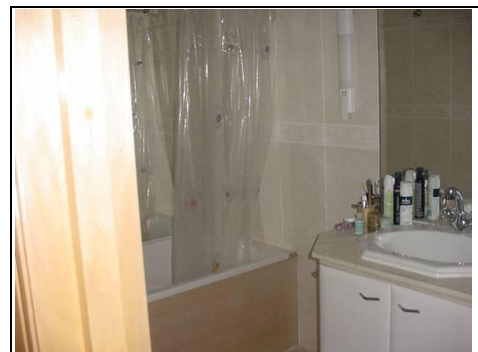
En-suite bathroom to front left hand bedroom

This comprises a three piece bathroom suite, consisting of a bath, shower, wash hand basin and WC, which looks in average condition. The shower mastic needs checking.

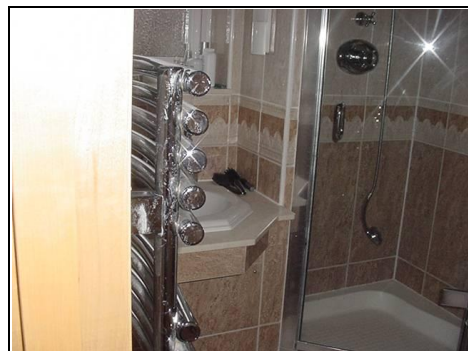
En-suite shower room to front right hand bedroom

This comprises a three piece bathroom suite, consisting of a shower, wash hand basin and WC, which looks in average condition. We would recommend you check the seals around the shower.

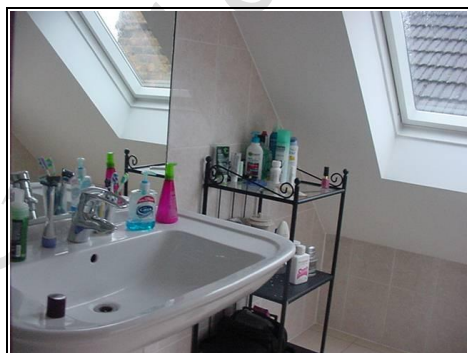
Bathroom to top floor

This comprises a three piece bathroom suite, consisting of a shower, wash hand basin and WC, which looks in average condition. Again, we would recommend you check the seals around the shower.

Finally, although we may have already mentioned it above we would reiterate that it is important to ensure that seals are properly made and maintained at the junctions between wall surfaces and baths and showers etc. We normally recommend that it is one of the first jobs that you carry out as part of your DIY on the property, as water getting behind sanitary fittings can lead to unseen deterioration that can be costly, inconvenient and difficult to repair.

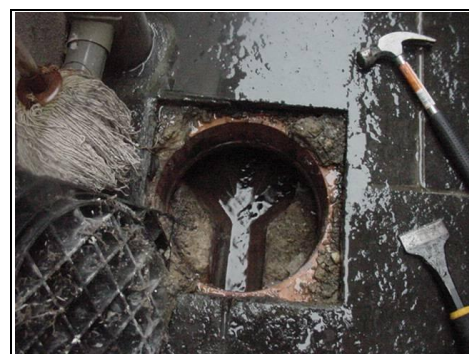
Manhole one

We duly lifted the cover and found it to be free flowing at the time of our inspection.

From what we could see it is plastic.

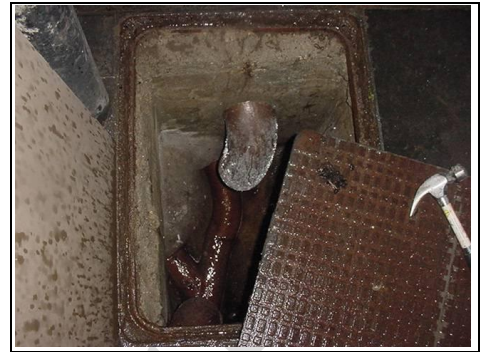
Manhole two

We duly lifted the cover and found it to be free flowing at the time of our inspection.

From what we could see it is concrete built.

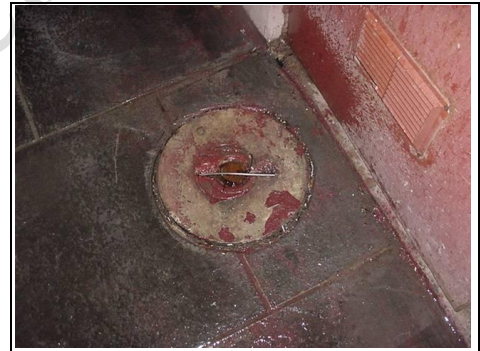
Manhole three

We were unable to lift this manhole. It is known as a modern inspection chamber.

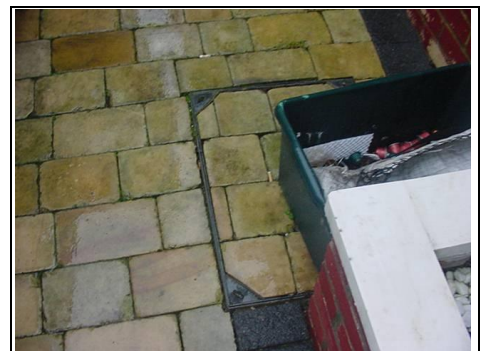
Manhole four

We were unable to lift this manhole.

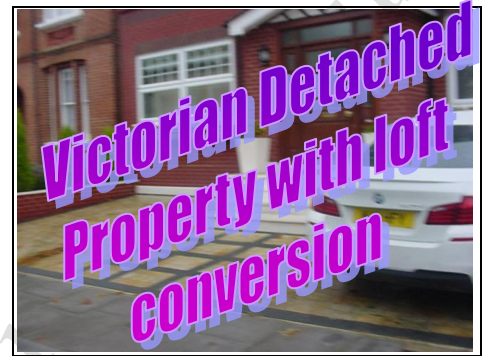
There is a car parking area to the front of the property.

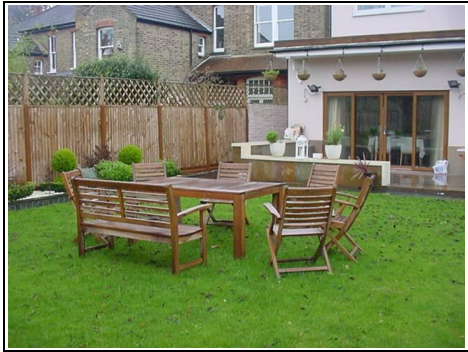
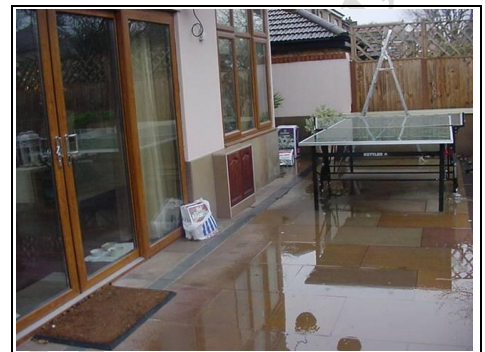
Rear Garden

The rear garden has a patio area and a grassed area. Please note our comments on the tree in the Trees Section, which could affect your insurance and could be affecting the rear of the property.
