JOB REFERENCE: XXXX

RESIDENTIAL BUILDING SURVEY

London

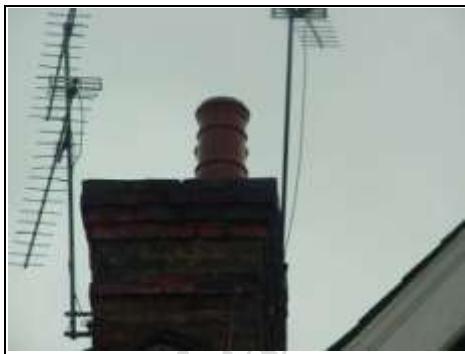
1.1) We could see that the front left hand chimney and also rear right hand chimney (all directions given as you face the property) requires work. To the front left hand chimney we believe re-pointing and possibly repair work to the flashings and to the rear right hand chimney we believe repairs are required to the flashings although we could not view the chimney properly.

Front left hand chimney

ACTION REQUIRED: Repair as necessary the chimneys to make water tight. We believe it is likely re-pointing and adding/amending flashings required.

ANTICIPATED COST: The main cost relates to the scaffolding required, we would anticipate costs for the chimneys to be in the region of £1,500 to £4,000; please obtain quotations. If this work is left deterioration will occur to the roof structure.

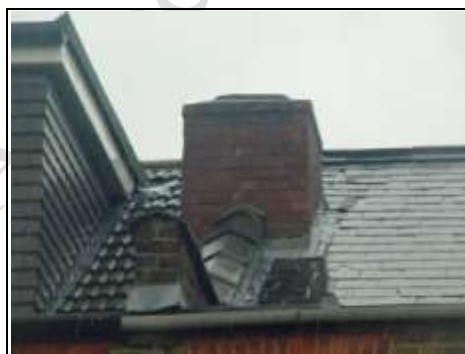
Rear right hand chimney
(lead looks to be cut straight rather than following the brick joint)

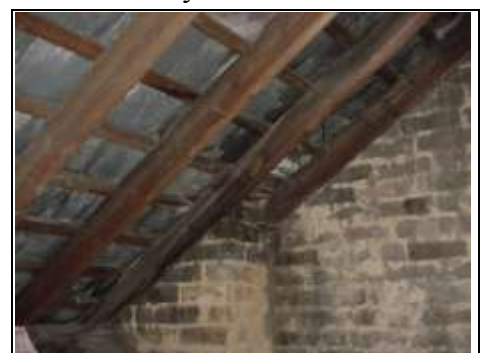
Dampness coming in around rear right hand chimney

In both cases when we were in the roof space we could see that rainwater was getting in; please see above photographs.

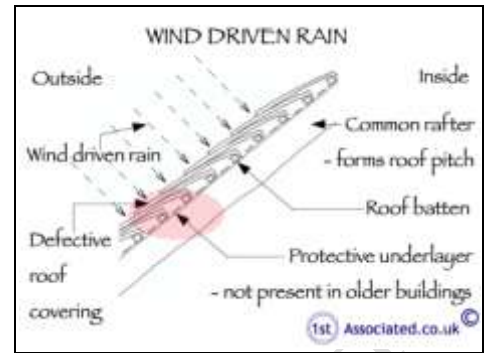
Having stood inside the roof space for quite awhile whilst it was raining there was not very much rainwater getting inside. Looking at the timber battens and common rafters (the timbers that form the pitch of the roof) we could see staining from where rainwater has got in which is probably wind driven rain that has penetrated the roof.

We are always in a Catch- 22 with regard to this type of roof as to what to recommend, as although it is letting in some rain water it is not letting in that much.

Wind driven rain

ACTION REQUIRED: As a short term measure we would suggest boarding out the roof with a board with a solid insulation back (such as Celotex or Kingspan) which would then give a pseudo second line of protection for any dampness penetrating through the slates and

also allow you to establish exactly where the major roof leaks are and have these repaired.

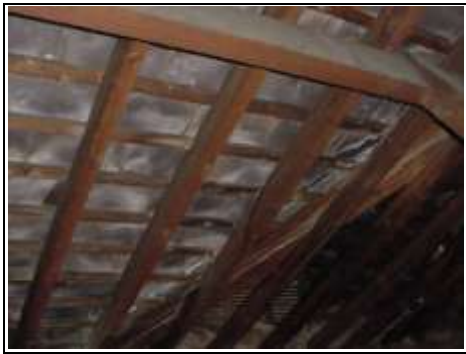
Views from within your roof when it was raining.

Dampness visible on timbers

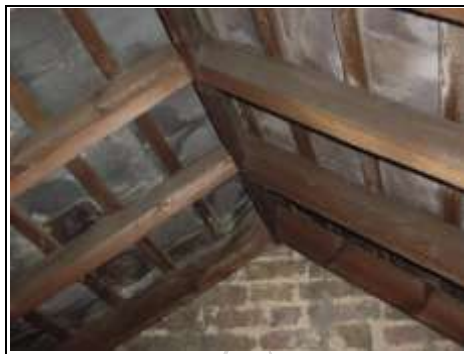
Dampness visible to underside of some of the slates

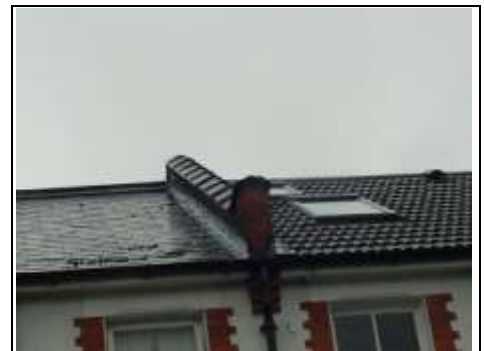
Adjoining roofs have been replaced with concrete tiles and the majority of the roofs in the road have been replaced.

Next door's loft conversion with concrete tile to right hand side and your roof to the left hand side

We believe you should negotiate a reduction in the price because ultimately you will have to replace the roof as have the majority of properties in the road.

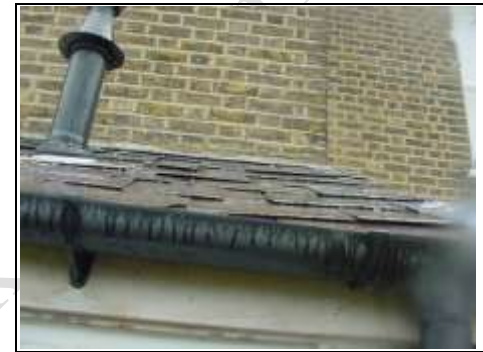
- 3.1) Whilst the rear roofs did not leak during the course of our inspection they are a miss mash of different types, styles and ages of roofs. These roofs, we would say, will suffer from problems in years to come probably starting with the middle tiled roof where the tiles already look to be uneven and displaced.

Poor quality slate to rear low level roof

ACTION REQUIRED: Next time it rains heavily observe how the roofs cope with heavy downpours if you intend to keep them and then employ a roofer to carry out repairs during dry weather and also obtain a supply of the slates.

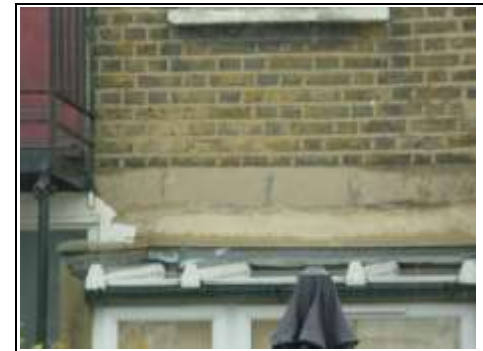
Polycarbonate roof over small conservatory and lead flashing where it meets the building and adjoining roof

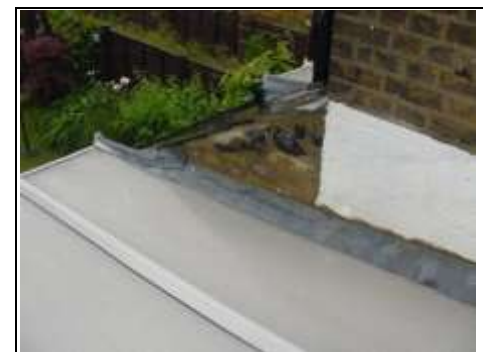
Polycarbonate roof over kitchen area

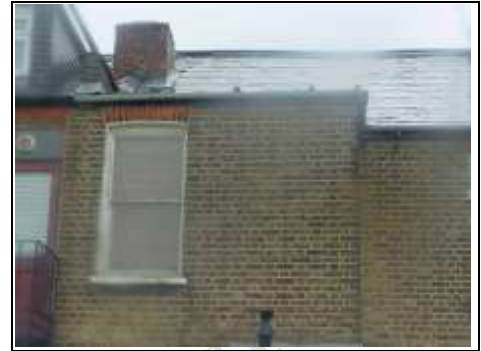
There is a flat roof at high level that is hidden from view. We believe it is a flat roof but obviously we cannot actually view this roof.

Flat roof we could not view to the rear which looks likely to be a lead roof

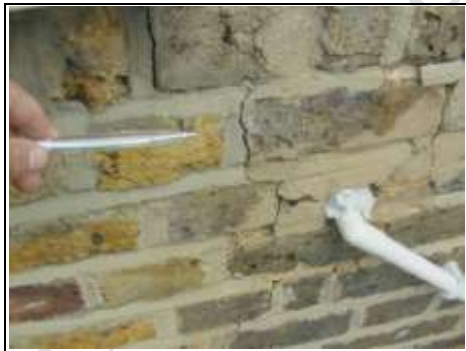
The property has Flemish Bond brickwork which is traditional for this era of property unfortunately the brickwork has been incorrectly re-pointed in a cement mortar.

Cement mortar re-pointing

ACTION REQUIRED: We normally recommend you need to employ the oldest brick layer you can find and asking him to come and carry out re-pointing work for the next few years using a stiff brush once or twice a year on the cement and re-point in a lime mortar until a good proportion of it is replaced.

Unfortunately the cement re-pointing, whilst well meaning, is not appropriate for this type of construction. A cement mortar has been used rather than a lime based mortar. We recommend you use lime mortar in any future repairs regardless of what the builders say! Using lime mortar will limit further damage to the brickwork, which is almost impossible to repair successfully. However, we would add that many, if not most, of the properties that are re-pointed are re-pointed wrongly; it is only in recent years that we have discovered the problems that can occur from it.

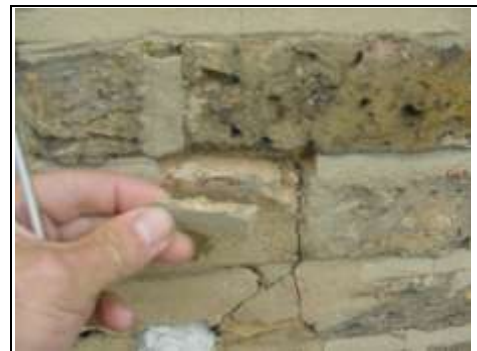
Cement mortar re-pointing
breaking away

As we showed you, if you recall, the cement mortar will fall out on its own over time as it tends to become hard and brittle as opposed to the lime mortar that stays relatively soft.

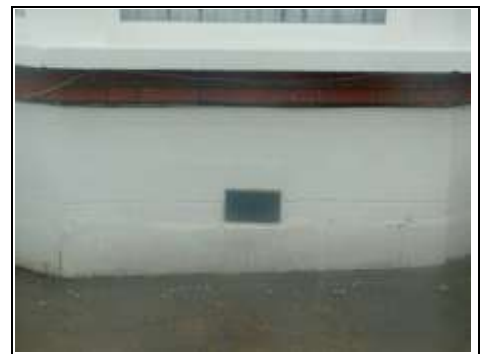
Airbrick to front. Has the property had a damp proof course added? Guarantee required if it has been added.

ACTION REQUIRED: Ensure all airbricks are clear.

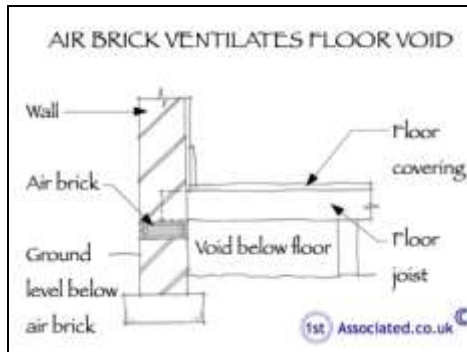
Airbrick to rear

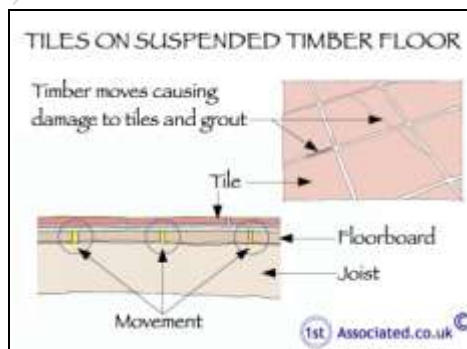
A tile being added to a timber floor which deflects slightly tends to lead ultimately to the cracking of the tile joints and re-grouting is required.

Tiles on a timber floor

ACTION REQUIRED: Check condition of tiles and grout regularly.

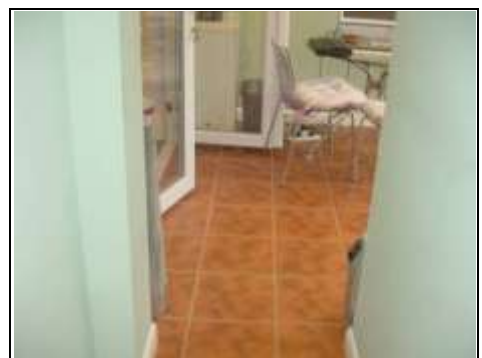
Tiled floor

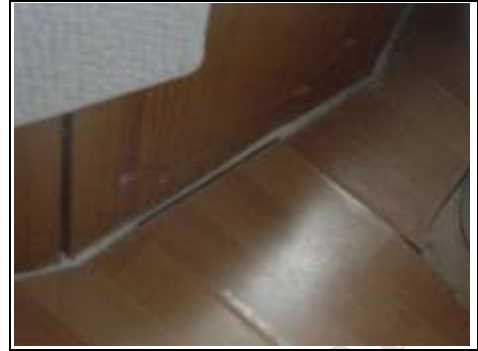
The laminate boarding that has been fitted is very poor in some areas and worn particularly in the bathroom.

Poor quality DIY laminate floor boarding

ANTICIPATED COST: This will naturally depend upon the quality and flooring material you require; please obtain quotations.

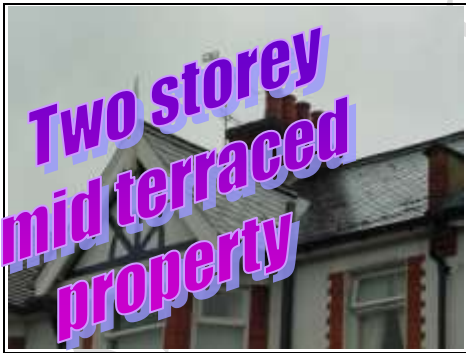
Chimney One

This chimney is brick finished with a lead flashing and one chimney pot. From what we could see from ground level it looked in average condition considering its age, type and style. Re-pointing work is required.

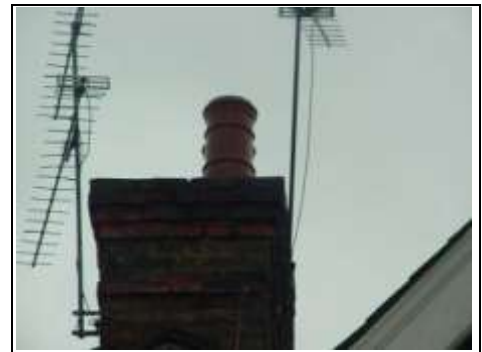
Close up of chimney One

The only other point to make with regard to the chimney is the straps that have been used for the aerial. We have found in the past that

these cause damage to the brickwork as they produce pressure points on the chimney; we suggest that this be checked.

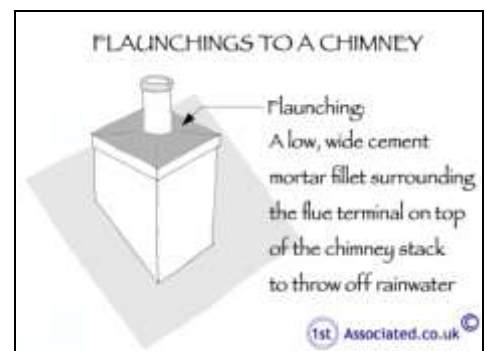
Unfortunately we were unable to see the top of the chimney known as the flaunching, we therefore cannot comment upon them.

Chimney flaunchings

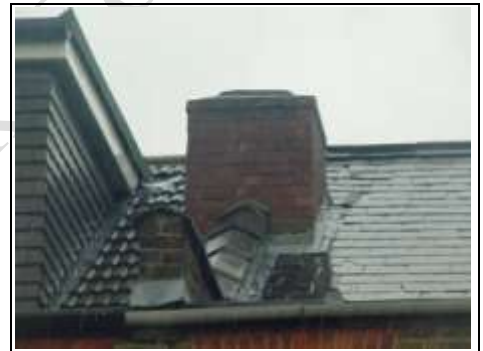
Chimney Two

This chimney has been relatively newly built in brickwork which we could see at first floor level but we could not see at ground floor level as it has been removed.

ACTION REQUIRED: Your Legal Advisor to check Local Authority Approval has been obtained.

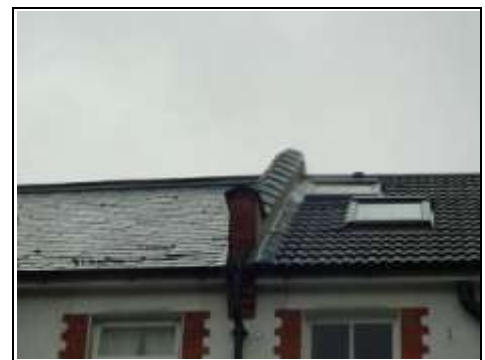
Parapet wall

In this case there are parapet walls to either side of the roof these are built from brick with a coping stone, where we could see it, and a stepped flashing.

Finally, we were only able to see approximately fifty percent of the parapet wall, therefore we have made our best assumptions based upon what we could see. A closer inspection may reveal more.

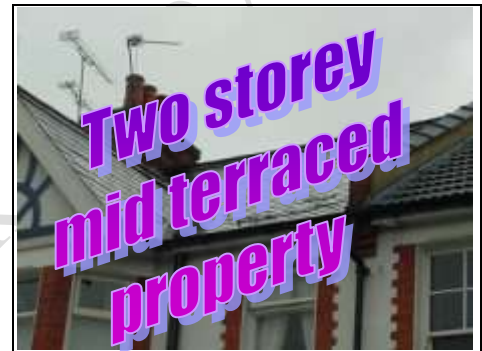
Main roof

The main roof is pitched and clad with slates and, from ground level, this looks in average condition considering the roofs age type and style although from viewing in the roof space we are aware that there is no protective underlayer. We would also add that there are some slipped slates and in particular we would draw your attention to the rear roof which undulates and does not sit flat. With this age of roof it is not that unusual to have a few missing or displaced slates.

ACTION REQUIRED: Please see our comments in the Executive Summary and carry out periodic inspections and maintenance of the roof, as required.

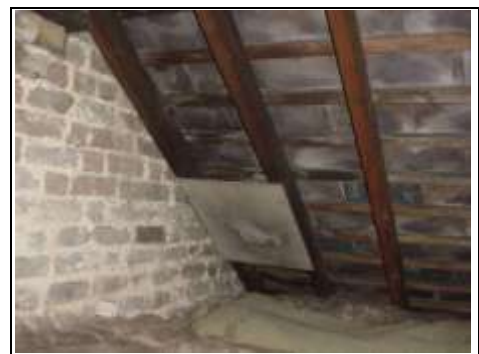
Underside of roof showing slates and piece of asbestos

ACTION REQUIRED: We always recommend all asbestos is removed as not only does it have the potential for problems it does tend to affect value as some people simply will not buy a property with any asbestos present.

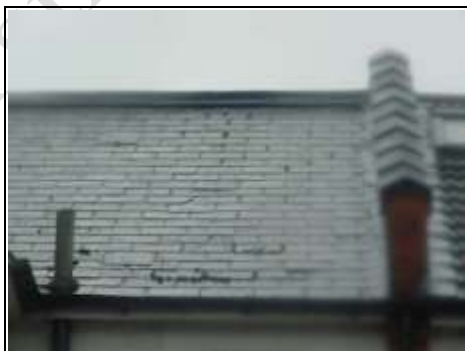
Some displaced and slipped slates to the front of the property

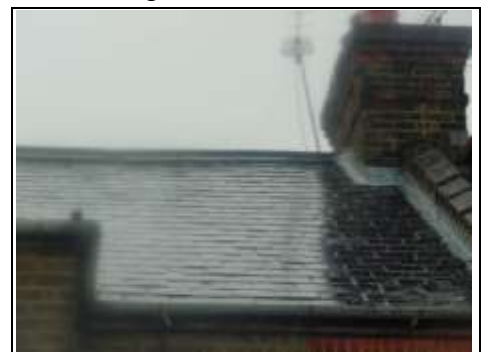
Undulating rear roof

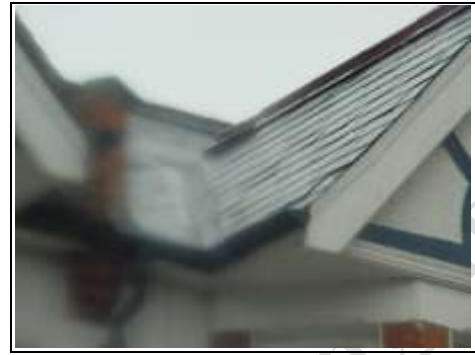
Photo of roof with raindrop on it showing perimeter has lifted slightly

We noted that some of the perimeter slates were lifting; this can happen where a slopped roof is not bedded flat as in this case and ultimately this can lead to some lifting of the slates.

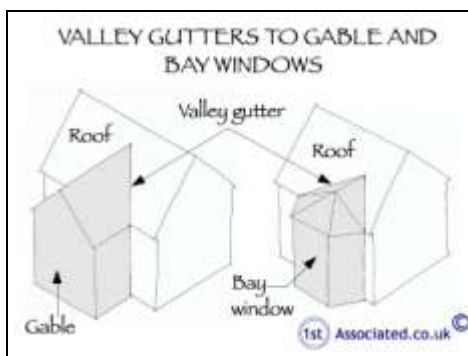
Valley gutters

There are some slipped slates which we could see dampness is allowing into the structure. This we believe probably relates to slates being displaced around the valley gutter. It is not possible to view this area from ground level and a more close up inspection is required.

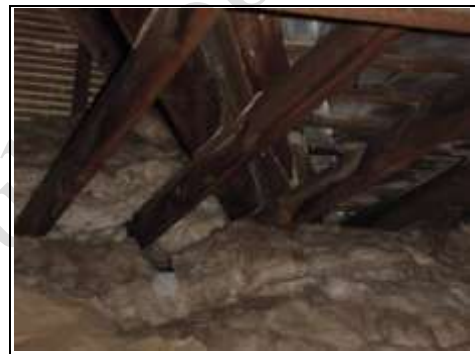
Dampness getting in beneath valley gutter

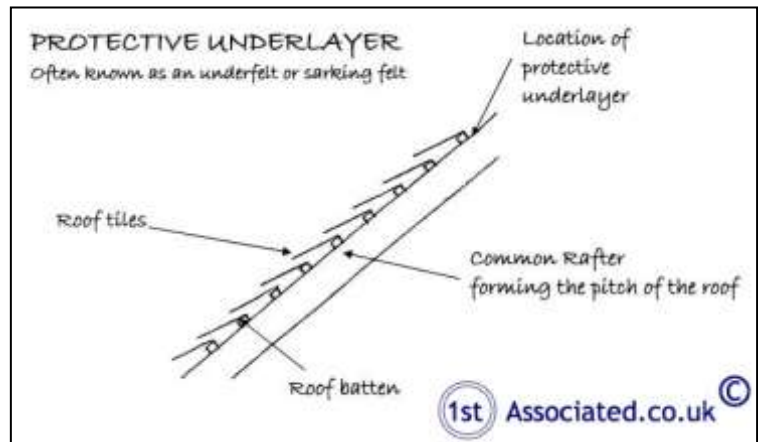
Protective underlayer

No protective underlayer is present. Often an older roof will have no protective underlayer at all unless it has been re-roofed post war and then it will have a Hessian base bitumen membrane.

This photo shows the common rafters (the ones that form the pitch of the roof) and no protective underlayer. White salt stains indicate dampness is getting in.

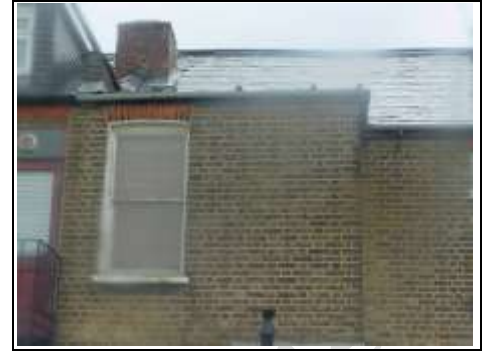
Flat roof to rear

Please see our comments in the Executive Summary as we could literally not see this roof and it does require a close up check.

The edge that we could see looks to be metal possibly lead this type of roof very much depends upon the type of decking and the skill of the person that has made the roof.

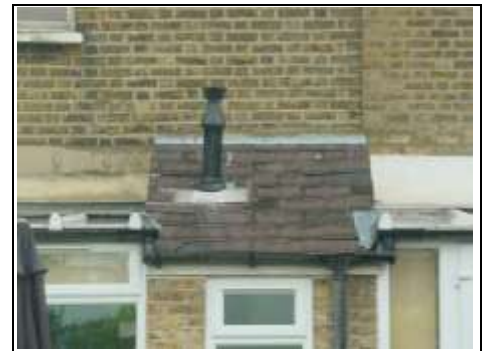
Low level slate roof

We are aware with regard to your comments about extensions to the rear of the property and would refer you to our comments within the Executive Summary with regard to the slate roof which is in below average condition.

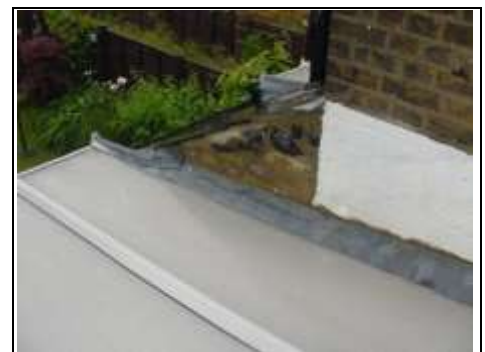
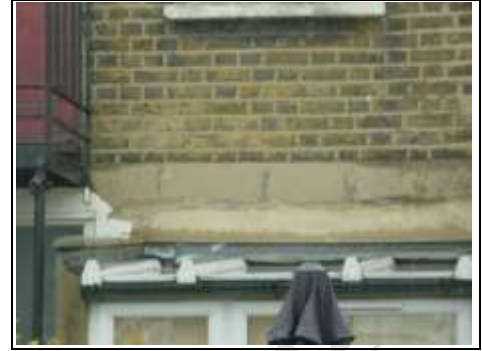
Polycarbonate roof over kitchen

There is a polycarbonate roof to the kitchen and conservatory area. We generally find that polycarbonate is a cheaper alternative to carry out a roof and ultimately it does tend to leak at the joints. In the case of where it has been used in a kitchen it may well get condensation.

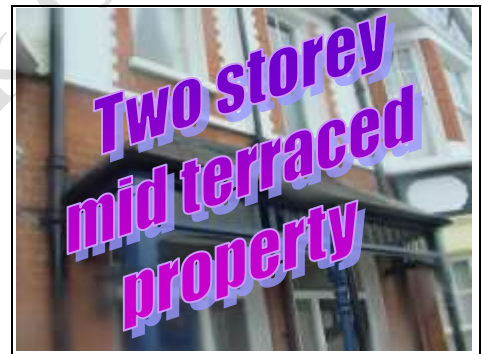
Front porch roof

There is a small front porch roof which is in average condition for its age, type and style.

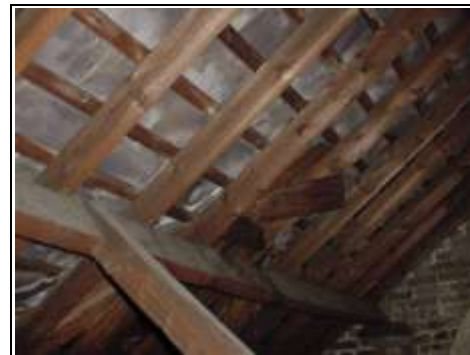
General view of inside of main roof

Our examination was limited by the general configuration of the roof and the insulation. What we could see was generally found to be in average condition for its age, type and style considering there is no protective underlayer i.e. there is dampness in some areas and salts showing that there has been dampness in other areas. It is, however, feasible that there are problems in the roof that are hidden.

ACTION REQUIRED: The only way to be 100 per cent certain of this construction is to have the roof cleared and checked.

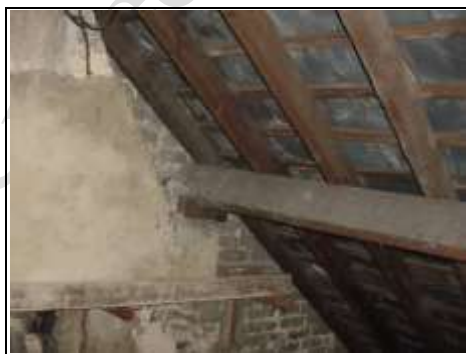
Purlin on rear left hand corner balanced on a brick needs securing

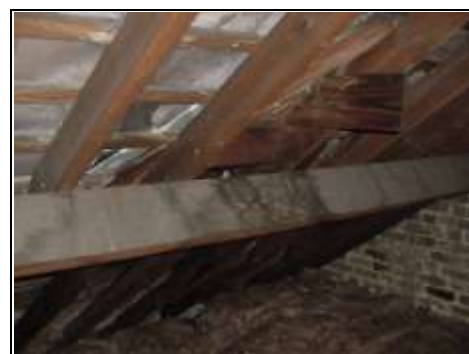
Dampness visible through timbers

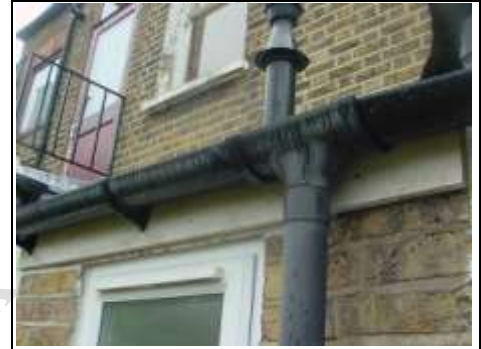
Gutter and downpipe

There may be some minor leaks but most people would be happy to live with these providing repairs are carried out within the next six to twelve months.

ACTION REQUIRED: We would recommend you stand outside the property next time it rains heavily and see how well the drains cope with the rainwater particularly looking at the guttering and the joints. We would also recommend that the gutters and downpipes are cleaned out, the joints are checked and the alignment checked to ensure that the gutters fall towards the downpipes.

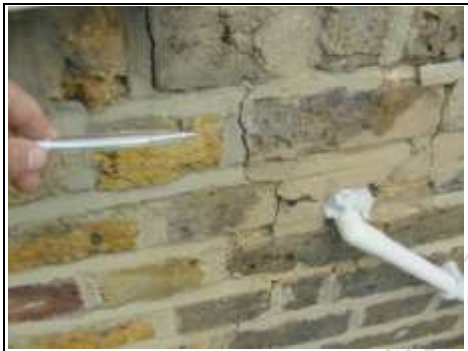
The brickwork has been incorrectly re-pointing using a cement mortar rather than a lime mortar.

Cement mortar re-pointing

ACTION REQUIRED: Re-point in a lime mortar. Please see our comments in the Executive Summary.

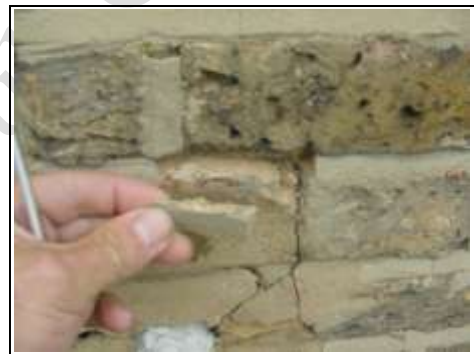
Cement mortar re-pointing
crumbling away

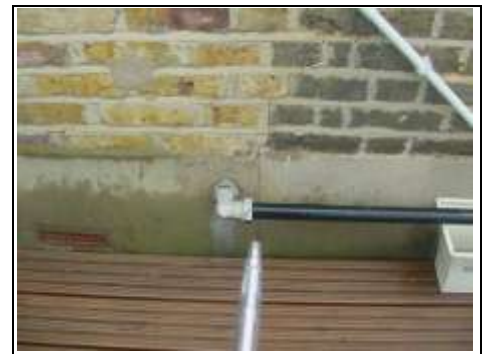
We noted different brickwork to the rear of the property.

Different brickwork to rear

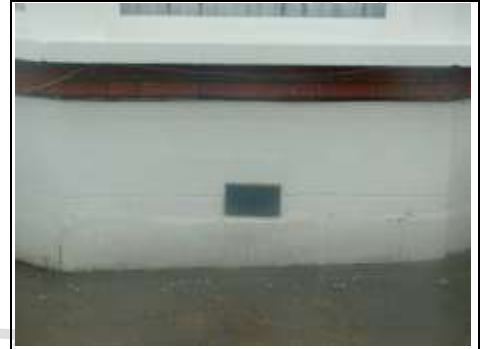
All modern properties should incorporate a damp proof course (DPC) and good building practice dictates that a differential of 150mm (6 inches) should be maintained between the damp proof course and ground levels. In this case, cannot see a DPC, in theory one should have been added.

Damp proof course may have been added?

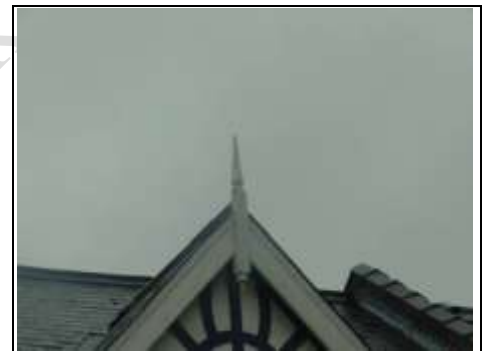
Fascias soffits and bargeboard

The fascias, soffits and bargeboards are timber. They are painted and we would comment they are in slightly below average condition for their age, type and style.

ACTION REQUIRED: We recommend redecoration in the summer of 2013. Make sure gutters and downpipes are watertight before carrying out any work on fascias and soffits.

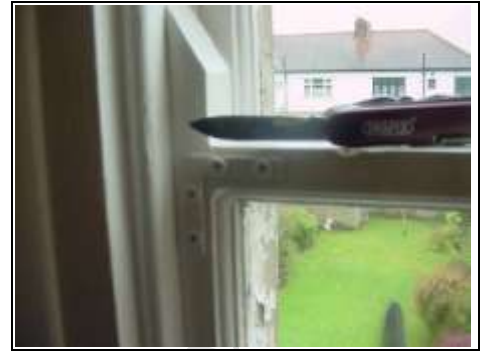
Window held together by metal straps

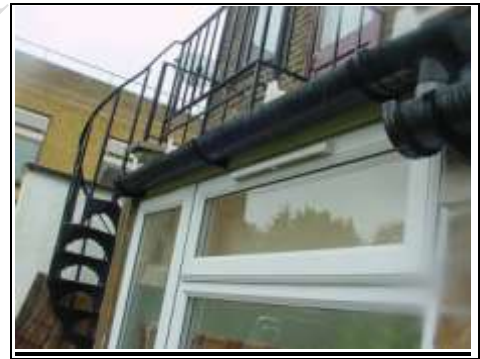
Double glazed plastic windows

Generally they look to be of an average quality for their age, type and style.

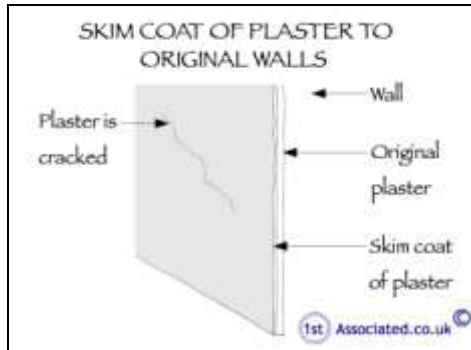
We noted some hairline cracking to front left hand bedroom plaster and rear left hand bedroom (all directions given as you face the property). Whilst there has been movement in the property we believe this cracking relates specifically to a modern gypsum plaster being applied, please see our sketch.

Skim coat of plaster

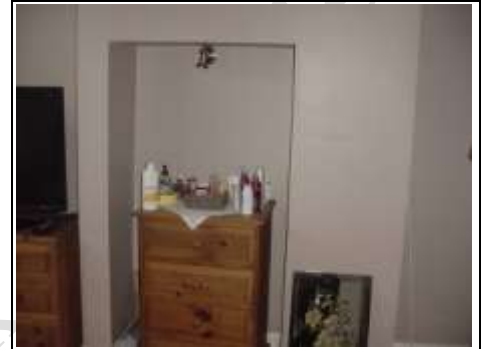
We noted chimneys have been removed both to the left and right hand side.

Unusual fireplace front left hand side Master bedroom

ACTION REQUIRED: Please see our comments in the Executive Summary.

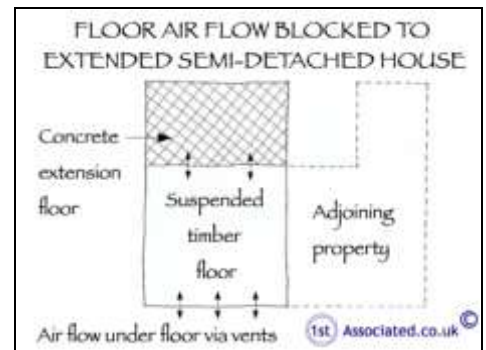
Suspended timber floor

Blocked air flow

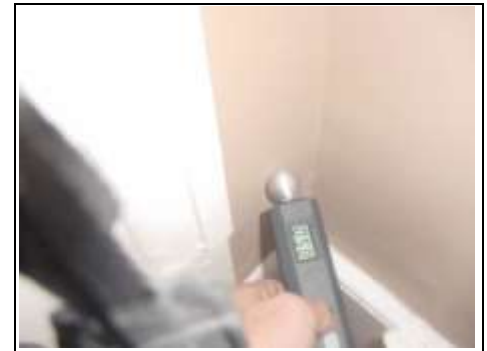
A random visual inspection and tests with a moisture meter have been taken to the perimeter walls and some internal walls. In this particular case we have found rising damp and we would comment as follows that the readings were higher than we would have expected in this age, type and style of property.

Testing for rising damp

ACTION REQUIRED: Please see our comments in the Executive Summary.

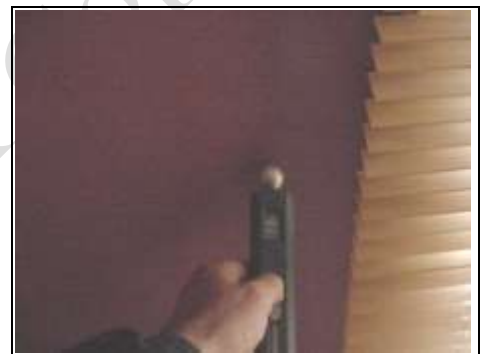
We used a damp meter on the external walls. We have found minor dampness which is in line with what we would expect to find.

Testing for lateral dampness

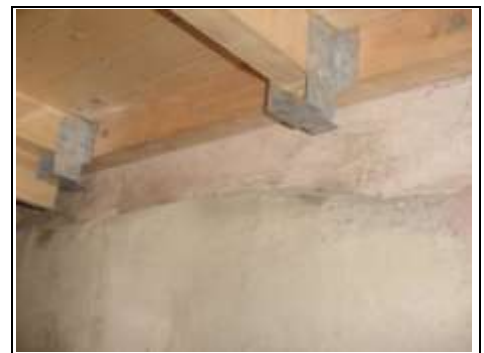
Quite unusually the floor has been changed in the cellar, this may relate to wet rot as the walls are damper than expected or may relate to woodworm.

Wet rot and/or woodworm previously to the floor

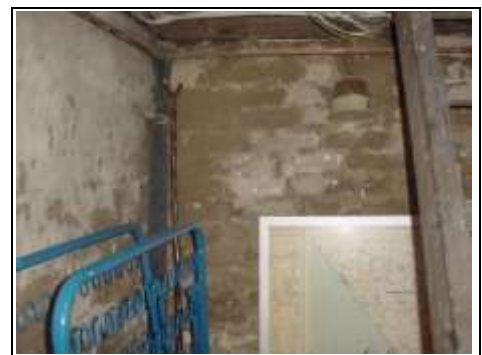
You have a small cellar we assume this was originally a coal cellar which is damp and we would not store anything of value in this area.

Cellar

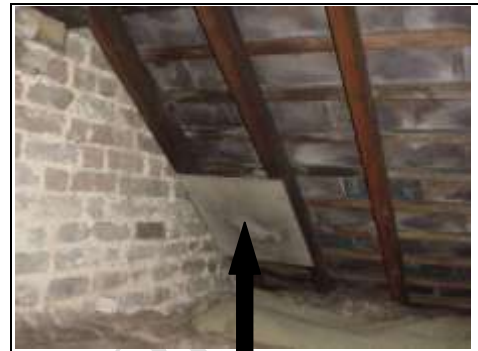
Asbestos to the underside of the roof slates.

ACTION REQUIRED: If you wish to confirm you are 100 percent free of asbestos you need to have an asbestos survey carried out.

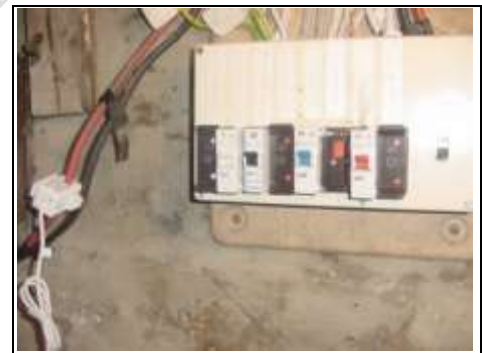
The electric fuses and consumer units were located in the cellar. The fuse board looked dated from the 1960s/1970s and better are now available.

Fuse Board

ACTION REQUIRED: Install a new fuseboard and add additional socket points.

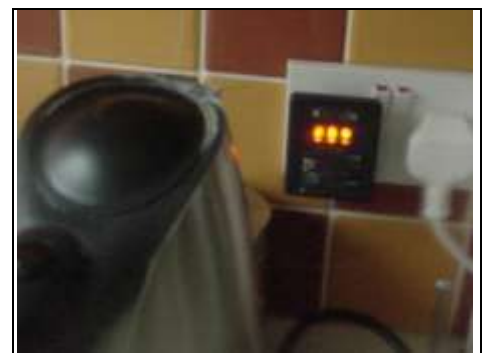
We carried out an earth test in the kitchen area to the socket point that is normally used for the kettle, this proved satisfactory.

Earth Test

ACTION REQUIRED: As the property is changing occupancy an Institute of Electrical Engineers (IEE) test and report should be carried out by a NICEIC registered and approved electrical contractor or equivalent.

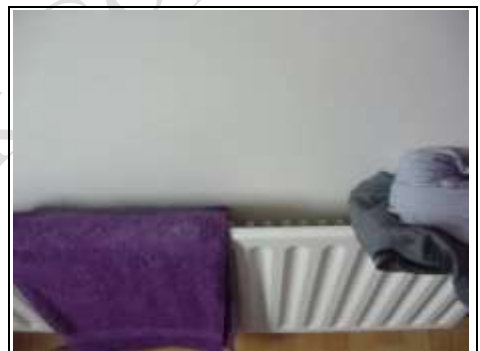
We noted single panelled radiators which may not heat the rooms to your desired level as quickly as you may wish.

Single panelled radiator

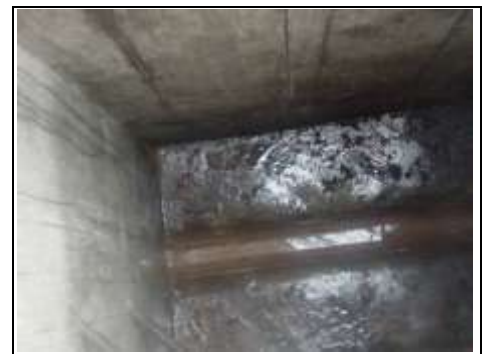
From what we could see it is **concrete** built and looks to be a relatively modern drain.

Manhole

ACTION REQUIRED: Your Legal Advisor to check and confirm if there have been problems with the drains by posing a written question on this issue.

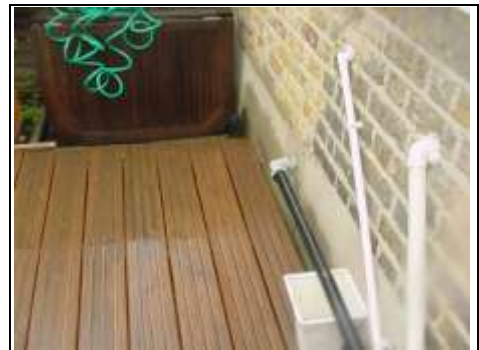
There is a decking area next to the property which where it touches the main building may be causing capillary action.

Decking to the rear

ACTION REQUIRED: Moving decking away from the building a fraction.
