RESIDENTIAL BUILDING SURVEY

Stanmore,
HA7

INDEPENDENT CHARTERED SURVEYORS

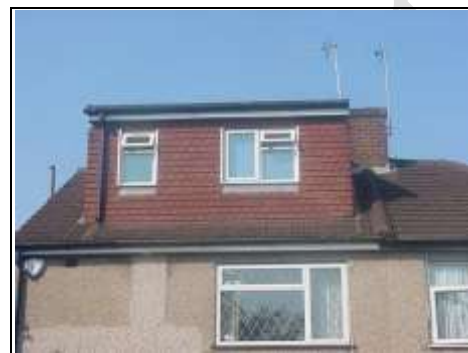
With an older style loft conversion such as this it may not have been insulated and as such can suffer from solar heat gain during the summer months and heat loss during the winter months.

Rear of loft conversion

ACTION REQUIRED: We would generally recommend that a roof access is formed into it so that you can actually access the roof to view it. We also recommend that at the same time insulation cut to falls is added to the roof and a high performance felt. This way you will deal with any roof problems in this area once and for all.

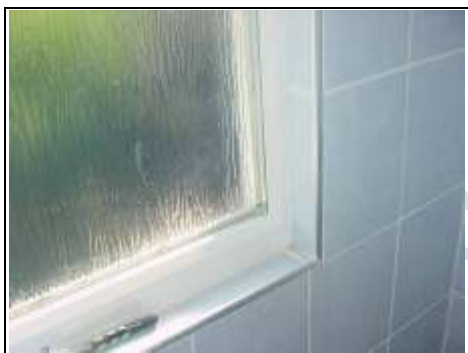
Thin walls in loft conversion
(en-suite shower room)

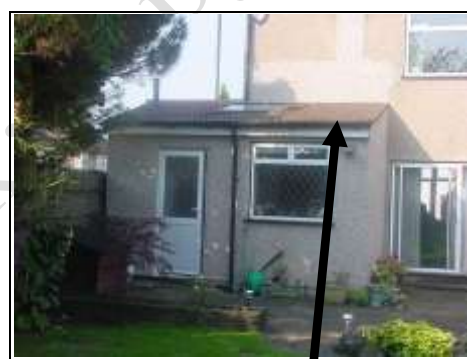
We are always slightly concerned when there is such a shallow pitch on a tiled roof as wind driven rain can get underneath it. From a visual inspection internally there are no visual signs of dampness coming in.

Shallow pitched roof to kitchen extension

ACTION REQUIRED: Keep all the gutters clear and remove moss and tree debris as the build-up can aid water getting into the roof.

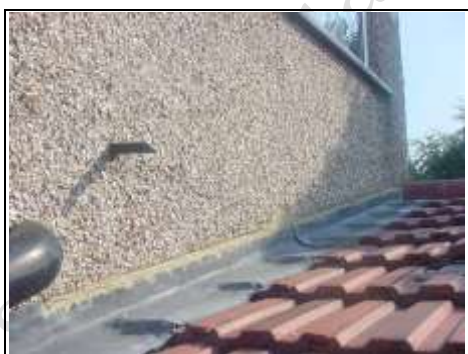
Flashing where the extension meets the main building

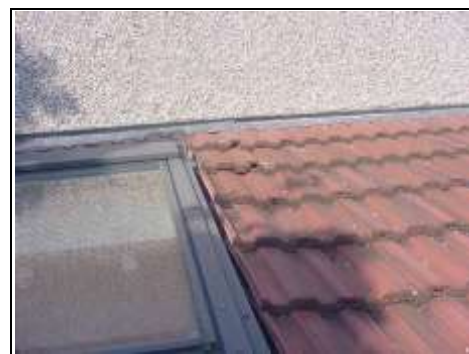
Shallow pitch of roof (remember to keep guttering around roof lights clear)

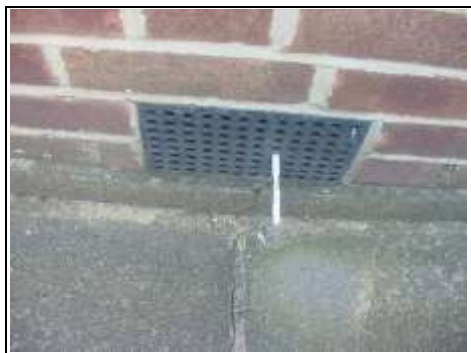
Air brick

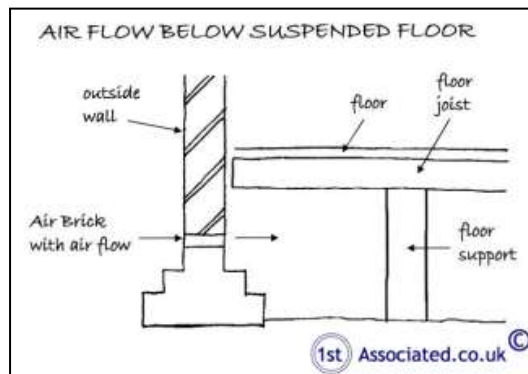
Suspended timber floor

Blocked air vents

Possibly due to the extension being added there do not seem to be sufficient air bricks to the property.

ACTION REQUIRED: We recommend that you double check that there are airbricks to both the front and the rear of the property to allow a through flow of air. Next time the carpets are replaced (or before 2014) we recommend you open up a section of the floor to check the condition of the timbers underneath.

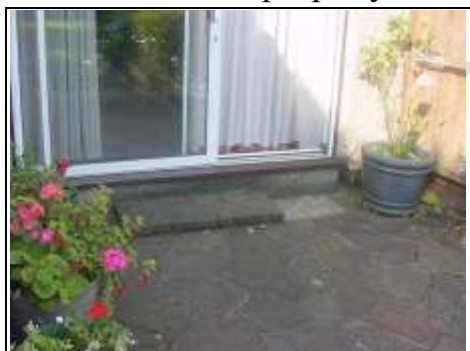
Patio doors with blocked air bricks

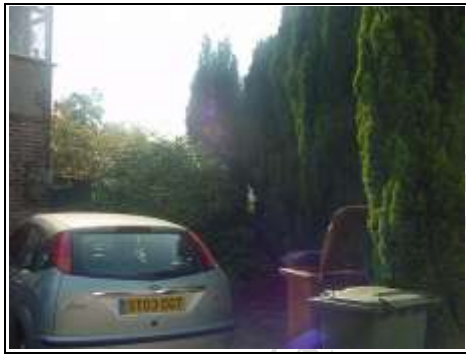
There are trees closer than most insurance companies would like and you may have to pay a premium because of this. We have personally found that where there is a mature tree and the house is relatively old, as in this case, then as long as the tree is well maintained then little damage occurs.

Trees to the front right hand side

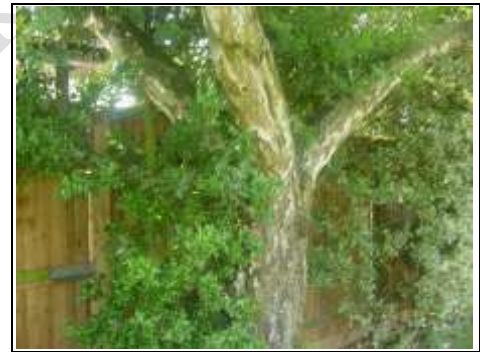
Trees to the rear of the property

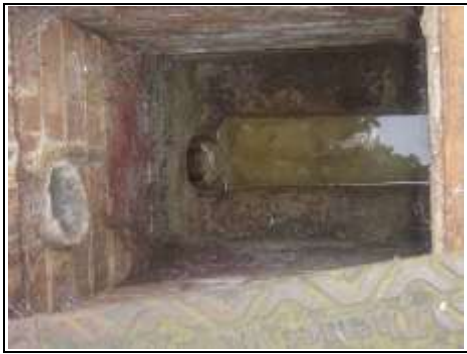
However in this instance we can see roots are starting to get into the drainage system so these need to be cut back. This also indicates that the trees need to be lopped.

Drain (front) with tree roots coming through (not very clear in photo)

ACTION REQUIRED: Your Legal Advisor should specifically ask in writing if the owners have had problems with roots in the drains in the past. We would recommend a closed circuit TV camera report to establish the condition of the drains to check if there are roots within them.

Please see our photographs earlier in the report showing some roots in the drains. These need to be cut back. For this reason we would recommend a closed circuit TV camera report to establish the condition of the drains to check if there are roots within them.

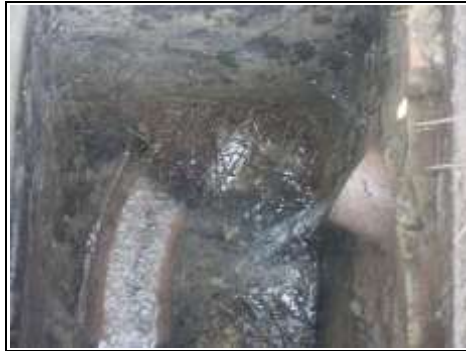
Drain (rear) with tree roots coming through

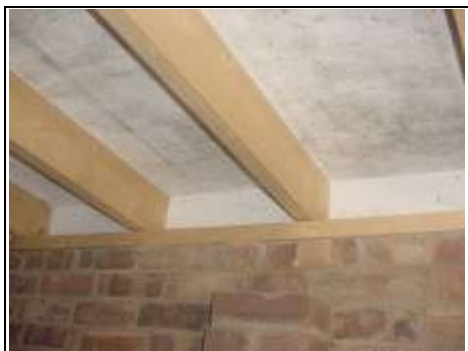
Mould coming through

ACTION REQUIRED: The roof is vented sufficiently from what we can see and it may simply be there is not enough general air movement in the garage. If this is the case you need to add some air bricks. We would also recommend that you cut back the bushes etc. that are starting to take over the rear of the roof and at the same time make good the parapet wall.

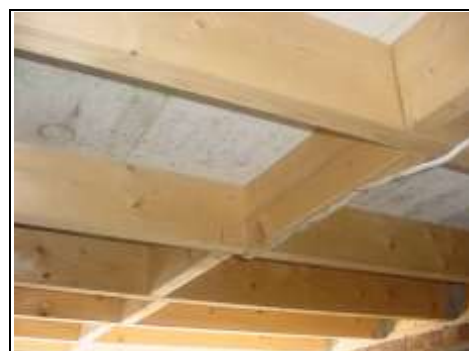
Mould indicates condensation is occurring

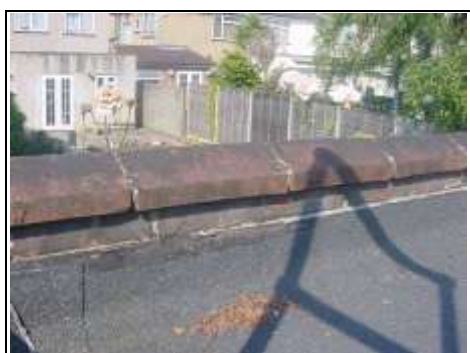
Parapet wall needs re-pointing

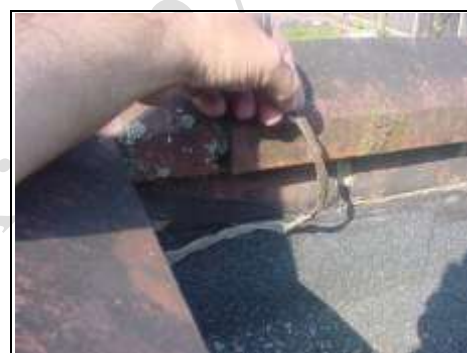
Mastic coming away

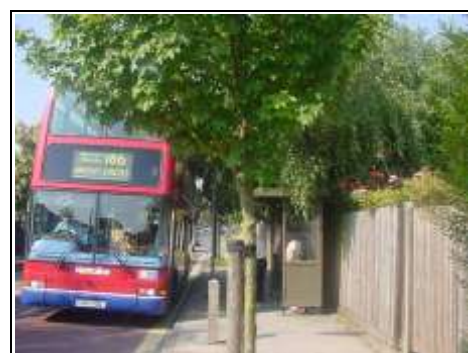
There is a fairly active bus stop near to the access to the garage. The trees may or may not shelter the view of your property.

Bus stop close to garage entrance

ACTION REQUIRED: You need to check that you are happy with this.

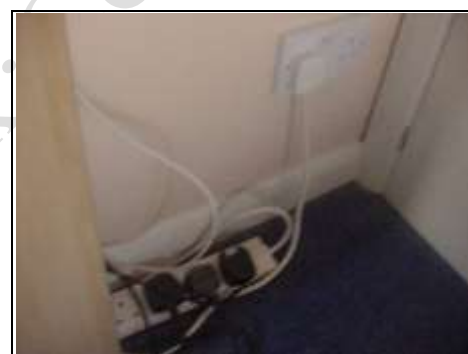
More socket points needed

We would also recommend increasing the number of socket points as there seemed to be a fair number of extension leads and adapters being used.

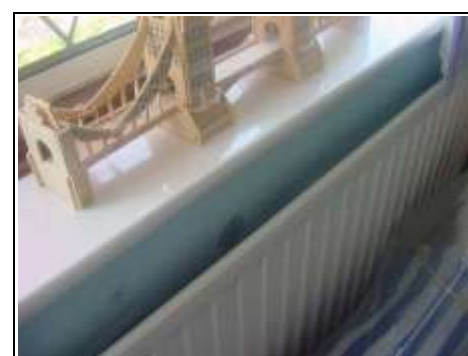
Single panel radiators

This property has single panel radiators. These may not warm the property as you would wish.

Single panel radiator

ACTION REQUIRED: You may wish to add double panel convection radiators. It is best to live in the property for a while and establish if it is warm enough for you before you carry out any work.

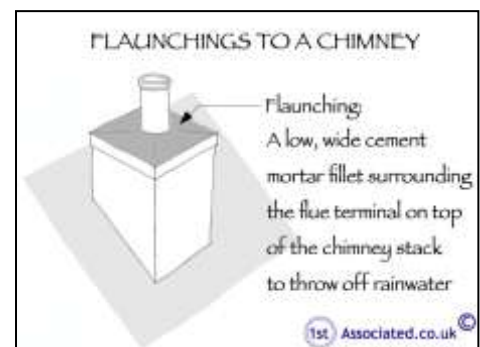
This chimney is brick finished with a lead flashing and no chimney pots. From what we could see, as we had a limited view, it looked in average condition considering its age, type and style.

Unfortunately we were unable to see the top of the chimney known as the flaunching, we therefore cannot comment upon them.

ACTION REQUIRED: Periodically inspect the chimney for weathered pointing.

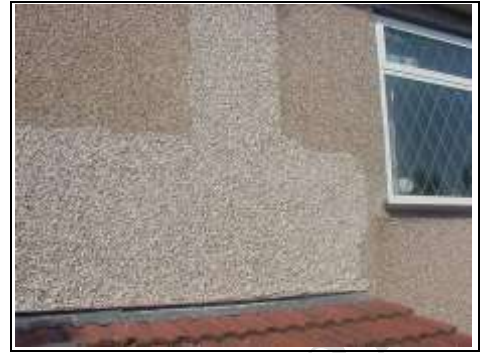
We spoke to the owners about this and they advised us that when the extension was carried out the rear chimney that used to vent the boiler was duly removed.

Chimney has been removed to the rear of the property

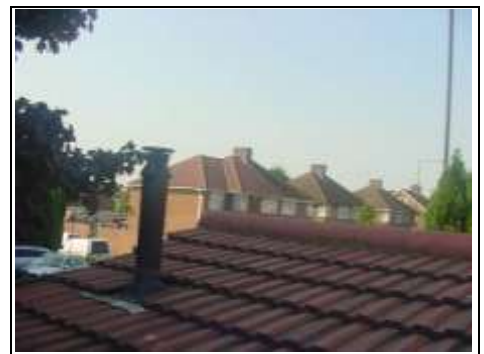
The property has a metal flue leading from the boiler that is visible on the rear extension roof. Where it is through the roof there is a lead flashing (which we were pleased to see).

Flue from the boiler in the kitchen

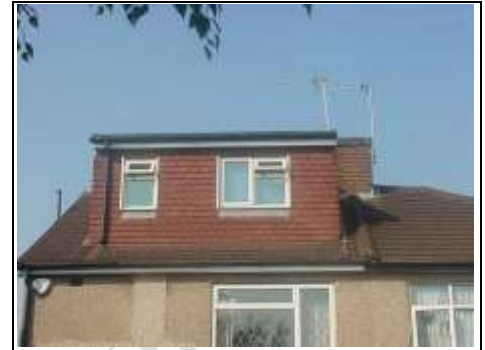
To the rear of the property a major dormer window has been added to allow for full height within the loft extension. The dormer window is made from a vertical tile with a felt roof (we could only see the edge of this). Our main concern about this is we cannot see the flat roof. What we could see seemed to be in average condition for its age, type and style.

Dormer window

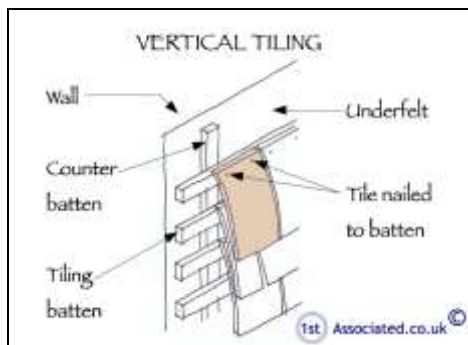
Vertical tiling

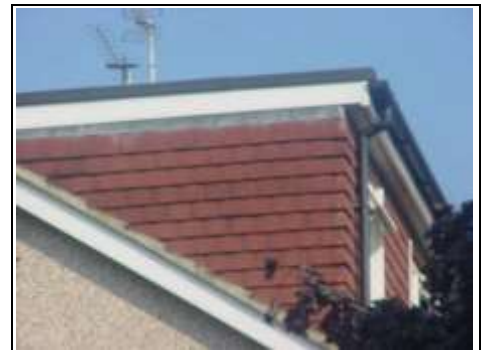
Dormer window side

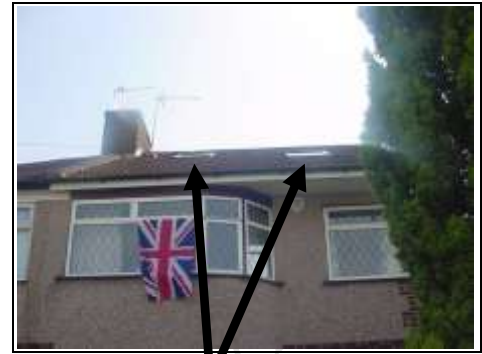
The property has four purpose made roof lights, two at the front of the main roof and two to the rear extension roof which all looked in average condition. The important factor with roof lights is the flashing around them.

Roof windows (front)

We would always recommend that your Legal Advisor double checks that full Local Authority approval has been obtained. In this particular case where there are roof lights to the front of the property they can sometimes be considered not acceptable by Local Authorities.

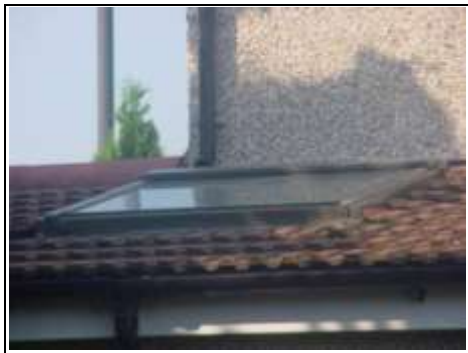
Roof window to the rear extension

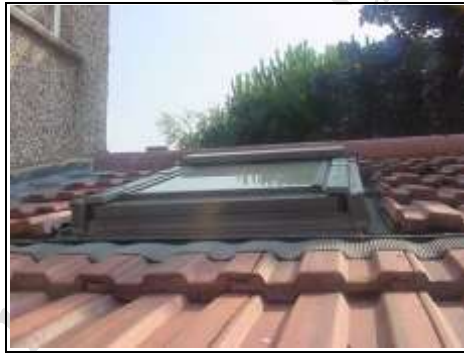
Roof window to rear extension roof

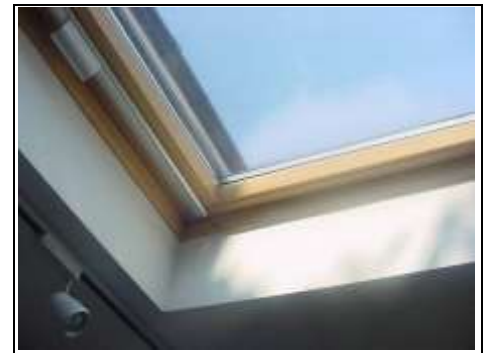
Roof window from within kitchen

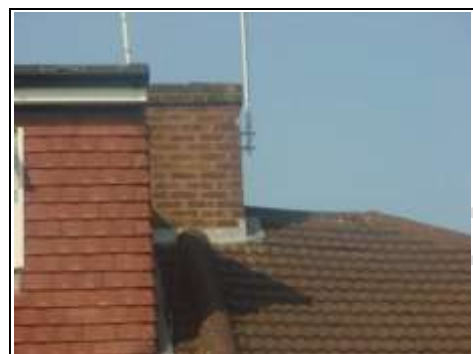
Hidden roof

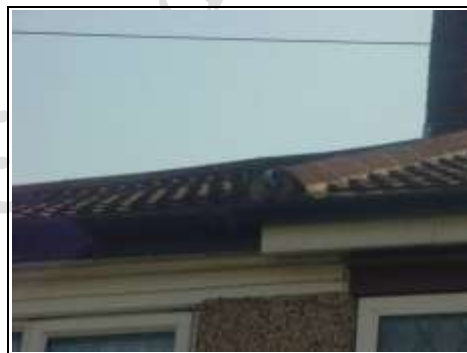
Hog backed tiles between the two roofs that indicate they were put on at different times.

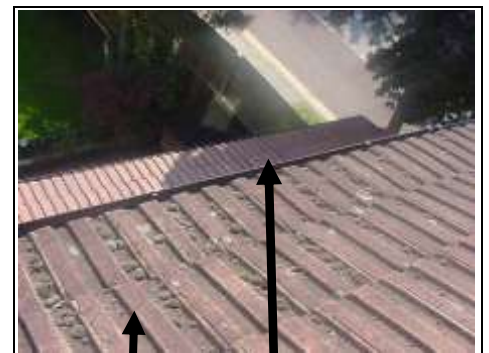
Main roof. Shallow pitch roof.

ACTION REQUIRED: Carry out periodic inspections and maintenance of the roof and clear roof of moss occasionally or as required. We would not recommend the roof is pressure cleaned.

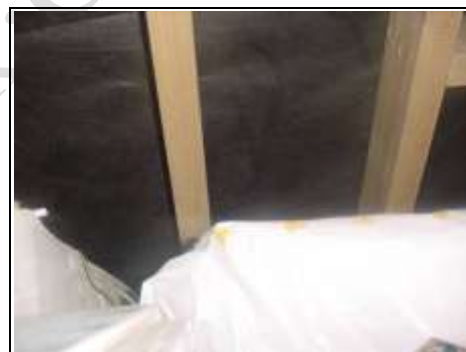
We have had a limited view of the protective underlayer due to rooms being formed in the roofs. The photos that we have included in this section are taken from within the cupboards and show perhaps ten per cent of the roof. They do indicate to us that an older style protective underlayer has been added – we could not see any ventilation that would typically be present in a more modern conversion.

This photo shows the common rafters (the ones that form the pitch of the roof) and the dark area between is the underlayer.

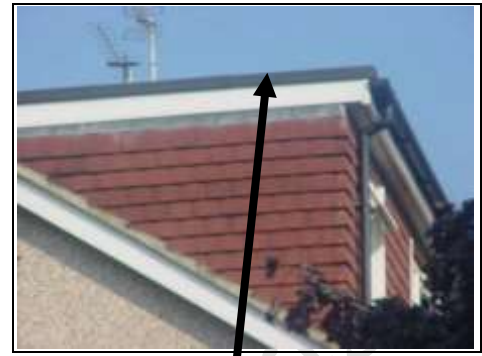
Dormer flat Roof

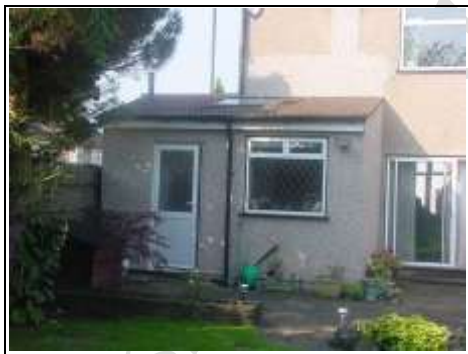
There is a shallow pitched roof clad with a concrete tile. There is a protective underlayer visible into the gutter which is our preferred detail. Wind driven rain getting in is the weak area and also where the pitched roof meets the main building.

Shallow pitched roof to kitchen extension

ACTION REQUIRED: Please see our comments within the Executive Summary and carry out periodic inspections and maintenance of the roof, as required.

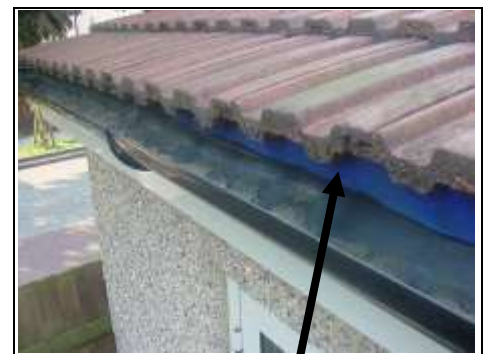
Underlayer visible on pitched roof

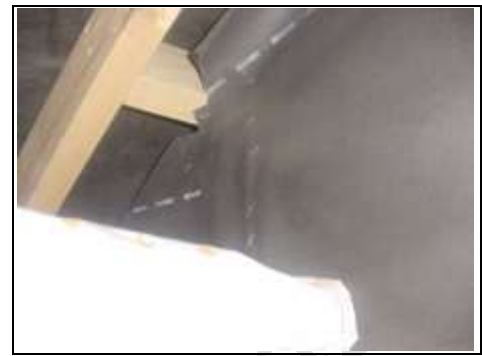
We could only see a very small section of the roof. In this section we could not see any of the following.

- Serious active woodworm
- Structurally significant defects to the timbers
- Structurally significant dry rot
- Structurally significant wet rot

Limited view of roof timbers

However this is not representative of the whole roof.

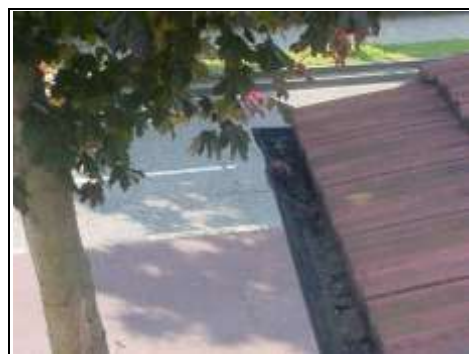
Gutters need clearing of leaves

We would always recommend that the gutters and downpipes are cleaned out, the joints are checked and the alignment checked to ensure that the gutters fall towards the downpipes.

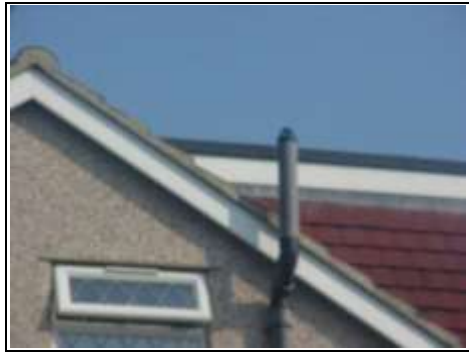
Soil and vent pipe

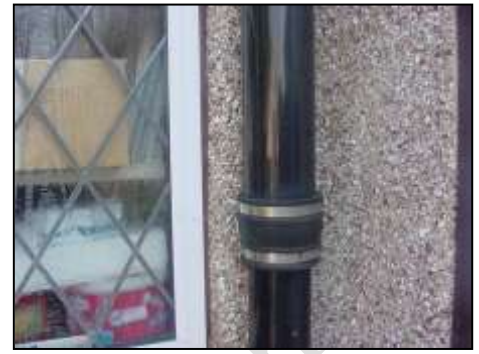
Combination of cast iron and plastic soil and vent pipe

ACTION REQUIRED: We would always recommend you stand outside the property next time it rains heavily and see how well the drains cope with the rainwater particularly looking at the guttering and the joints.

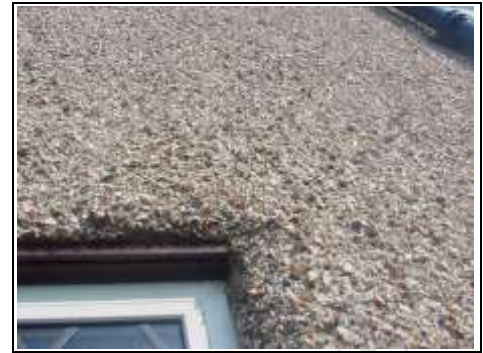
In this case we found no drip detail to the windows.

No drip detail over the window

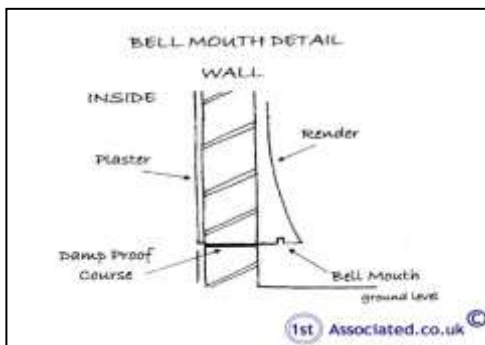
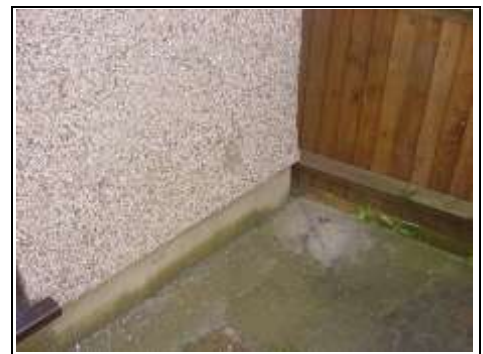
To the base of the render there was a bell mouth detail. We would also comment that the crazy paving may be slightly high.

Bell mouth to the base of the property

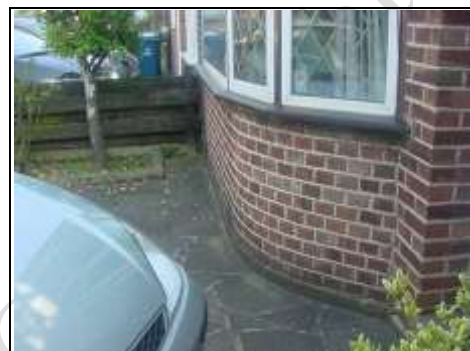
There is some decorative brickwork to the front around the bay window. The brick work coursing is a mixture of brick patterns and it would be normal in this age, type and style of property to have a solid wall construction which is what we would expect here.

Brick work detail to front bay

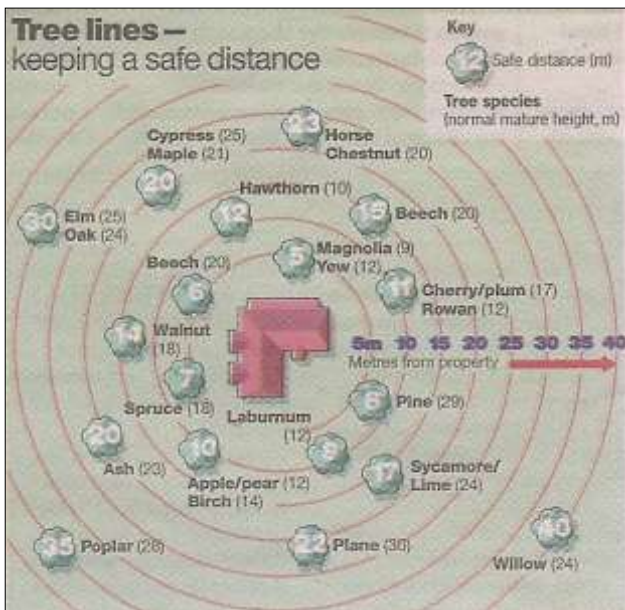
There are a fairly large number of mature trees in this garden. Most insurance companies are not keen on trees and these trees are within what insurance companies would term as influencing distance of the property.

Trees to the right of the property
(all directions given as you face the property)

We recommend that you check your insurance and check who the present owners are insured with before you purchase the property to see if there are any premium excesses etc. Please see our comments within the Executive Summary.

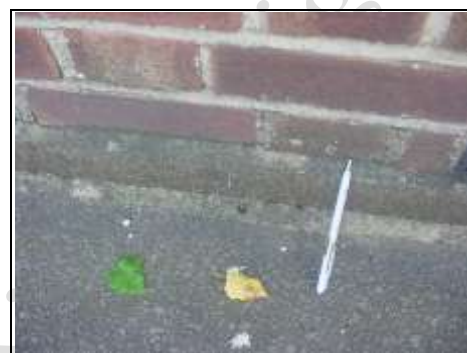
All modern properties should incorporate a damp proof course (DPC) and good building practice dictates that a differential of 150mm (6 inches) should be maintained between the damp proof course and ground levels. In this case we can see a DPC. This is slightly lower in some areas possibly due to the paving being added on top of the original surface.

DPC is slightly low in places

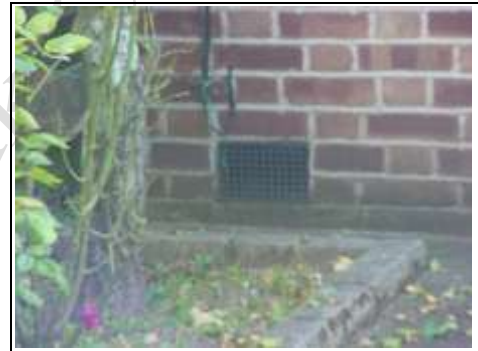
There are airbricks at low level. Air bricks are essential to have a through flow of air as this helps to reduce the chances of wet rot, dry rot and woodworm.

Air brick (front)

ACTION REQUIRED: Please see our comments within the Executive Summary

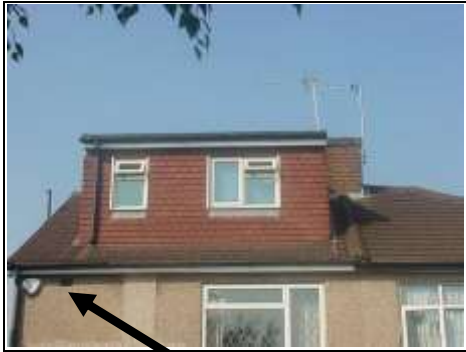
There are vents at high level.

Air brick

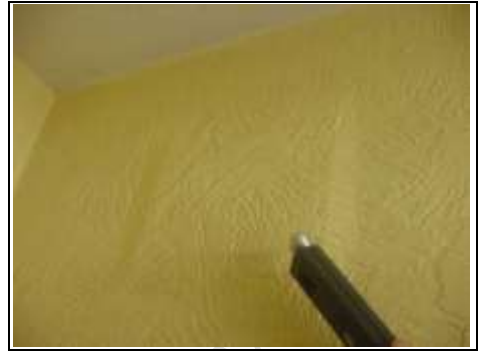
Internal air vent wallpapered over

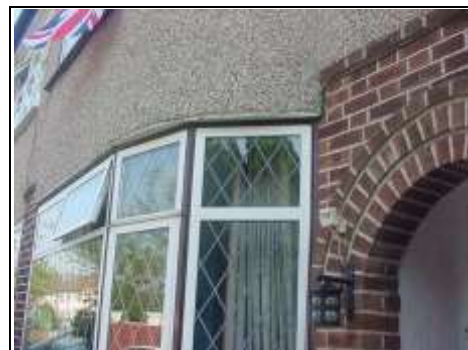
The property has timber double glazed windows in a timber frame without trickle vents, which generally look to be of average quality.

We would draw your attention to the fact that sealed double glazed units can fail, particularly as a result of poor workmanship during installation. Failure of the seal leads to condensation between the two panes of glass

Timber double glazed windows

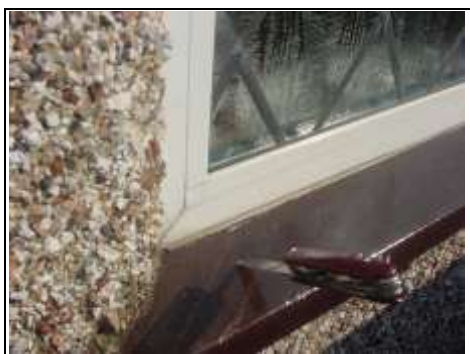
Testing the timber windows with a knife

This is where we push the knife into the window to check for rot. It is not rocket science!

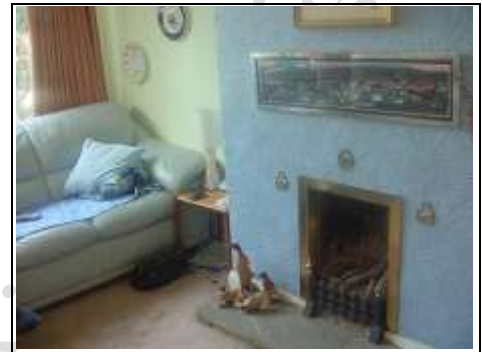
There is a feature fireplace in the lounge but we were advised it has not been used for many years and has only ever been used at Christmas.

Feature fireplace

It is strongly recommended that flues be cleaned and checked for obstructions prior to use to minimise the risk of hazardous fumes entering the building.

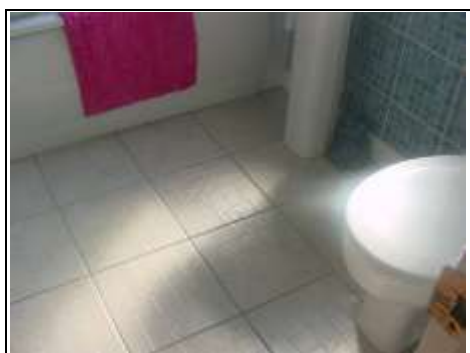
With a wooden floor you will always get some deflection, however minor. This deflection in the floor will ultimately mean that the tiles will need re-grouting.

Tiled floor on timber in bathroom

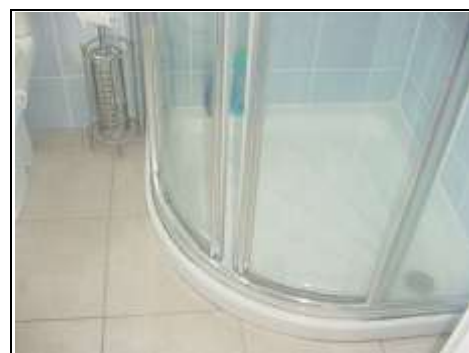
The en-suite shower room also has tiles laid on a timber floor, please see our earlier sketch.

Tiled floor on timber in en-suite shower room

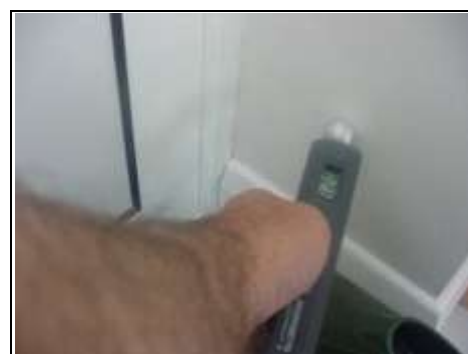
A visual inspection and tests with a moisture meter have been taken to the perimeter walls. In this particular case we have found no rising damp. We would comment that some areas of ground level are high externally and ideally should be lowered but this would be fairly difficult.

Testing for rising damp

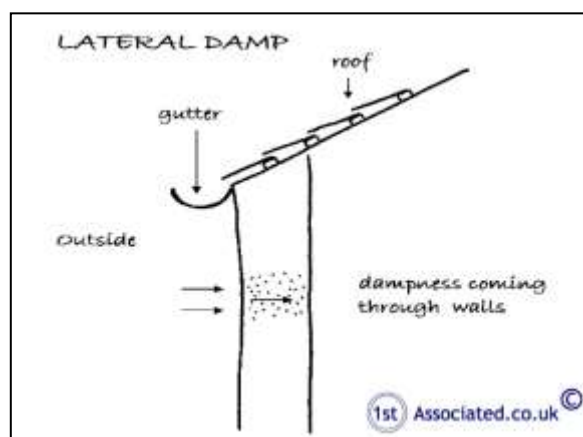
Removed chimney area

Sometimes we find that dampness comes through where chimneys have been removed or have not been removed properly. Without opening up the structure there is no way we can confirm this.

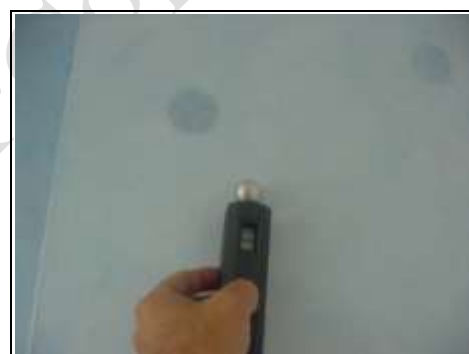
We used a damp meter on the external walls. We have not found dampness.

Testing for lateral dampness

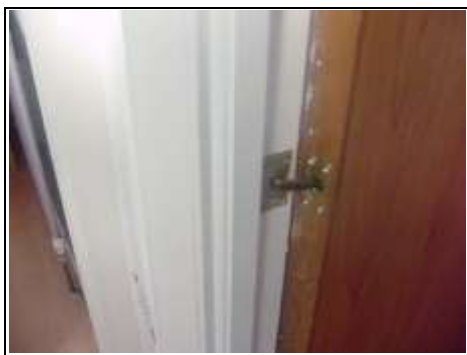
The doors are veneered doors. The perko door closers make these fire doors. At the time this conversion was carried out there was a requirement to have fire doors to a staircase. This was to stop the chimney effect of fire transferring from one floor to the next. You should keep these doors in place.

Perko door closers. These indicate loft conversion has been carried out legally

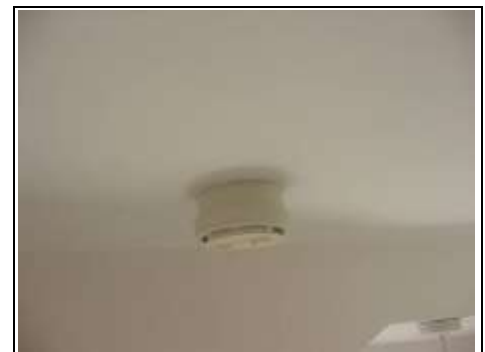
A hard wired system was noted which we were pleased to see.

Hard wired smoke alarm

ACTION REQUIRED: We would always recommend a hard wired fire alarm system and are also aware that some now work from a wireless signal which may be worth investigating. Whilst fire is relatively rare it is in a worst case scenario obviously devastating.

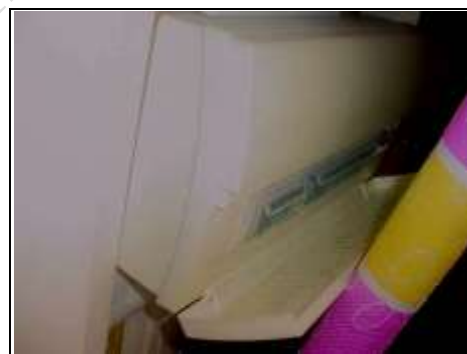
The electric fuses and consumer units were located under the stairs. The fuse board looked slightly dated, circa 1970's/1980's.

Fuse Board

ACTION REQUIRED: Please see our comments within the Executive Summary.

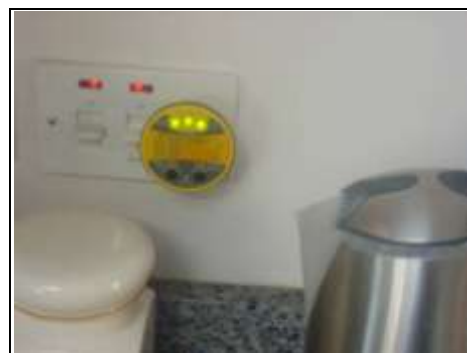
We carried out an earth test in the kitchen area to the socket point that is normally used for the kettle, this proved satisfactory.

Earth Test

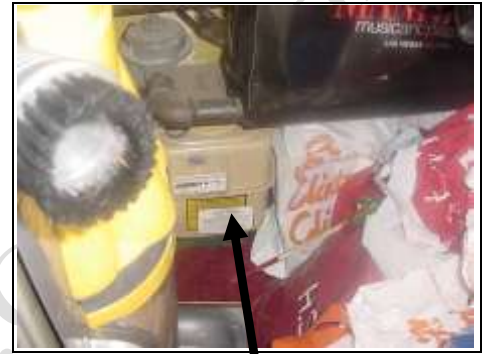
We are advised that the property has mains gas. The consumer unit is located under the stairs.

Gas consumer unit

ACTION REQUIRED: As a matter of course it is recommended that the entire gas installation is inspected and made good, as necessary, by a Gas Safe registered contractor. Thereafter the installation should be serviced annually.

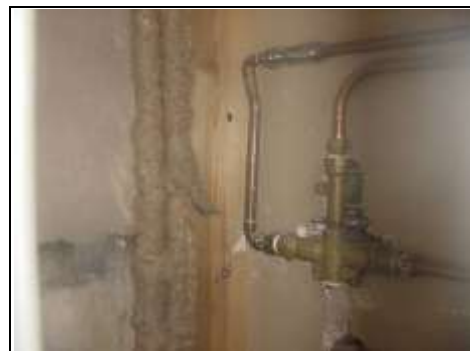
The plumbing, where visible, comprises copper piping. No significant leakage was noted on the surface, although most of the pipework is concealed in floors, walls and ducts. It was slightly unusual that we could see the back of it within the rear left hand room.

Plumbing visible in cupboard in rear right bedroom. The photo shows valves which can be turned on and off.

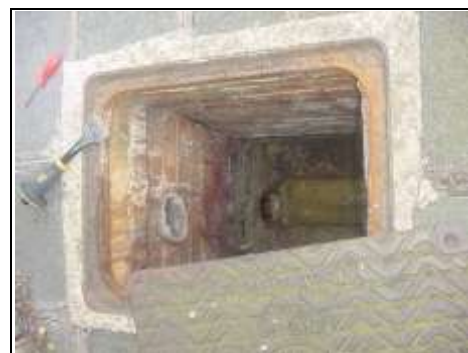
Manhole (front left)

We duly lifted the cover and found it to be free flowing at the time of our inspection.

From what we could see it is brick built. We could see tree roots in this manhole.

ACTION REQUIRED: Please see our comments within the Executive Summary.

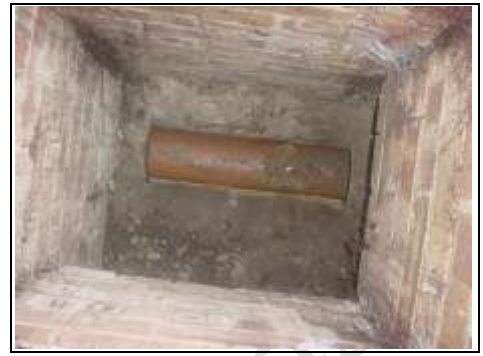
Manhole (front right)

We duly lifted the cover and found it to be free flowing at the time of our inspection.

From what we could see it is brick built.

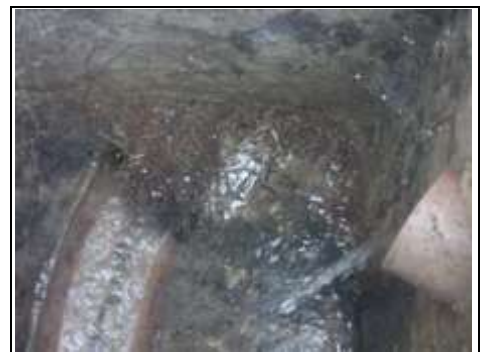
Manhole (middle right)

We duly lifted the cover and found it to be free flowing at the time of our inspection.

There are tree roots in this manhole.

ACTION REQUIRED: Please see our comments within the Executive Summary with regards to a closed circuit TV camera report.

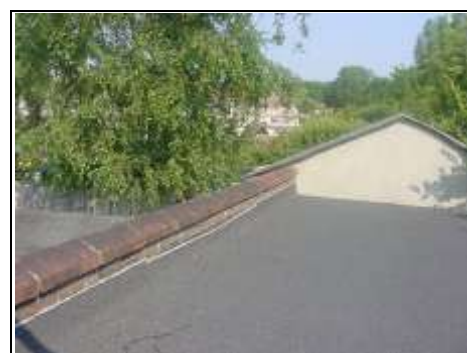
Flat roof

The garage roof is in average condition and probably has another ten years of life providing that the repairs are carried out to the parapet wall and the trees are cut back.

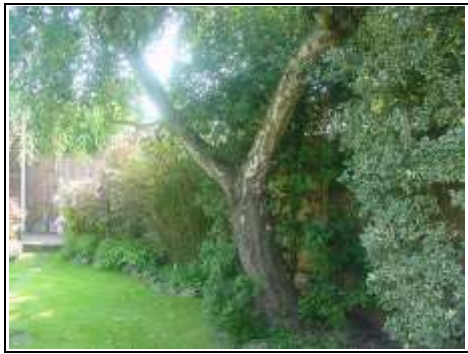
Large trees in garden

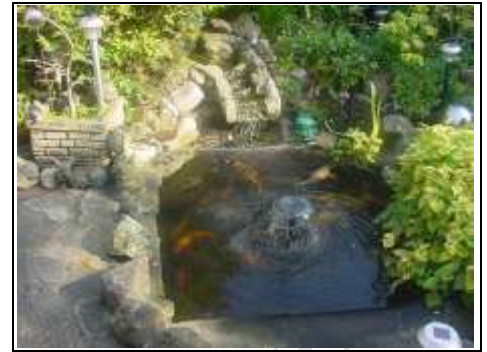
Pond
